# Preparation of ERT-RICH for RUN9

**K. Utsunomiya, Y. Watanabe**  
**University of Tokyo**

# ERT-RICH trigger boards

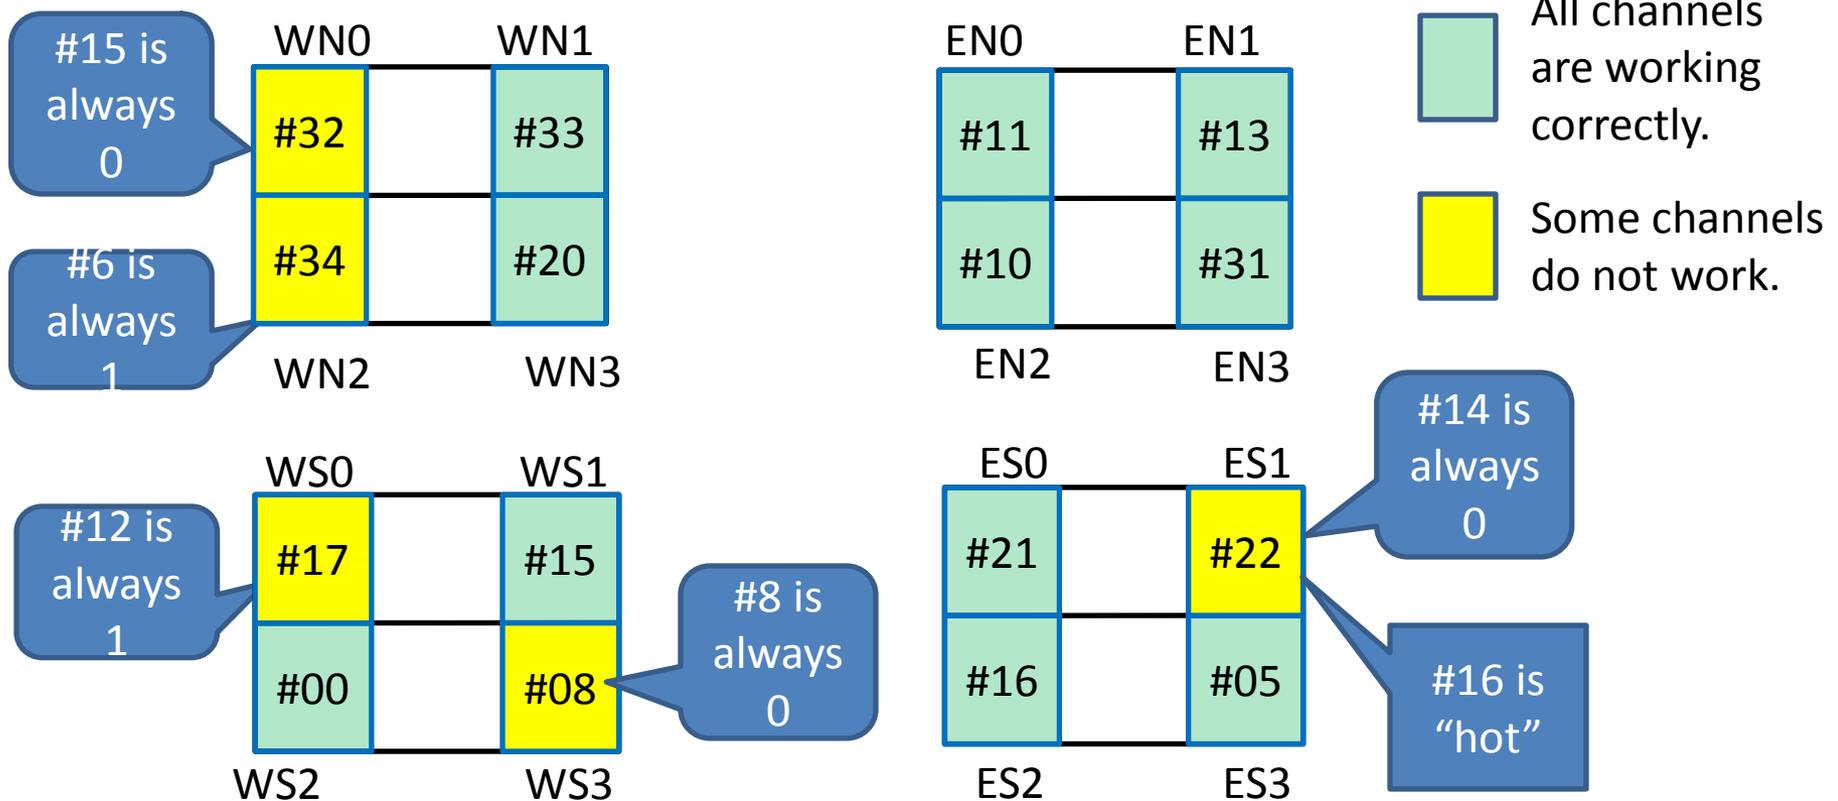
- We regard the channel "hot" when it has more than 50% "hot" events
- Even if we inserted another board, the channel always being 0 did not change, so problems are not in the ERT-RICH trigger boards but in the crates.
- We will replace the boards which have a channel always being 1.

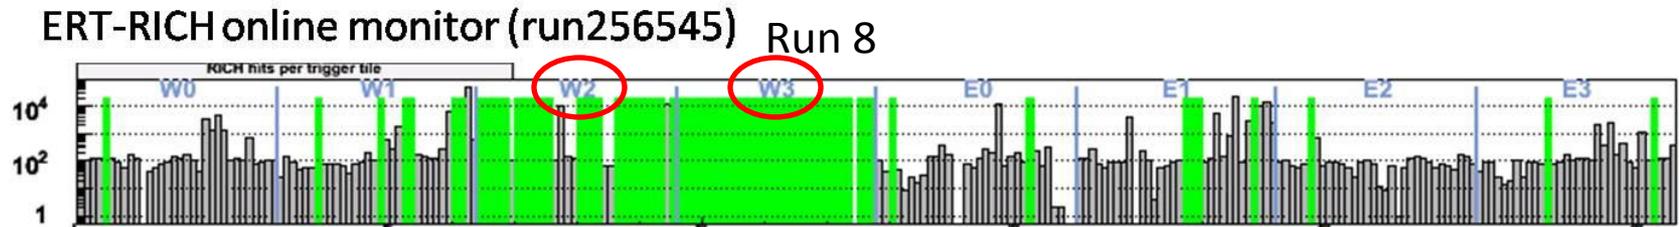
1: **98%** works fine.

4/16 level-1 trigger boards  
were not functioned.

**We can remove some masks on W2 & W3**
