Status of RICH LVL-1 Working

F. Kajihara, CNS
2002/Oct/10

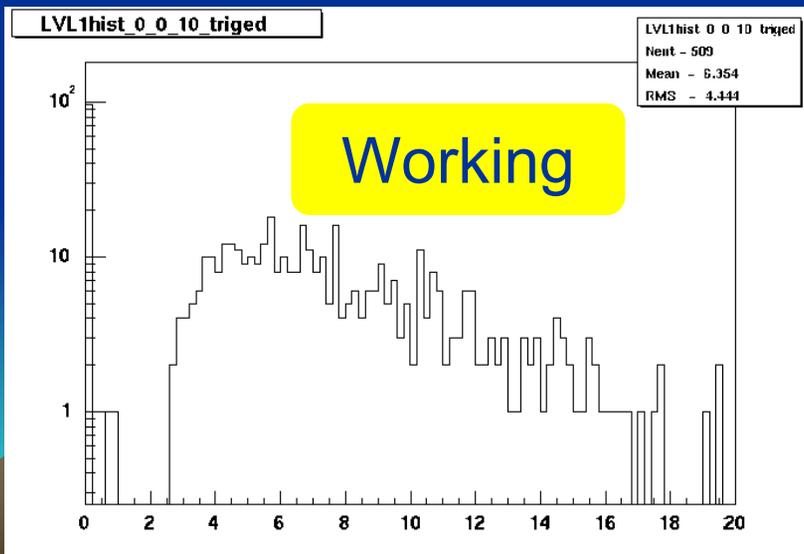
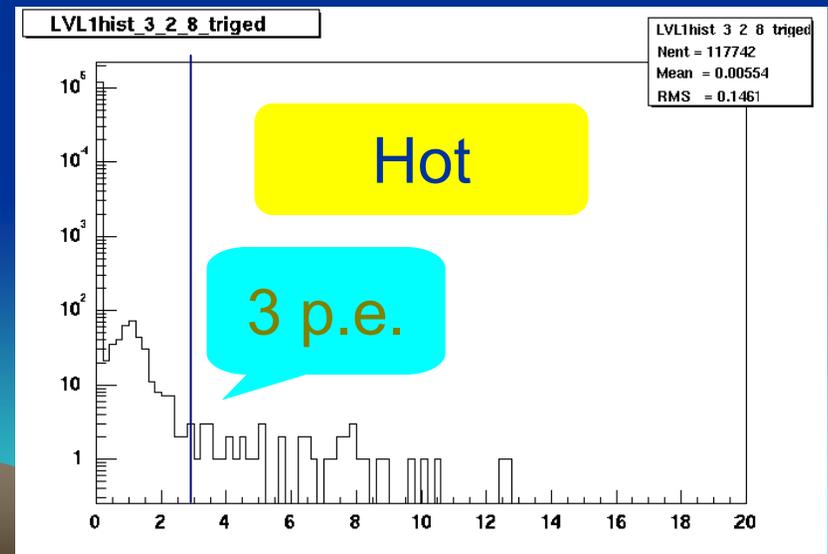
Problems in RUN 2

- In all 256 RICH LVL-1 tiles,
 - Working tile : 38 tiles (14.9%)
 - Noisy (Hot) tile : 74 tiles (28.9%)
→ Masked
 - No output (Dead) tile : 144 (56.3%)

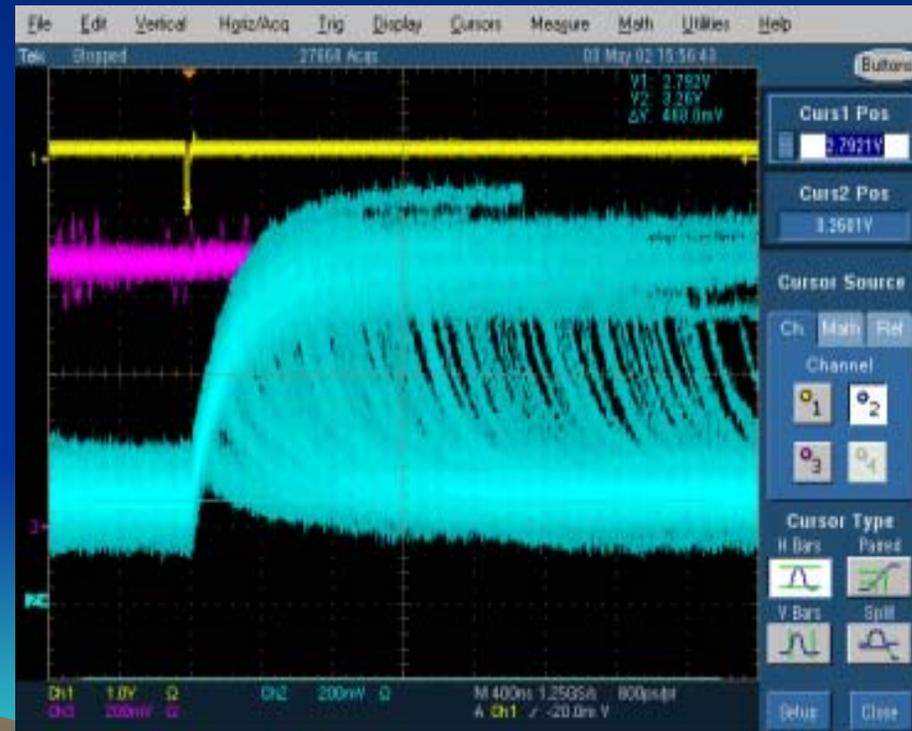
Noisy

- Hot channel
 - No trigger stop signal.(= The probable main cause)
 - Oscillation of base line by INT_R chips. (~ 1.0%)
- Dead channel
 - Differences of the bias voltage between 5 INT_R chips in some trigger tiles. (= The main cause)
 - RICH LVL-1 modules have some broken Op-amps. (~ 6.2%)

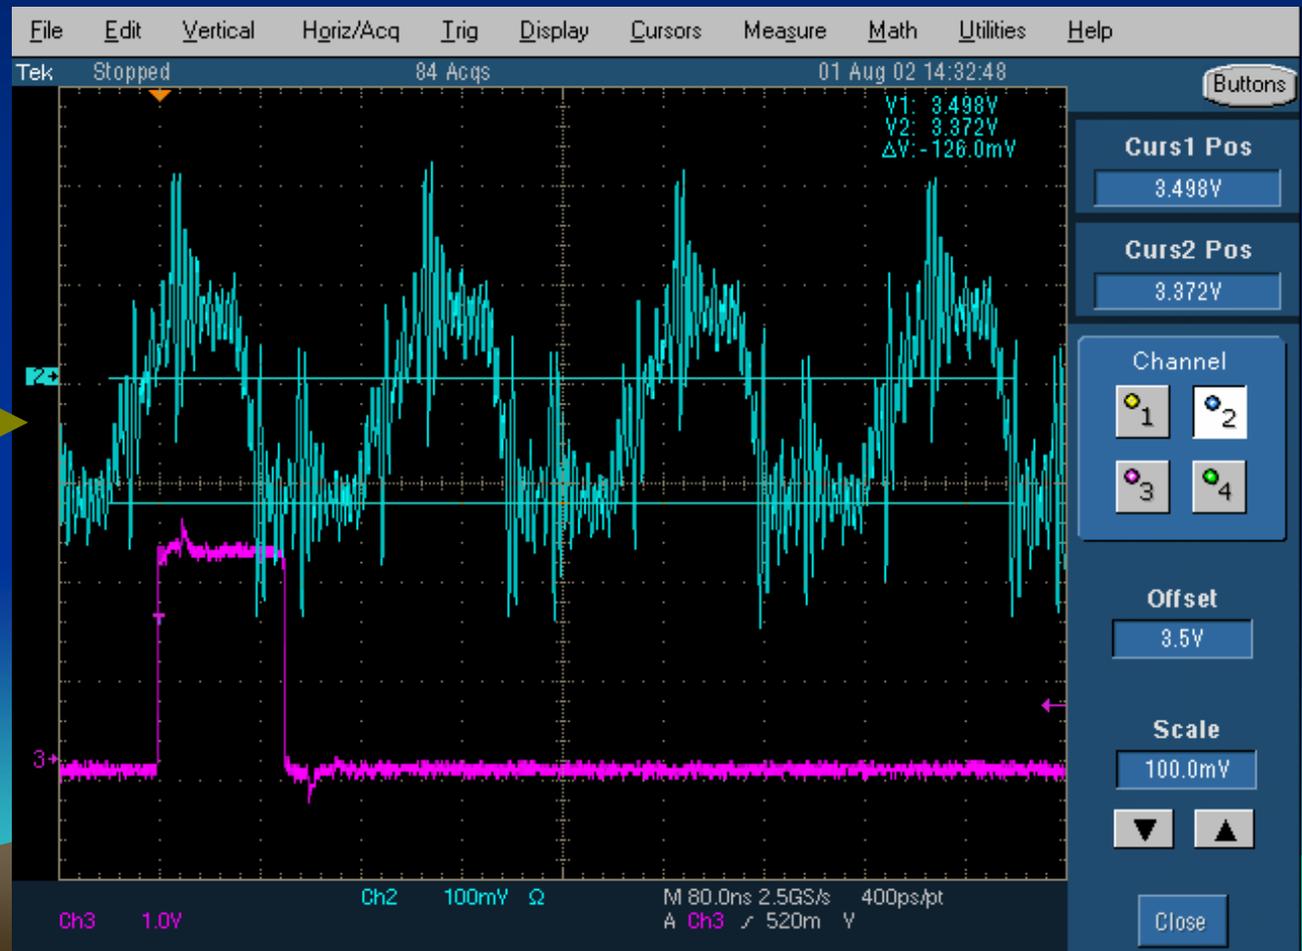
In front of FADC

Oscillation of base line

Base line
T ~ 200ns
A ~ 300mV
