Muon Tracker Electronics Performances and Issues

Vi-Nham Tram & Olivier Drapier, LLR, Ecole Polytechnique, France

Muon Tracker Electronics

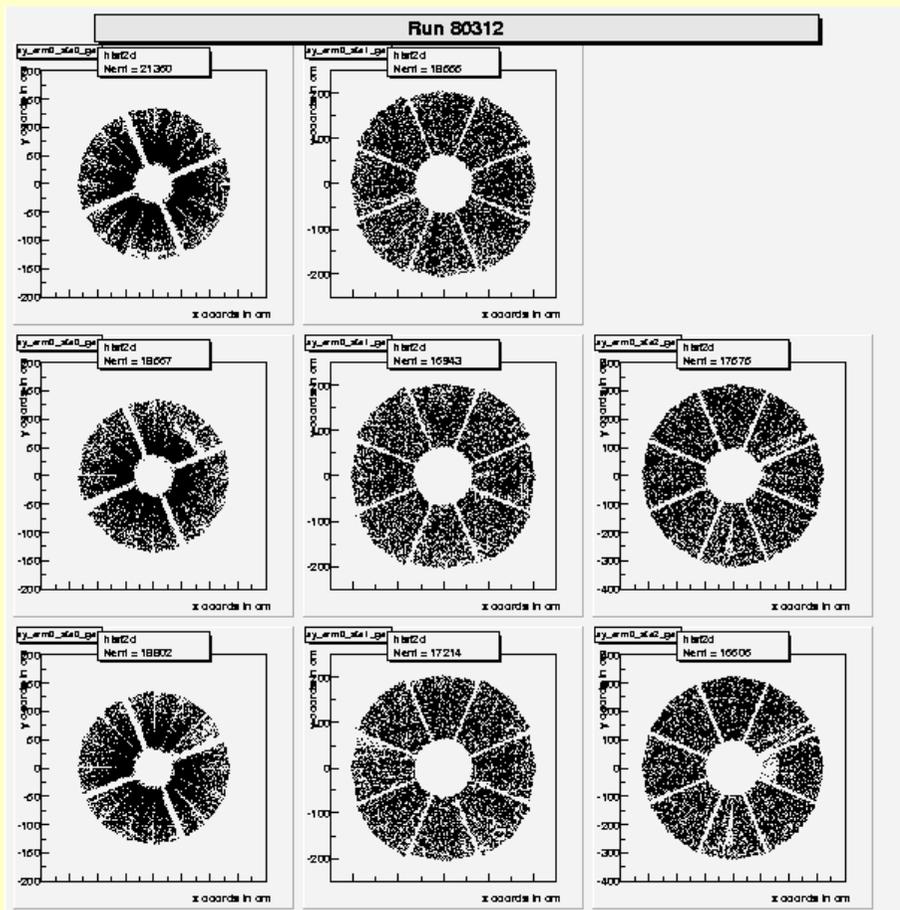
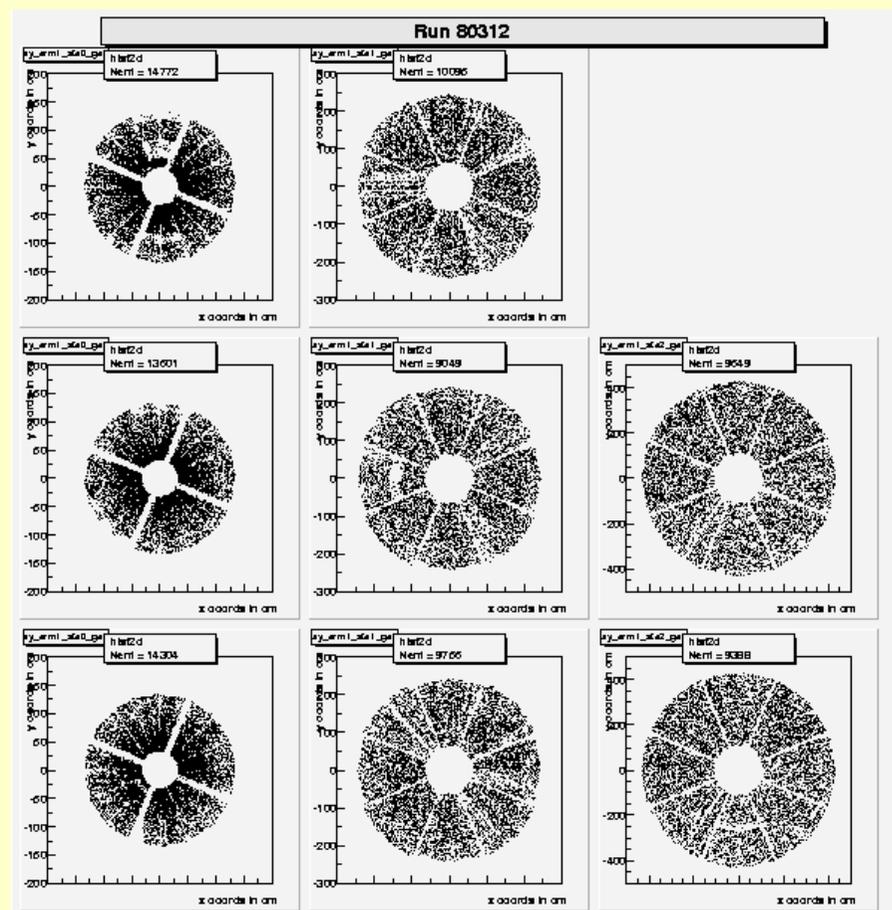
Run 3

Only few dead regions

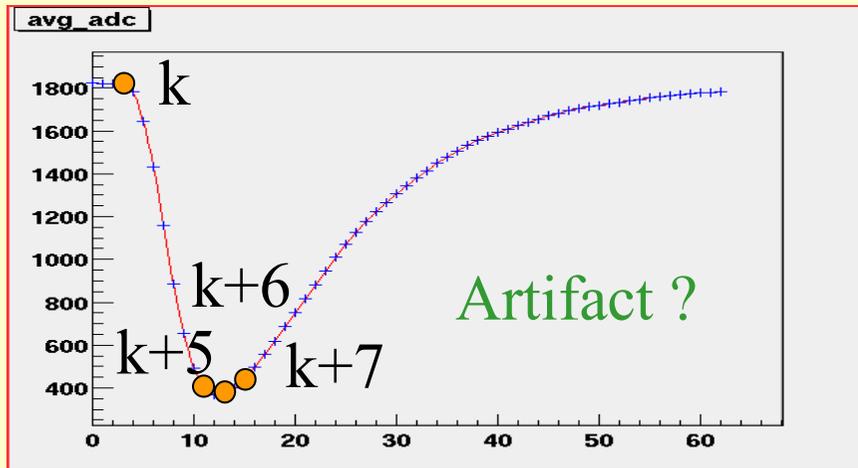
Some packets (~ 10 FEMs) have wrong cell addresses

- * either global shift : $k, k+5, k+6, k+7$ ($k \neq N$)
 - * or bad cell sequence : $N, N+5, N+7, N+8$
 - * total: $\sim 60\% - 100\%$ events in the worst FEMs
- \Rightarrow Artifact or real problem ?

= Good data

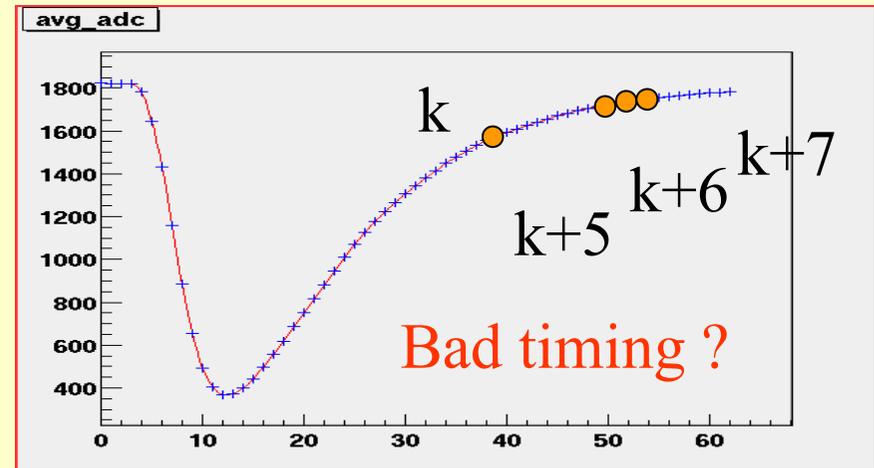
= Bad data

Mean values & RMS are identical for good & bad events

=> this AMU Cell problem does not affect data !

The internal counter just skips one clock tick sometimes, but we still don't know why it appears in some FEMs only...
