GEM test Update

**Anand K. Dubey
for the Weizmann Group**

Some problems faced during the production with second batch of GEMS (#32 onwards).

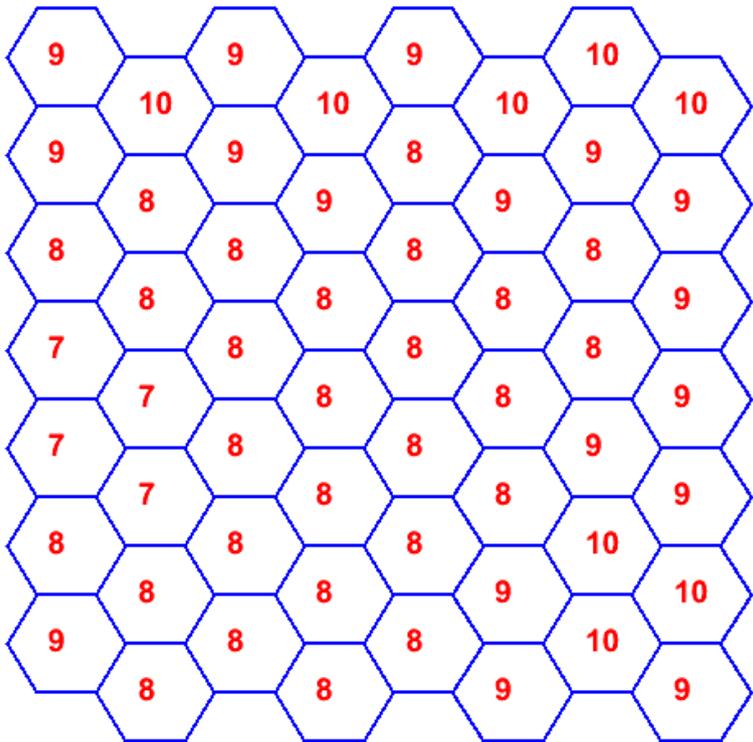
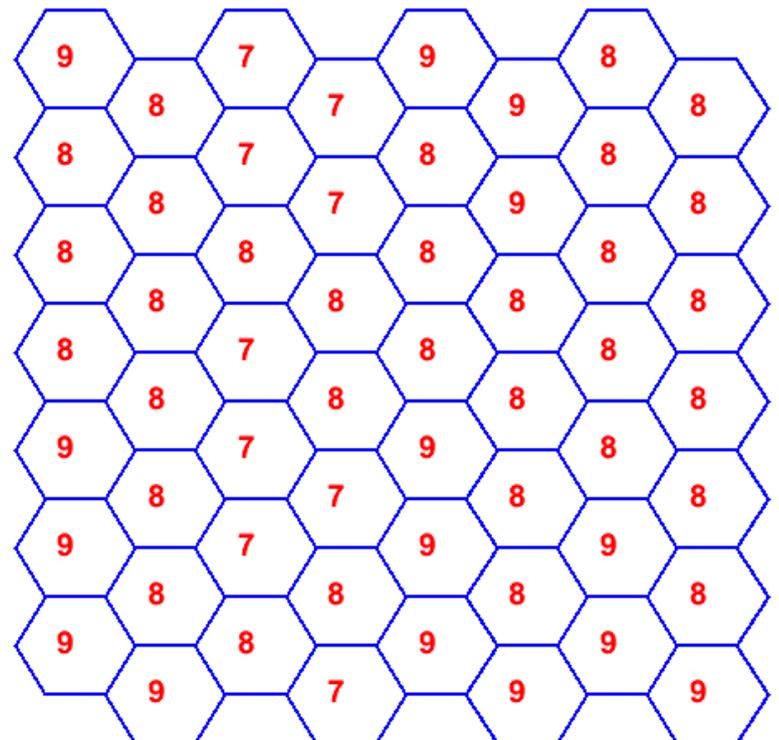
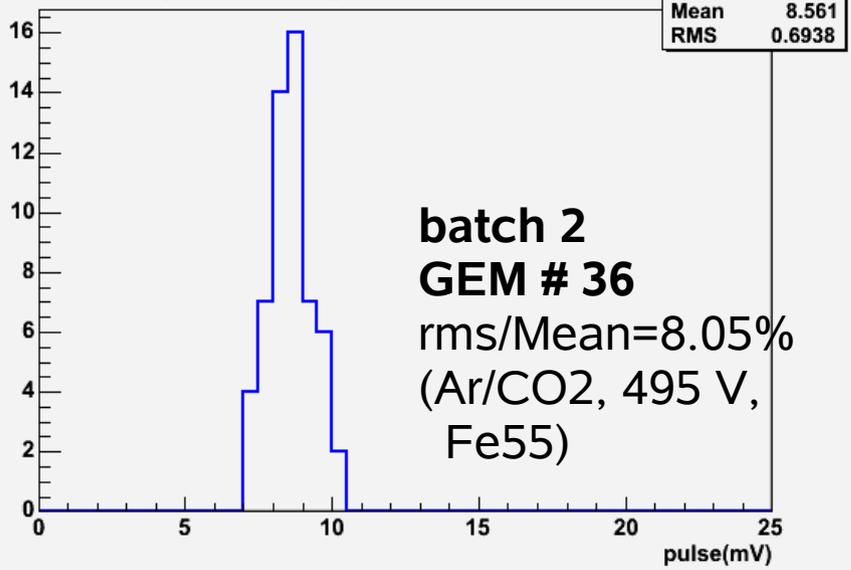
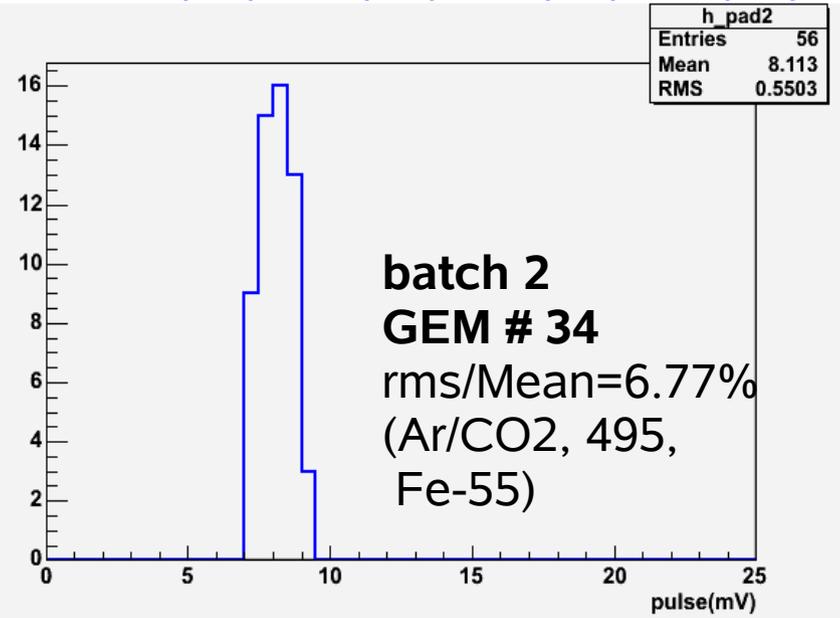
Peak pulse height distribution

- Cleaned two these GEMS(GEM #36, #34) with water thoroughly. They were tested at 500 V in air at 50 % R/H. Then carried out the Fe-55 test in Ar/CO2. NOW it showed normal behaviour. No discharges observed.
- The remaining 4 modules from batch 2 will also be water cleaned.
- Based on these -- some modifications introduced in the intermediate tests performed during the module production:
 1. Any new GEM foil will first be tested upto 500 V in air in the clean room, instead of 100 V.
 2. After all resistor soldering operations, the prepared module would again be tested at 500 V to ensure that no shorts developed during the course of gluing.
- The GEM production resumed after a brief gap. Results for the two GEMS from the second batch after water treatment are shown:
