PHENIX
Technical Support '14

October 2014 DC Meeting

- Major Projects This Shutdown:
 - VTX/FVTX Repairs and Maintenance
 - MPC-Ex Prototype removal - Done
 - MPC-Ex North & South Installations
 - MuTr maintenance (all stations)
 - MPC North Repairs and modifications to accommodate MPC-Ex - Done
 - DC East & West maintenance
- Other Detector support as necessary
- sPHENIX project planning and engineering continues

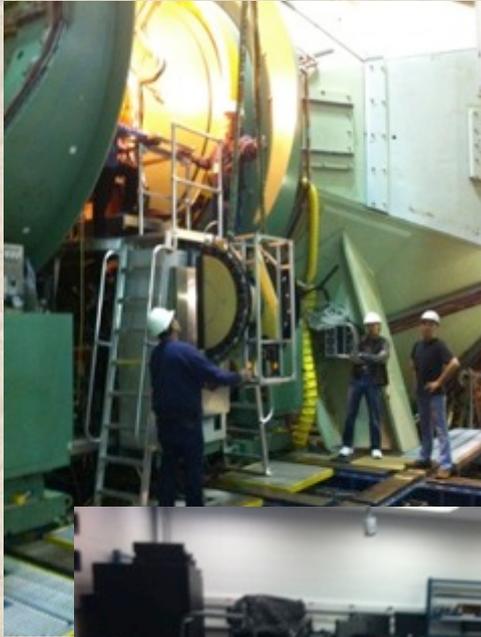
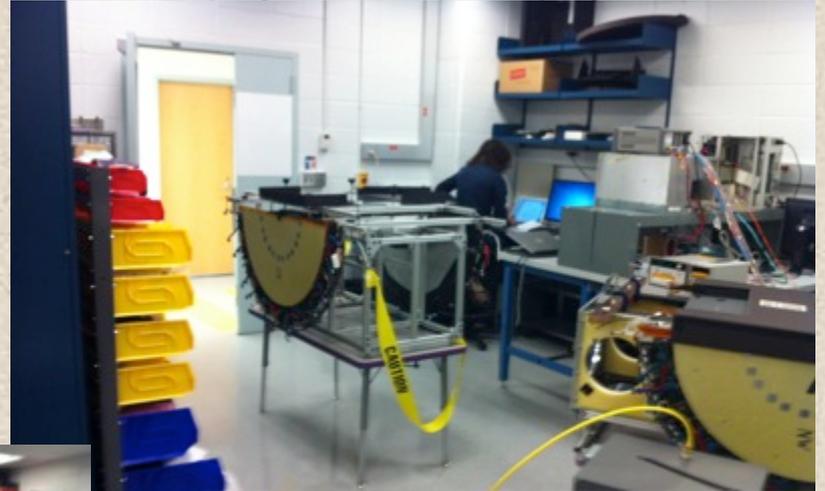
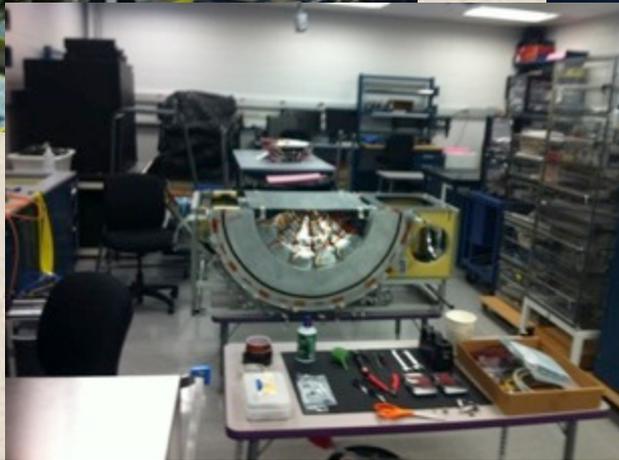
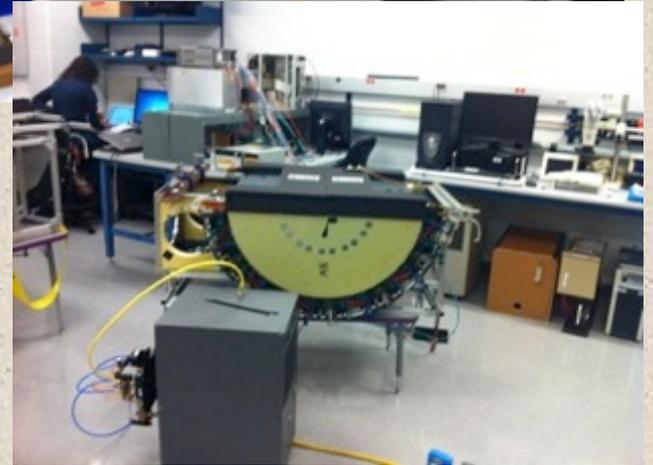
VTX/FVTX east & west repairs/upgrades
under way

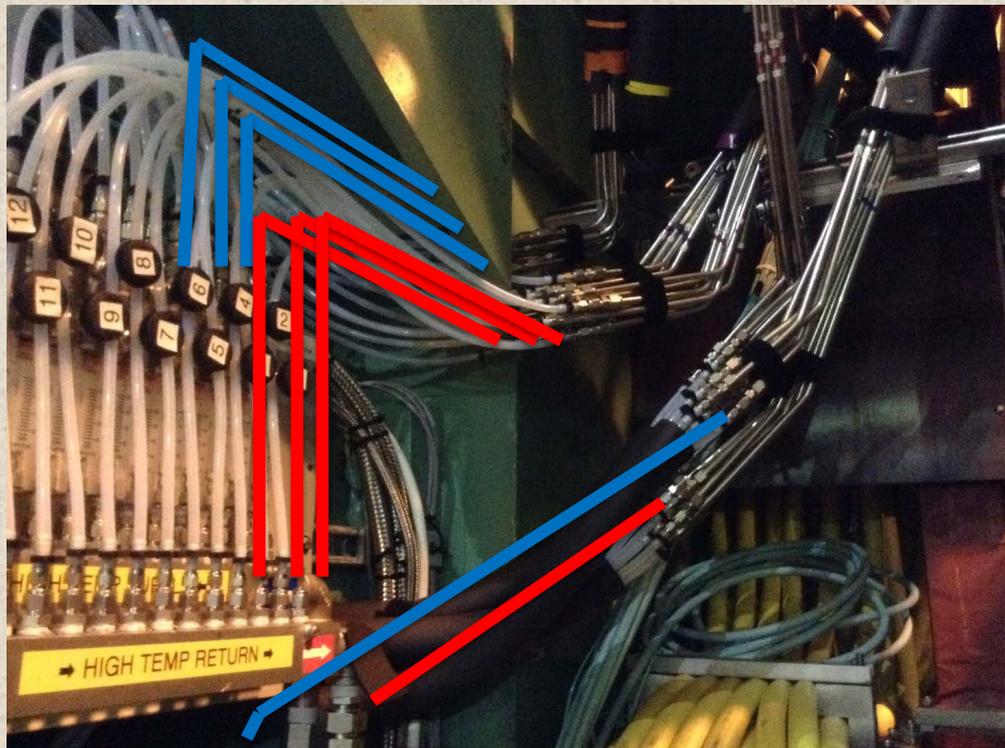
Top manifold has 13 Supply and 13 return lines.
Both North and south need to be replaced.

Bottom manifold has 9 Supply and 9 Return lines
Both North and South need to be replaced

Current labeling on tubes needs
to be maintained and copied to
new lines

Bends need to be done
carefully so not to
restrict flow. Swage
elbows can also be used
for sharp bends

Replace All Teflon
lines with $\frac{1}{4}$ " ID 316
thin walled Stainless
McMaster
Coil: 89995K82
Or Rigid with Min ID
0.21" (89995K288)

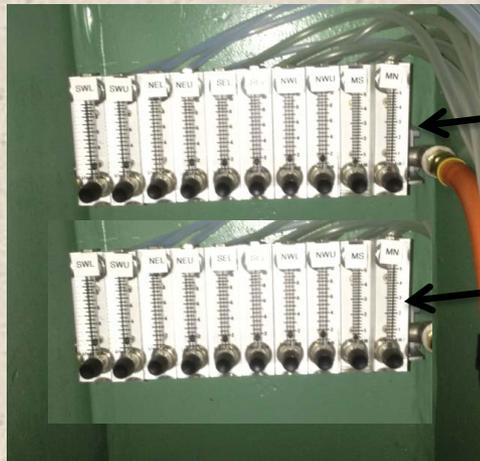
VTX/FVTX N2 Supply Manifold.
Located on south side of central
magnet

Original N2 Distribution Panel

New N2 Distribution Panel

- 10 flowmeters
- 0-10lpm
- Output ¼" I.D barb
- Leave about 10" space between manifolds.

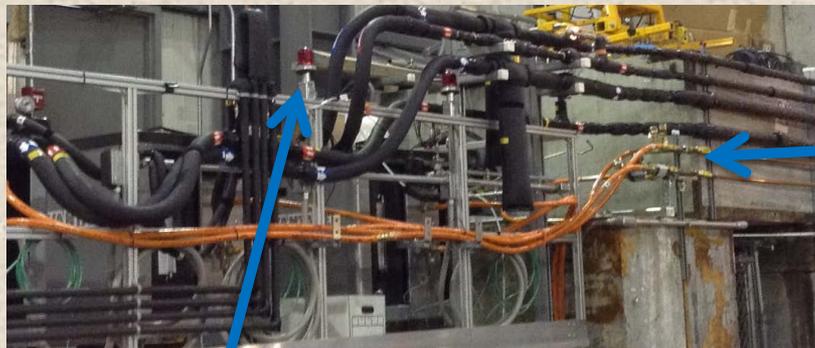
Manifold Location

Permanently connect water lines to all 3 chiller through a new 3 channel manifold. Currently the manifold only has 2 channels. It needs to have a 3rd channel added for the spare chiller. We should also replace the flowmeter s with ones that have a smaller scale.

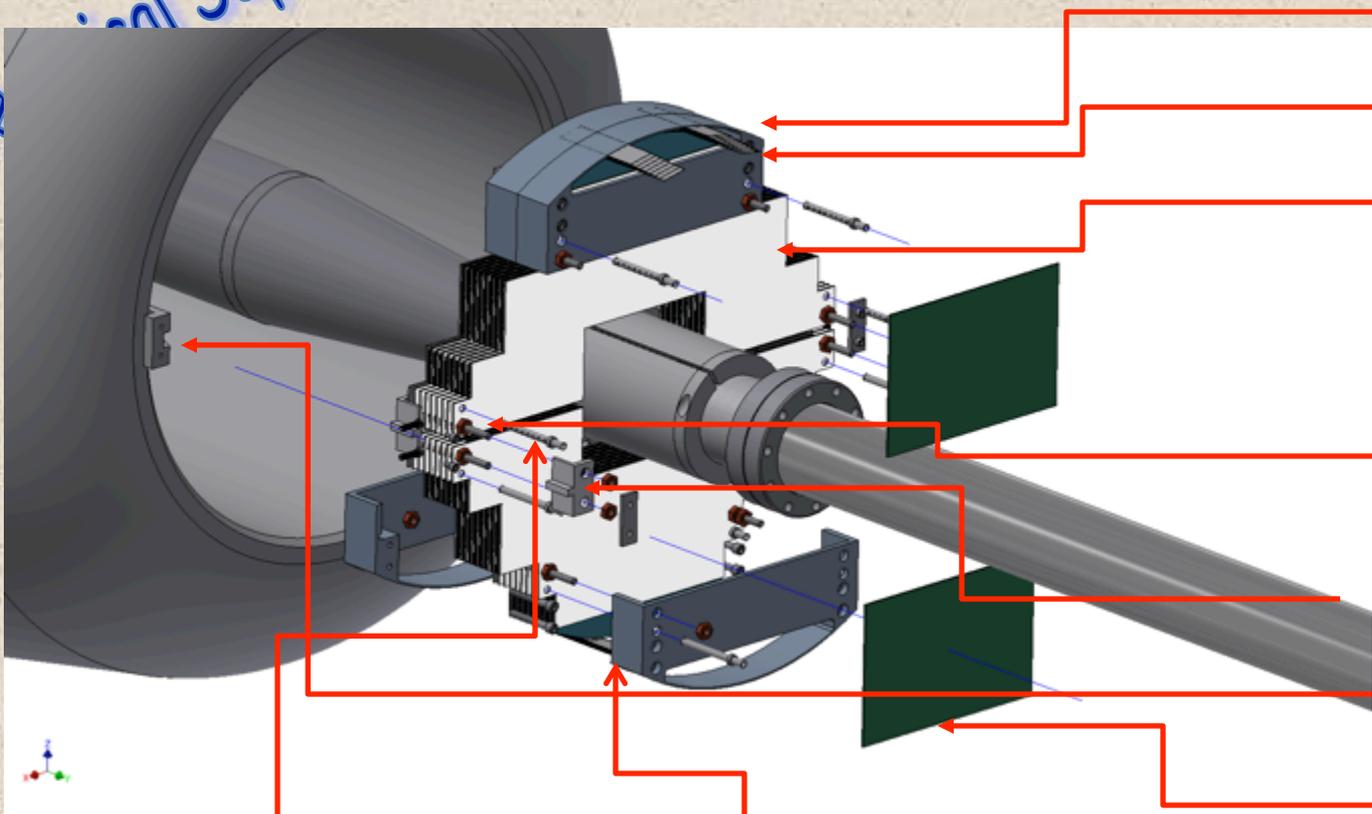
MPC-Ex Exploded view

- Upper covers
- Signal Cable pigtails
- 8 layers of tungsten & detector electronics backed by Delrin cover (top and bottom halves)
- Threaded rods and spacers
- Mounting tabs
- Mounting clips
- LV distribution boards

Lower covers

Cooling air manifolds

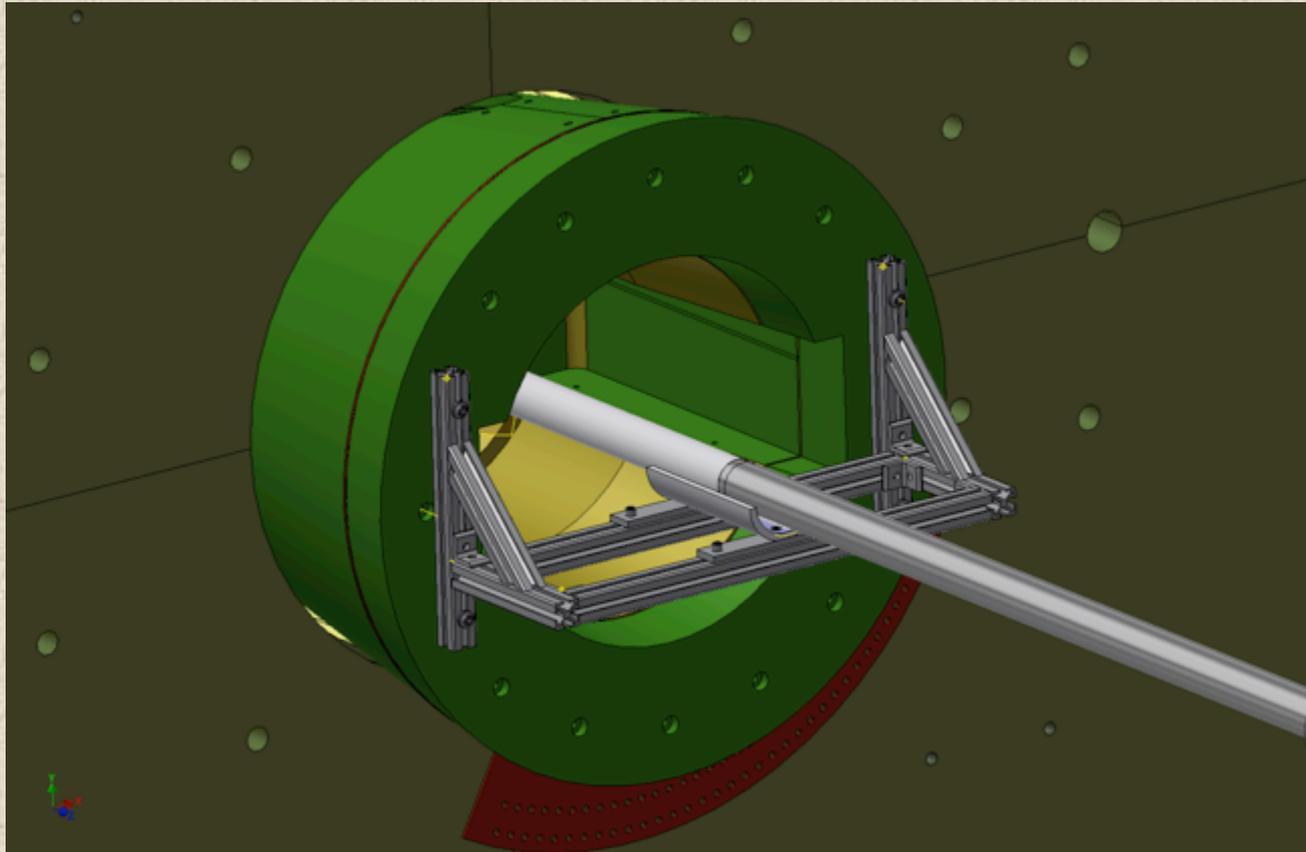
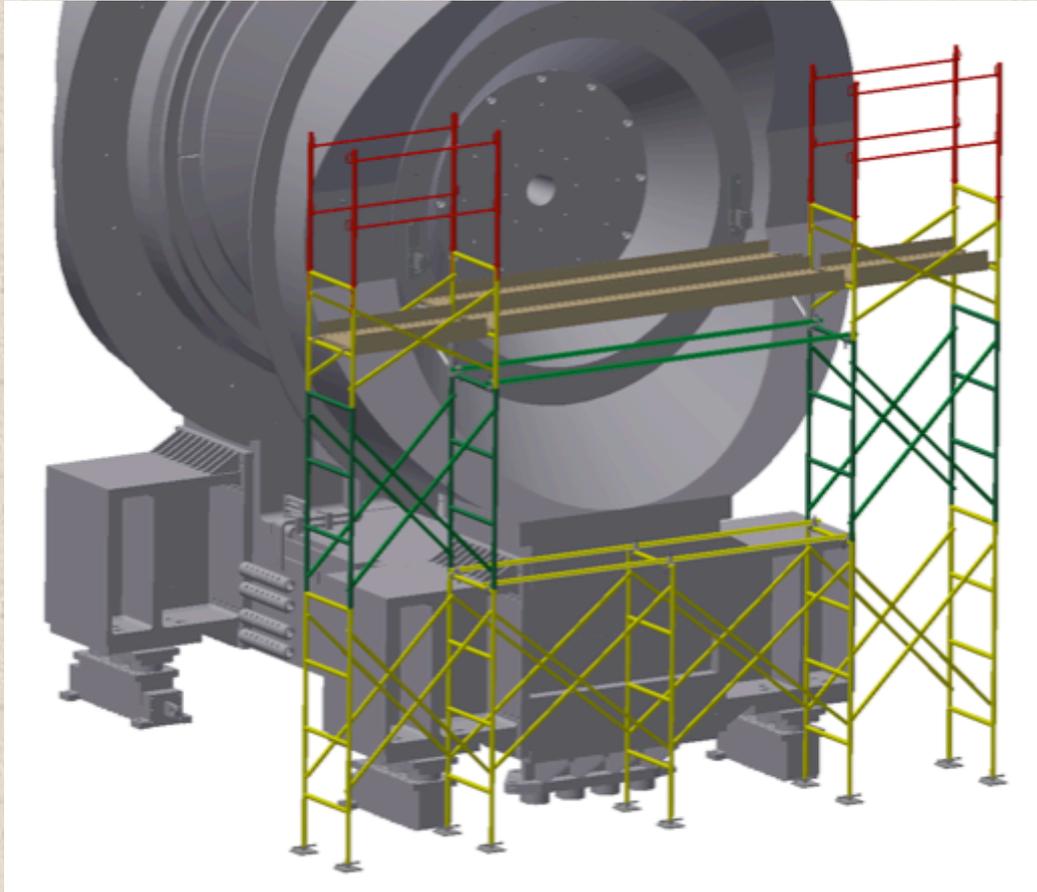
Scaffolding arrangement for upper access. Ladder and MMN not shown for clarity.

Configuration required for space between CM and MMS is similar.

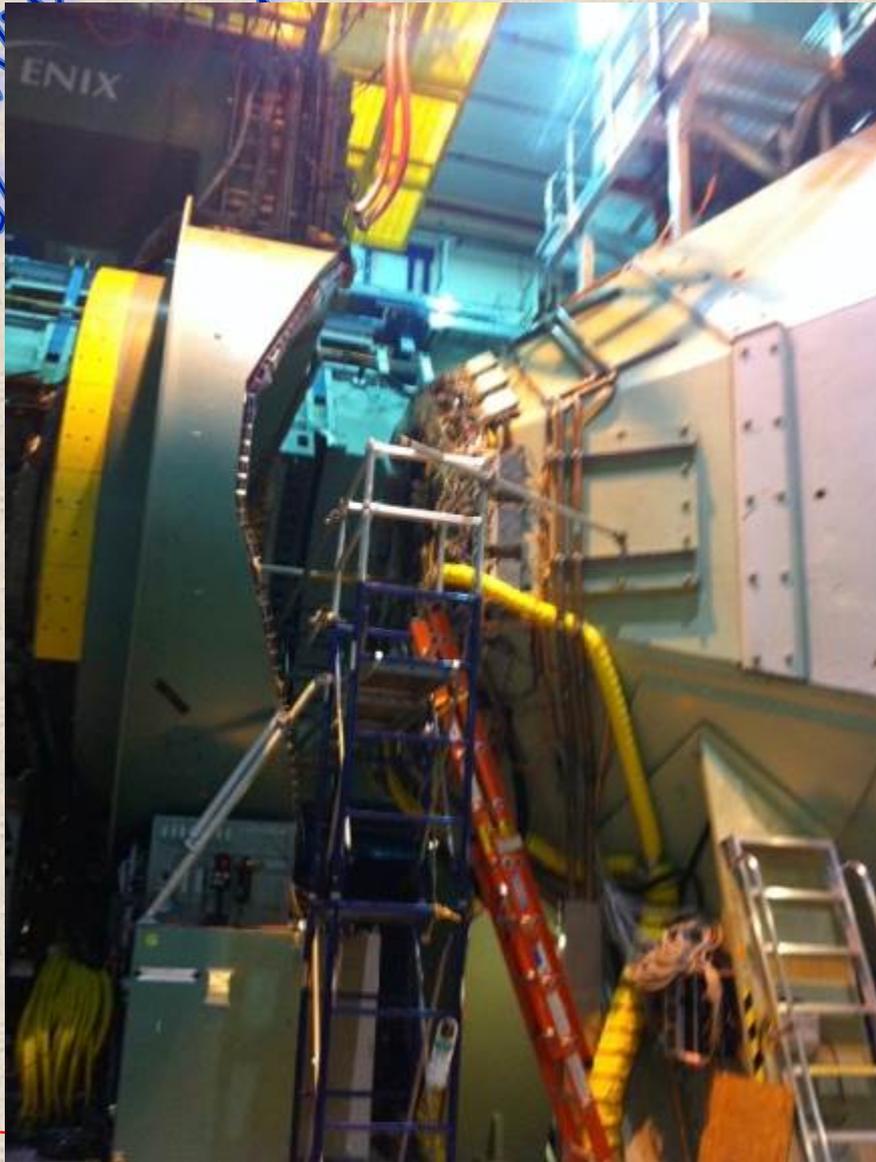
Scaffolding in north station 1

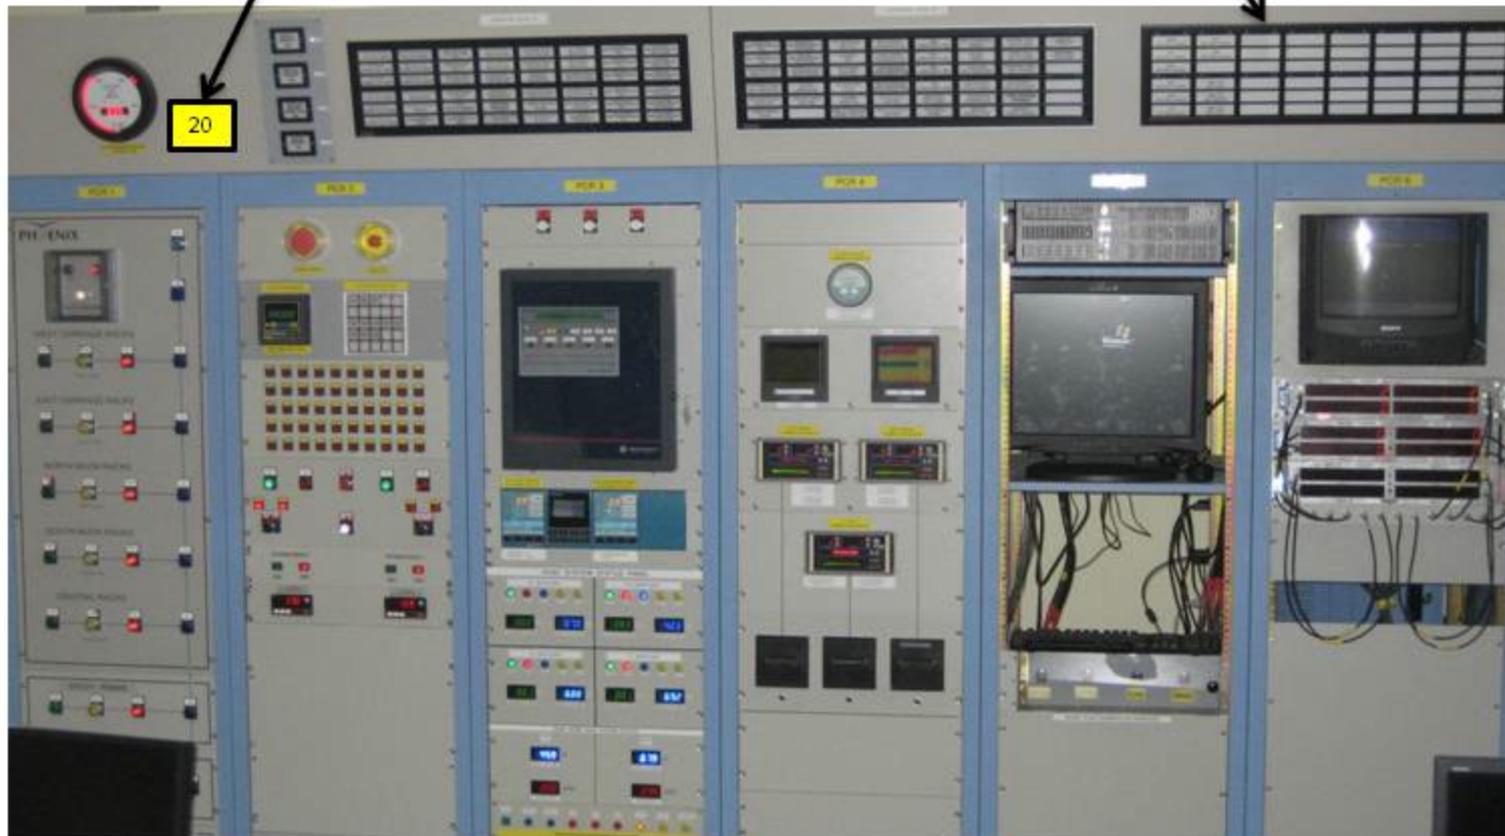
Electronics Cooling Water High Temperature Alarm

Display showing temperature of cooling water

Add Alarm to Panel
