PHENIX WEEKLY PLANNING

TECHNICAL SUPPORT ZONE

4/19/2012
Don Lynch

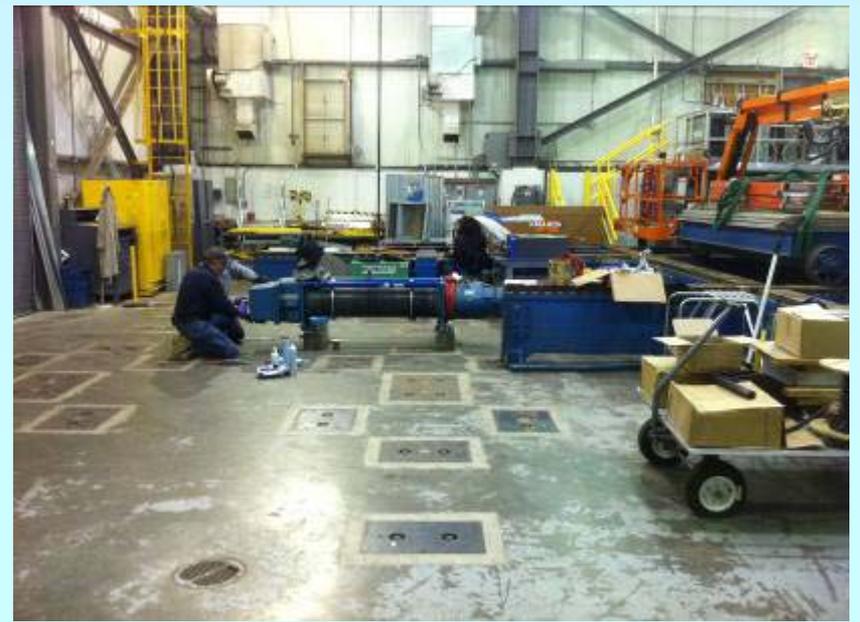
AH Crane variable speed drive and wireless remote upgrade ??

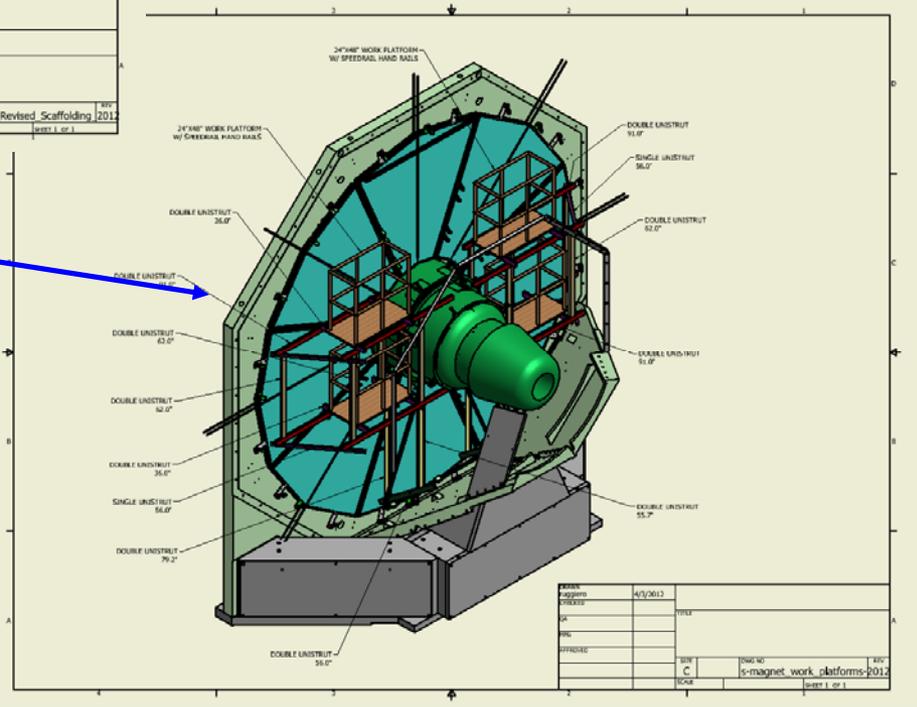
North & South internal work platforms for next summer's shutdown

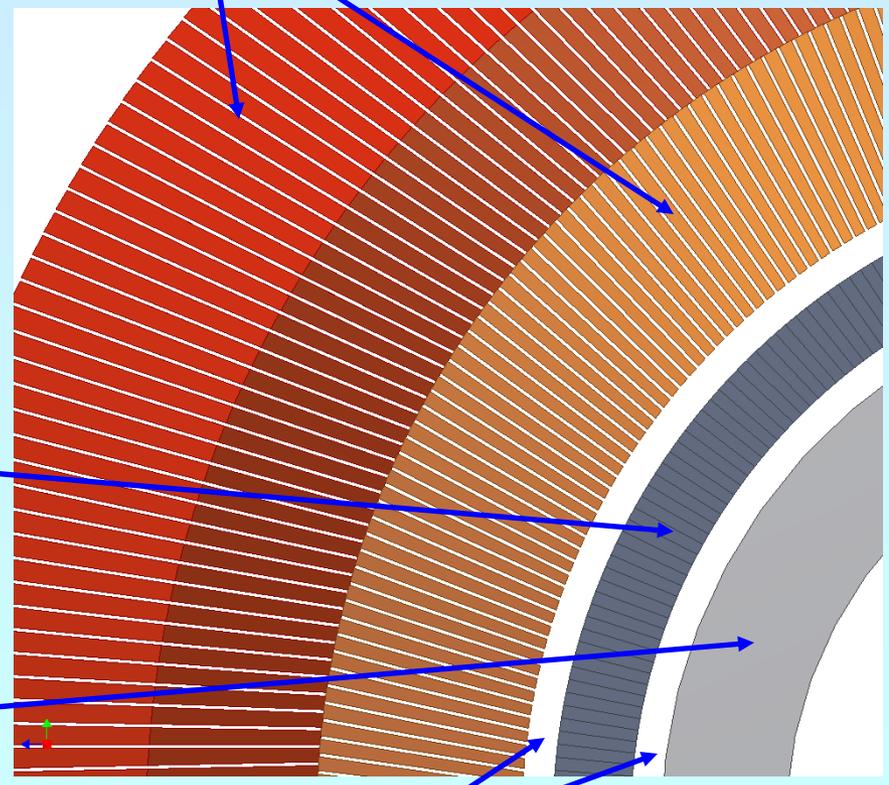
Inner and outer Hadronic Calorimeters
320 segments each, steel and scintillator
0.9 meter total thickness, ~4.6 meters
long. Note how the outer and inner steel
segments are angled with respect to
radial lines (by 5 degrees, with the inner
HCal steel angled in the opposite
direction of the outer HCal steel). The
inner and outer steel plates are also
offset by a 1/2 period.

ElectroMagnetic Calorimeter
314 segments, Tungsten
and scintillator 0.1 m th
~2.8 m long

Superconducting solenoid
2 Tesla Magnet and cryostat
.70 m inner radius, .20 m th
~2 m long

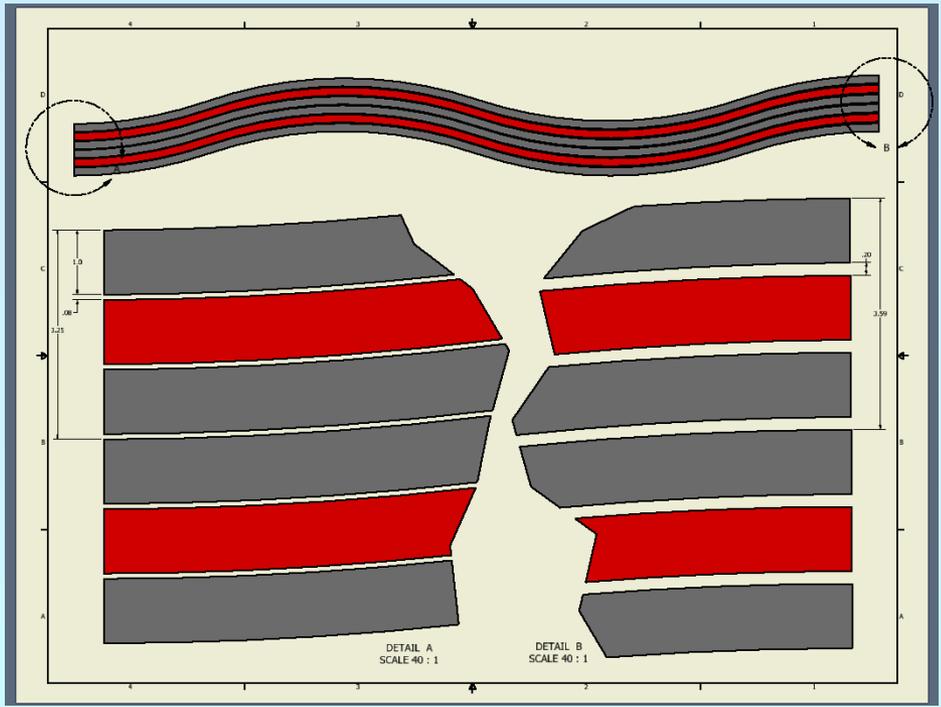
Envelope allowance for electronics,
support structure and detector services

*Note: All dimensions
are current estimates
and subject to change*

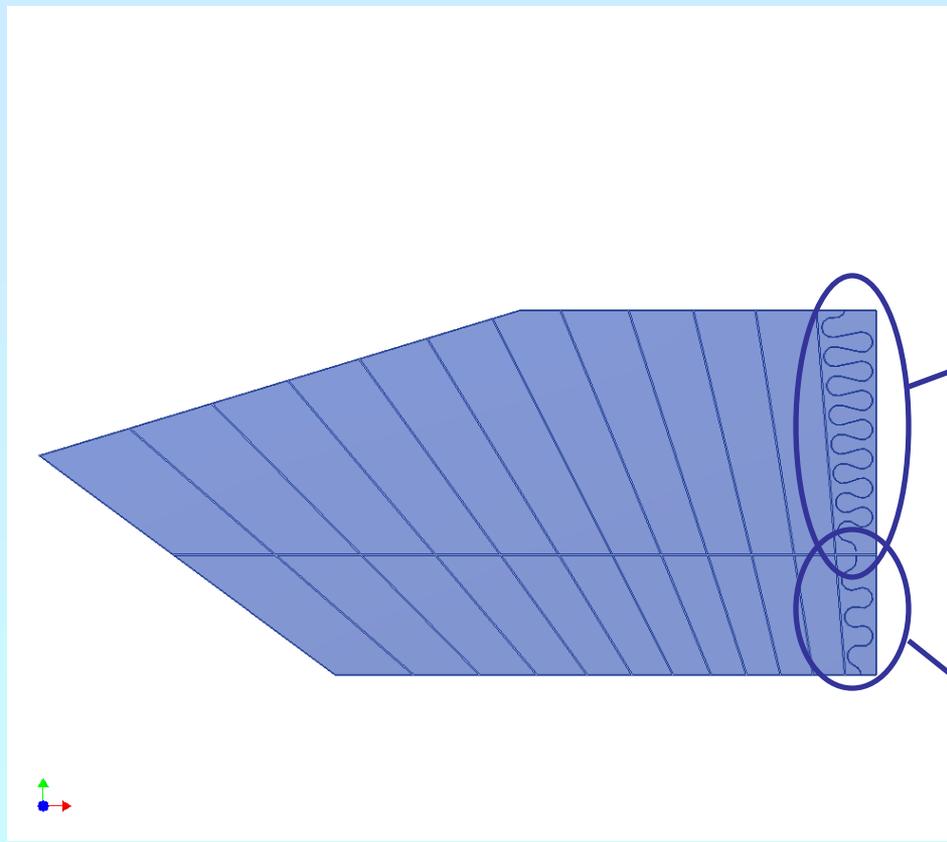
Electromagnetic calorimeter segments using "accordion" shaped scintillators and tungsten plates to optimize detector sampling

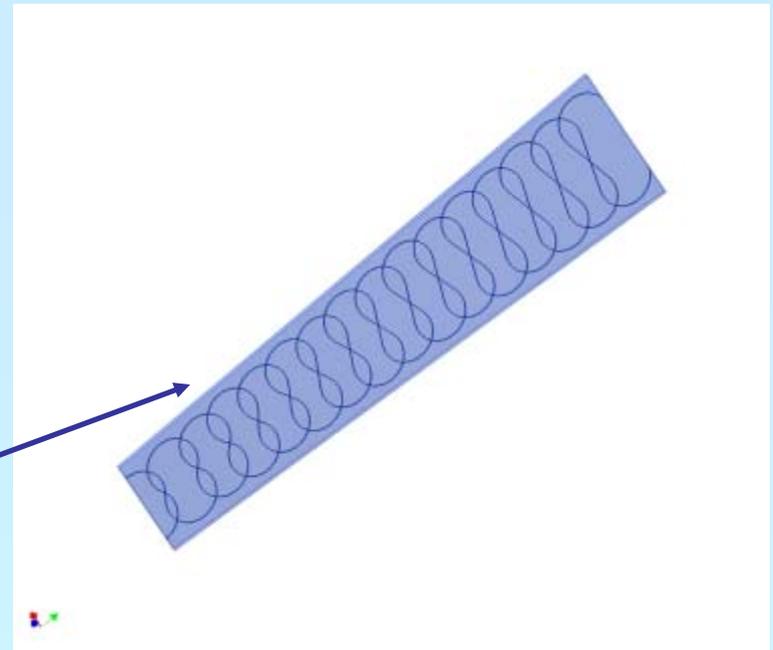
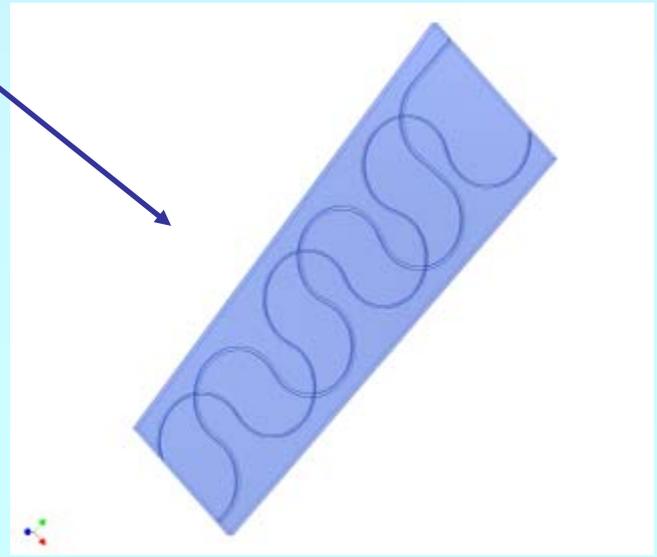
Typical Optic Fiber serpentine patterns on 1 inner and 1 outer scintillator sections. Opposing pattern on opposite side. Outer and Inner single piece blowups are made translucent so that the opposite side fibers pattern can be seen with the near side pattern

Design Concepts for each scintillator plate detail:

- Each plate has an optic fiber imbedded on both sides (illustrations at right are semitransparent so that the opposing patten can be seen)
- Minimum fiber bend radius is 2.75 cm
- Fiber is serpentine so as to come no closer than 2 cm to itself at any point and no closer than 1 cm to scintillator edges.
- Crossing of fibers in plane view is as close as possible to 90 degrees to minimize overlap.

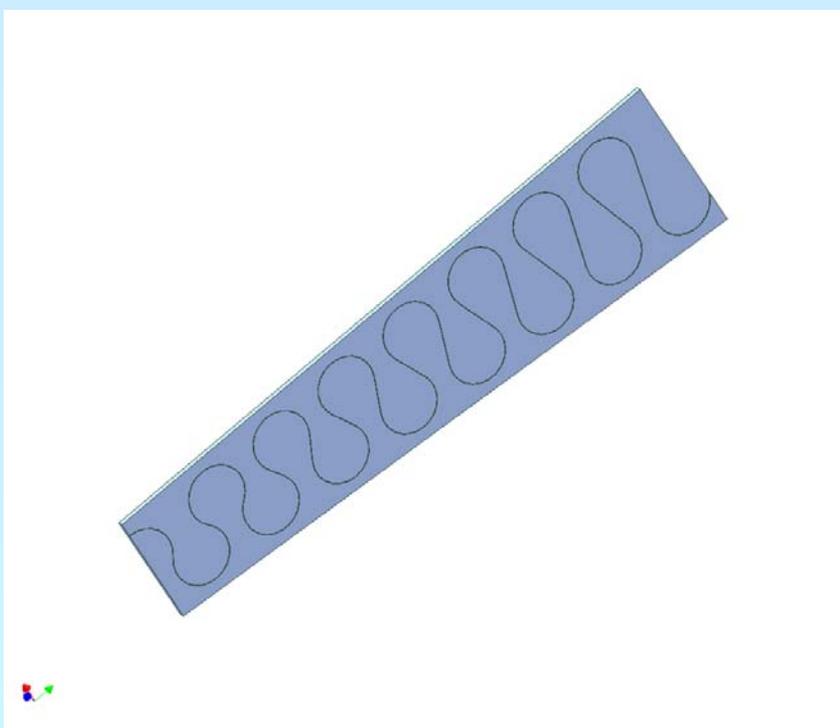
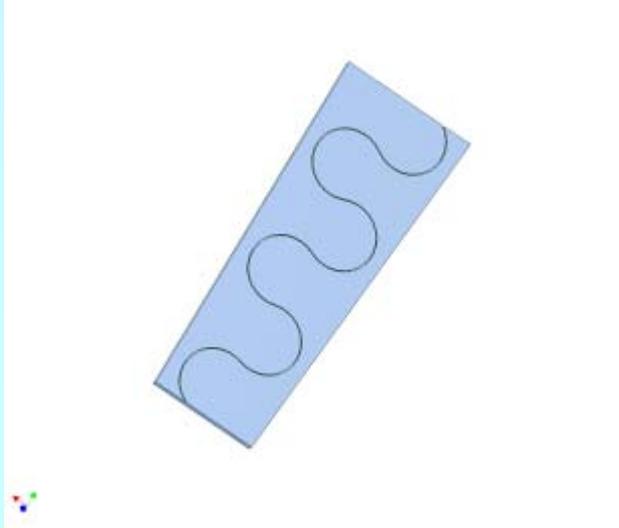
(Note scintillator sections shown are not transparent..Opposite side fiber is not visible)
