PHENIX WEEKLY PLANNING

TECHNICAL SUPPORT ZONE

6/14/2012
Don Lynch

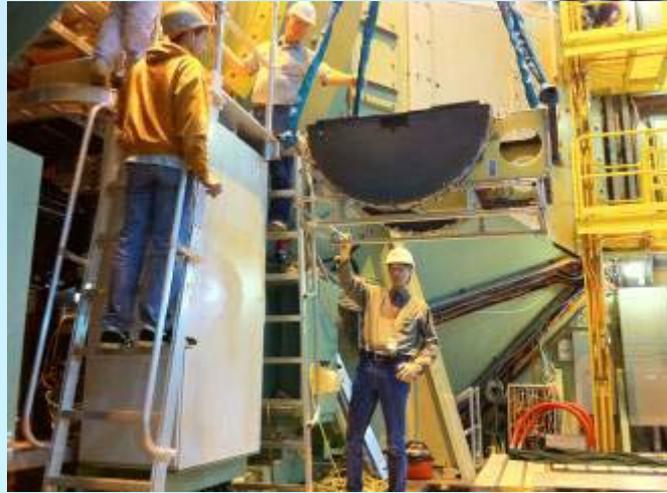
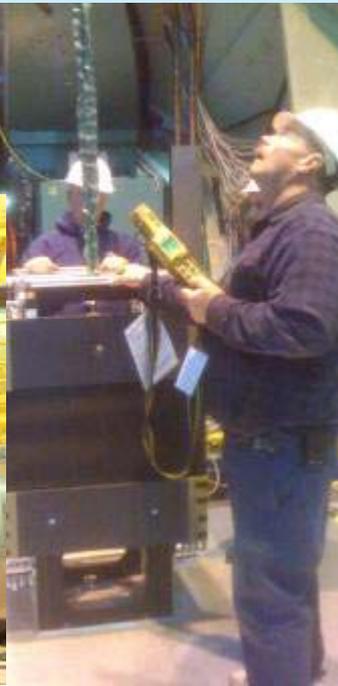
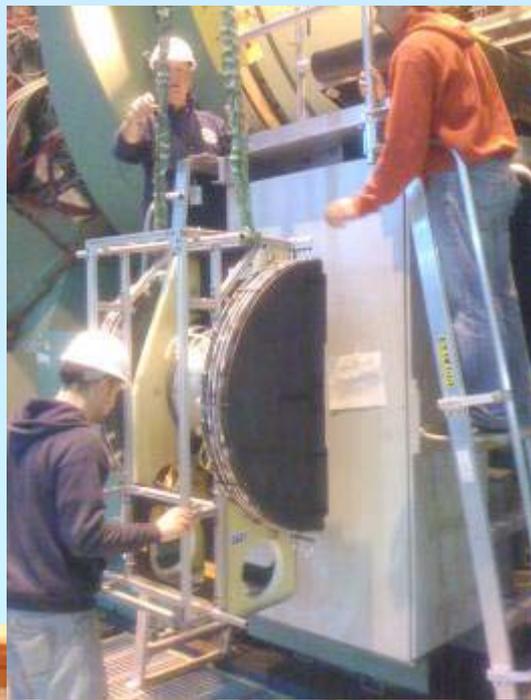
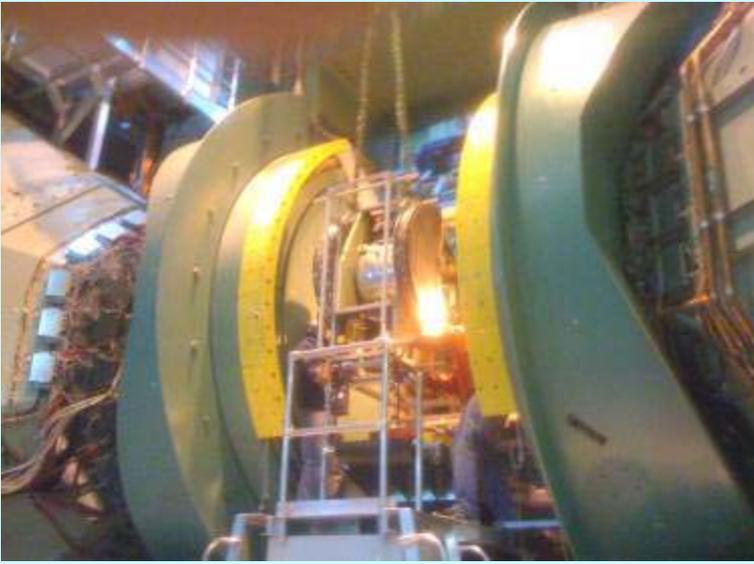
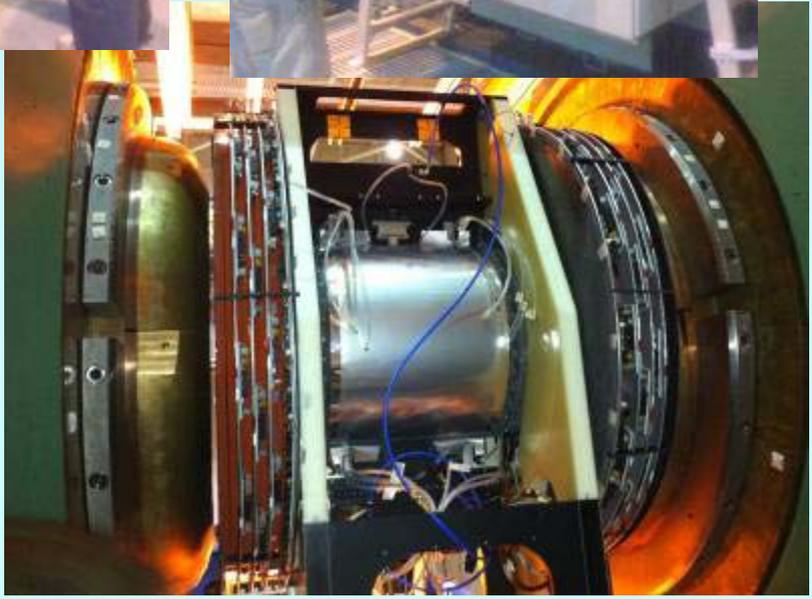
VTX Installation 2010 & 2011. 2012 Removal and re-installation will be same.

VTX/FVTX Disassembly - After Start of shutdown tasks are completed (EC out to AH), coolant and N₂ lines, LV, signal and HV cables and fibers will be carefully removed and coolant drained. East and west detector halves will then be de-mounted and transported to Chemistry bldg for maintenance and overhaul.

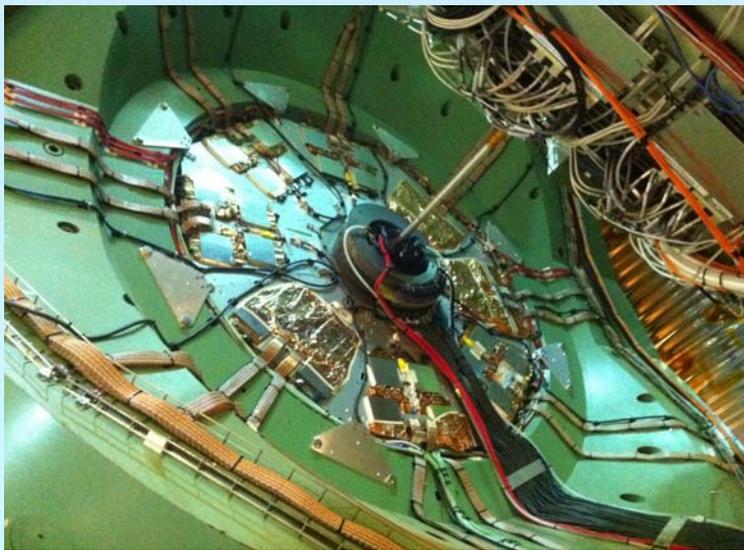
RPC Station 1 North and South Cooling Upgrade

- Prior to installation the RPC group had determined that the RPC1's did not generate sufficient internal heat to require active cooling. Passive cooling from the aluminum skin and FEM covers was deemed sufficient.

- After the CM and MMS were moved to the run positions with stations 1 north and south tightly closed, and after the magnets were energized it was determined that the operating temperatures on the surface of the RPC1's was higher than expected, suggesting marginally high temperatures internally.

- Subsequent measurements indicated that, while the RPC internal heat generation was not in itself problematic, the higher local ambient temperature due to magnet operation and other local subsystems was inhibiting the RPC1s' ability to shed its own internal heat.

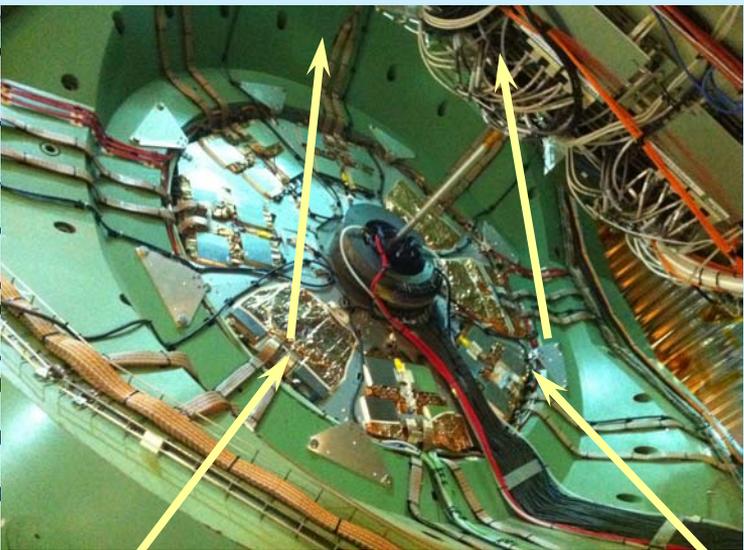
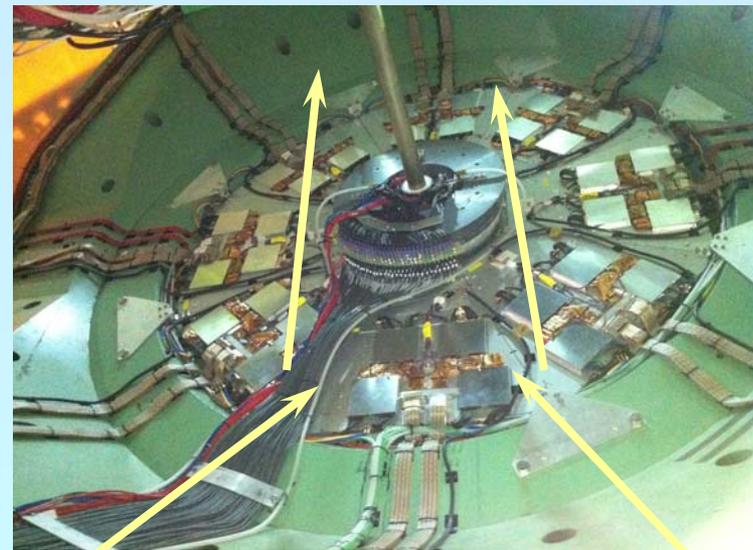
Approximate Air flow paths for the North and South RPC1's

This summer we will add 2 more blowers, one each for the north and south, and refine the flexible hose positioning to optimize air flow across the individual detector subsystem octants.

Flow will be directed inward and upward from approximately 4:30 and 7:30 on both the north and the south side.

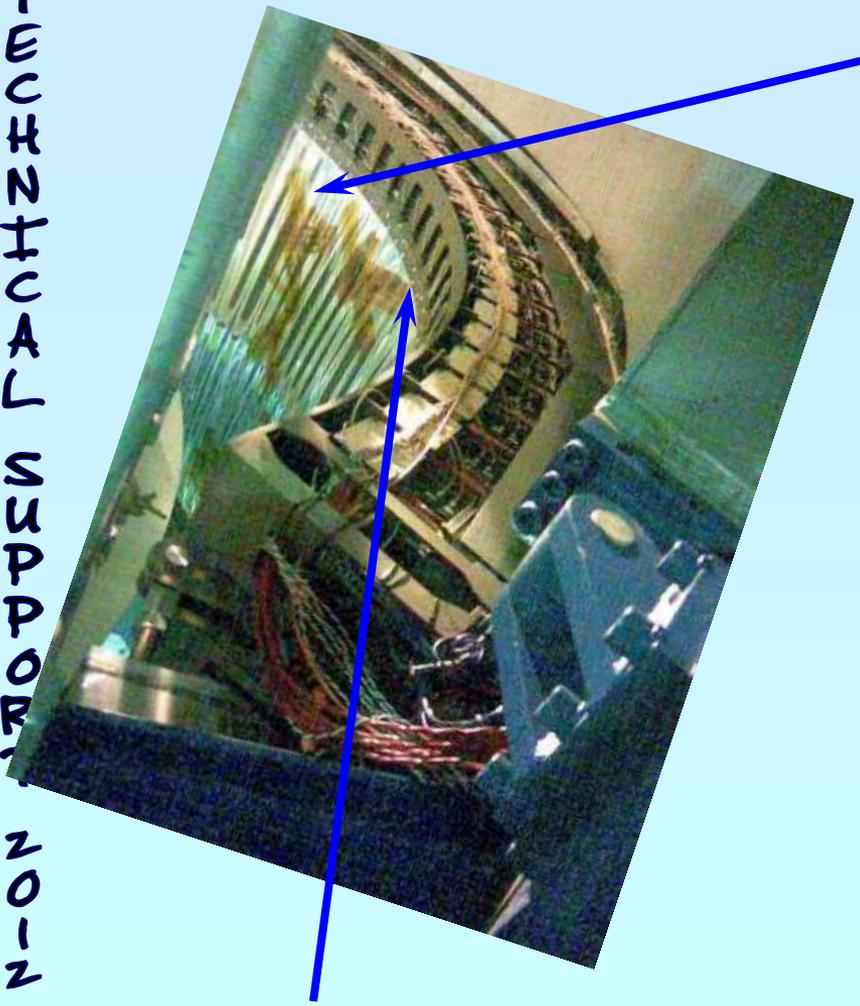
Sealing/window mounting plates (both sides)

Years of wire repairs on the DC west have rendered the DC west window a patchwork of tape and have elevated leak rates to the point where replacement of the mylar window is needed. The design of the DC west window is slightly different from the DC east which has an improved window support structure and sealing concept. These improvements are to be incorporated into the DC West this summer.

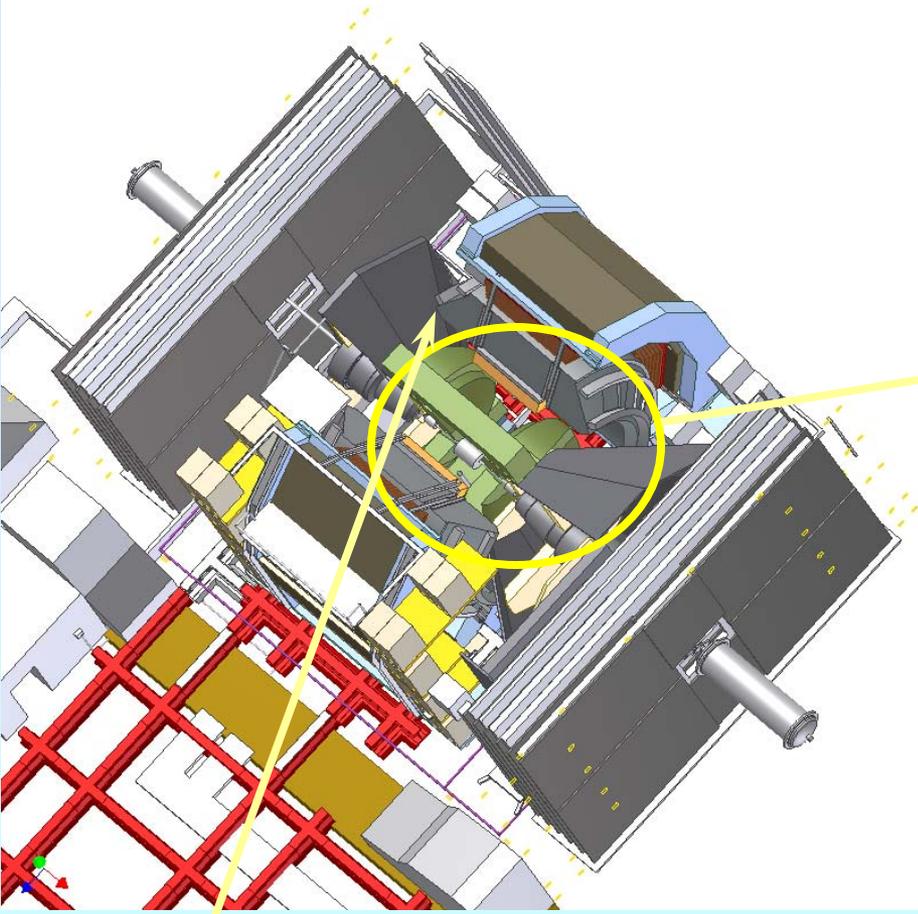
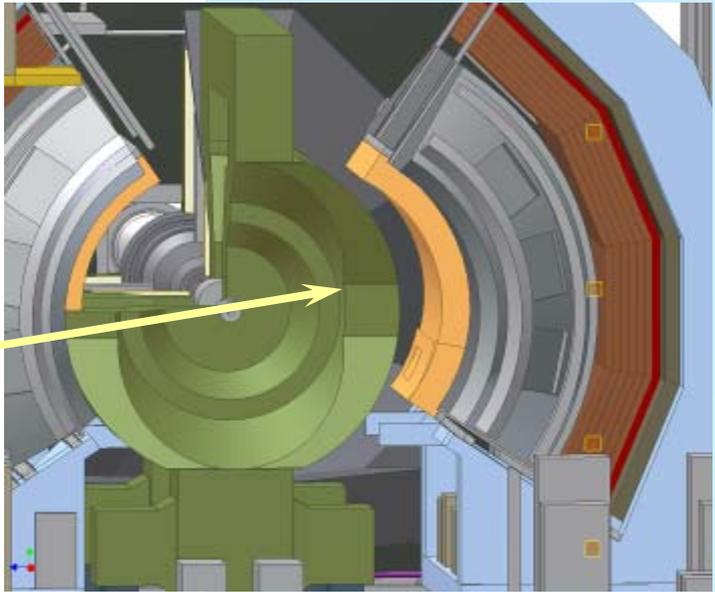
Need to design, fabricate and assemble a work platform between the CM and the DC West

Need to cover this area to prevent debris from entering the DC cavity while window is removed

- Gather drawings and materials from DC group
- Make measurements, new drawings and create parts lists as necessary
- Procure/fabricate parts
- Design work platforms and protective covering to access and protect DC west during disassembly/reassembly. CAD review.
- Disassemble existing window and sealing components
- Repair/remove broken wires, etc.
- Install new window and seal.
- Leak and functional tests

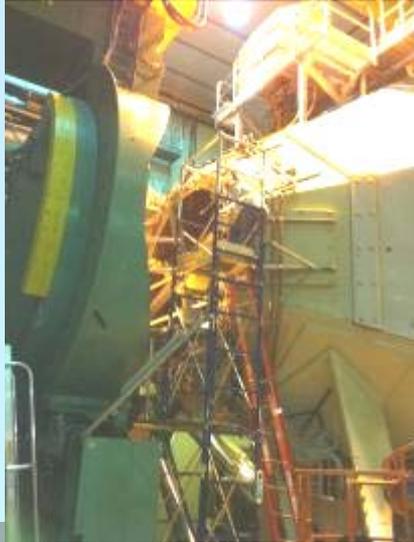
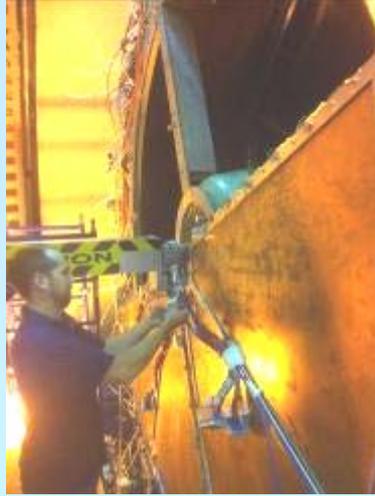
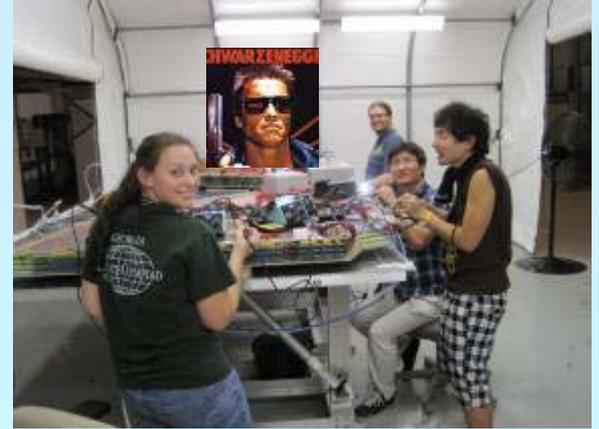
- Station-1 South re-capacitation and termination

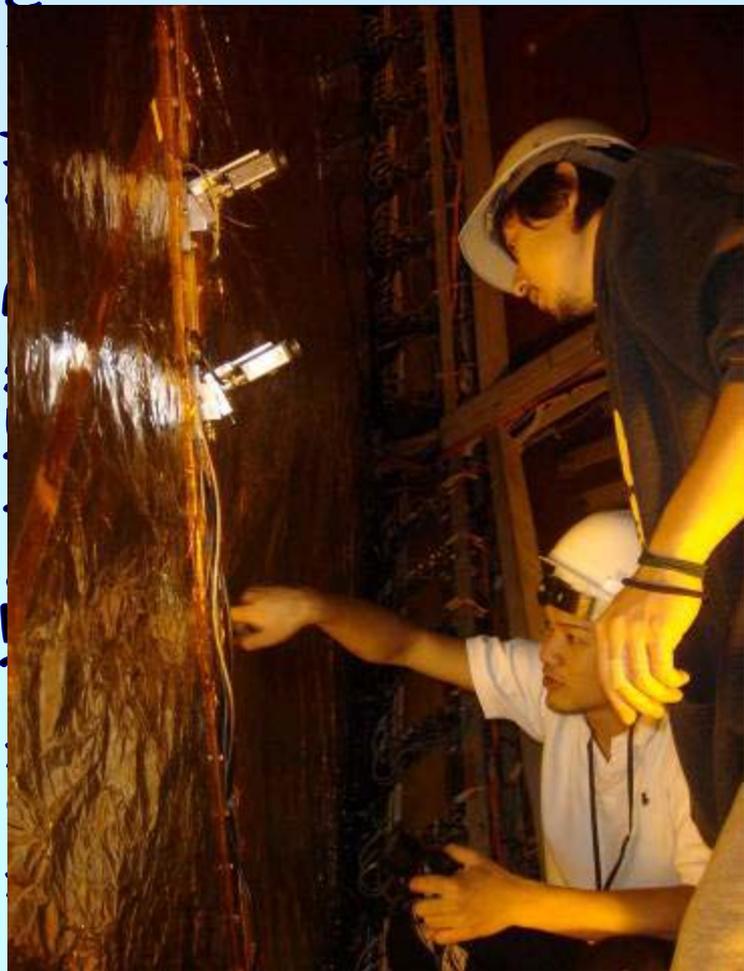
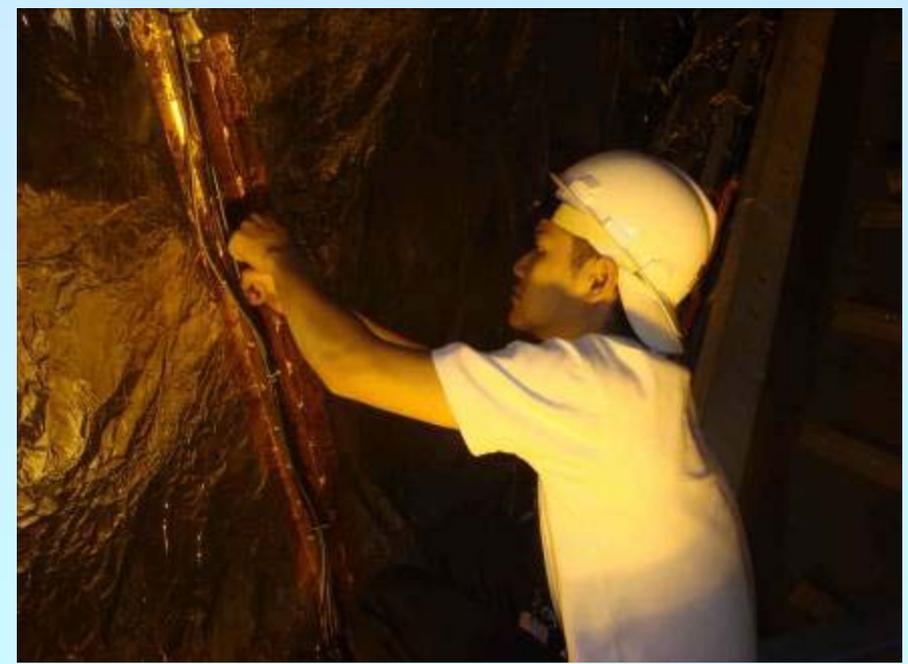
Station-3 Clamp Installation

- Anode card Inspection with mirror : < 5min./clamp.
- Anode clean up if necessary : < 15 min./clamp
- Clamp mount : ~ 5min./clamp
- Voltage readout : 5min./clamp
- HV test : 10min.
- Total : 25 ~ 40 min./clamp

Re-capacitation of MuTr stations 2 and 3 (inside MMS and MMN magnets) will be done using clamping and installation technique developed by MuTr experts during run 12 as was performed during 2011 shutdown. Method requires no soldering or gluing, requiring only mechanical clamps.

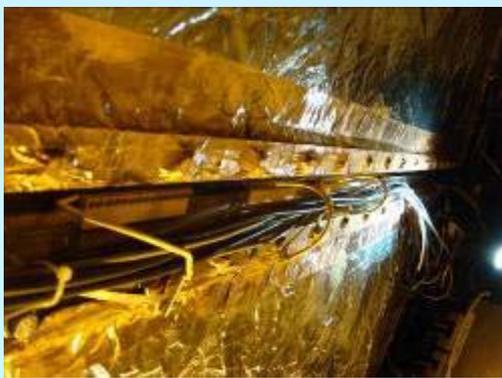
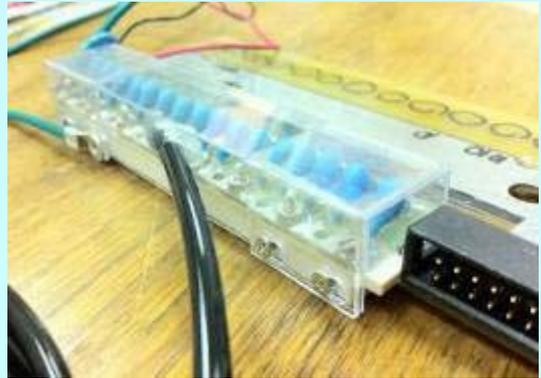
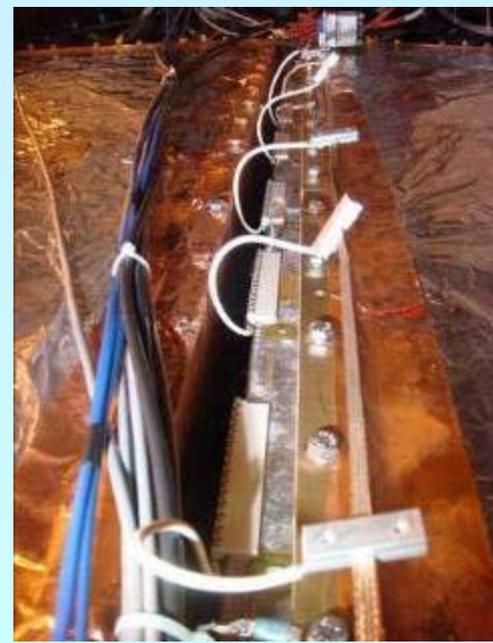
Clamp-on Terminator Installation on North & South Station-3

- Lower clamp-on terminators already installed for both north and south sta-3 (bottom 4 octants)
- With new work platforms that reaches all of sta-3; install remaining (upper) clamp-on terminators.
- Analyses submitted to CAD engineering.

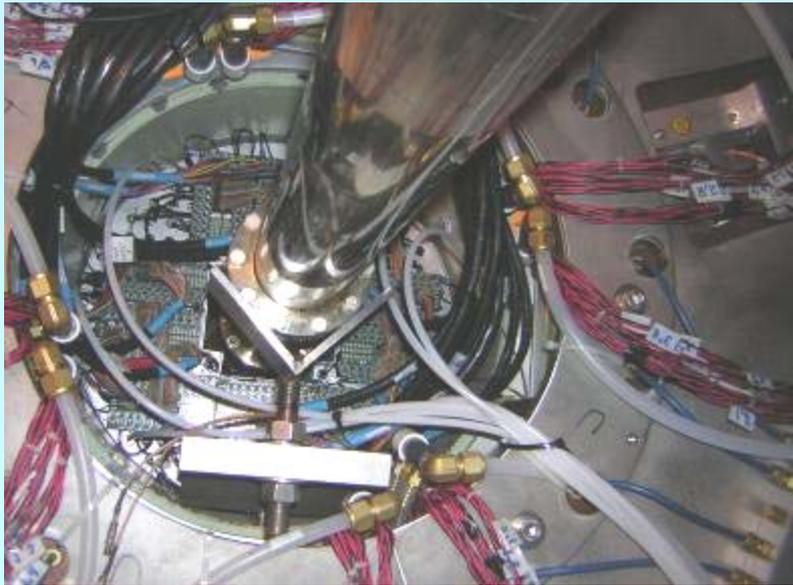
MPC repairs

During run 12 both the north and south MPC internal electronics experienced a damaging event that disabled a large fraction of the MPC modules. MPC experts have determined that the damaged components can not be repaired in situ. Consequently the MPC modules must be removed and repaired in the PHENIX electronics shop and/or at an external vendor. Additional steps are anticipated to provide protection against similar future events.

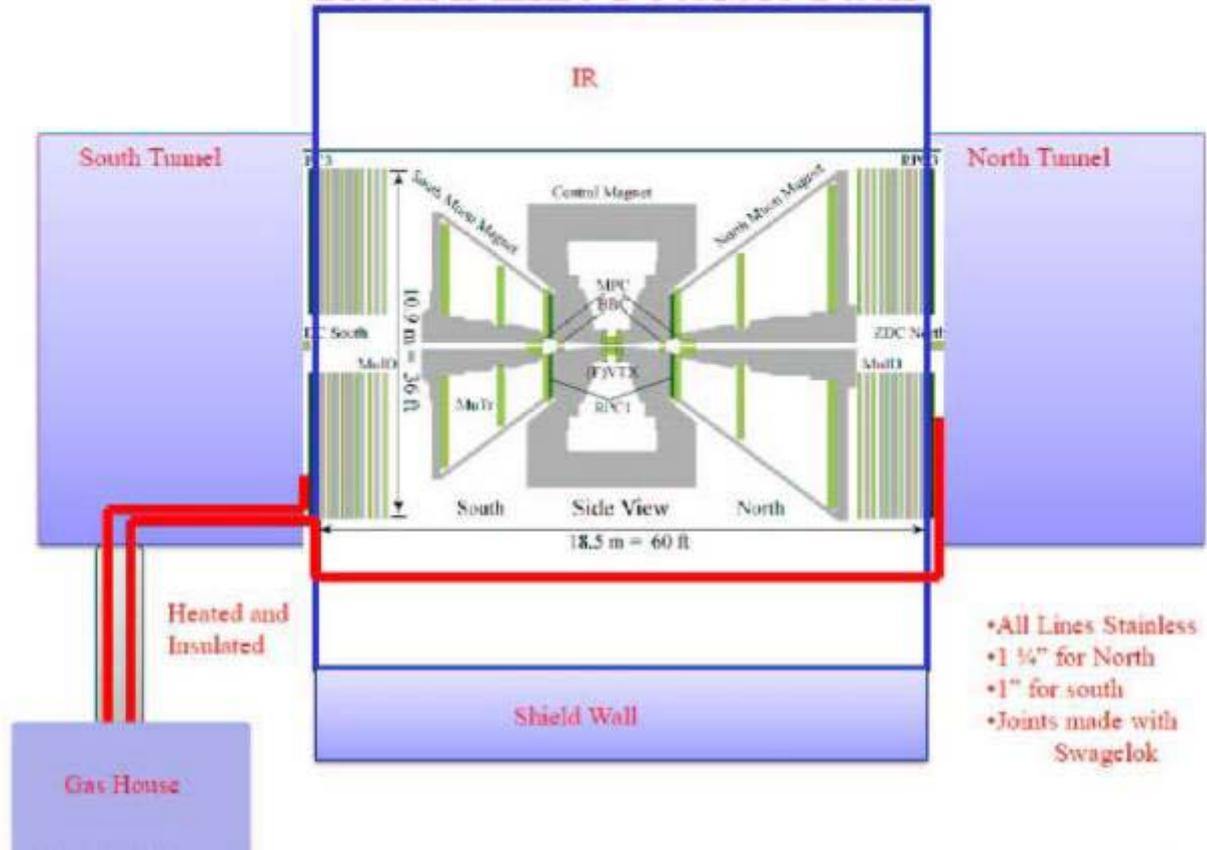
Return Line Possible Path

- All Lines Stainless
- 1 3/4" for North
- 1" for south
- Joints made with Swagelok

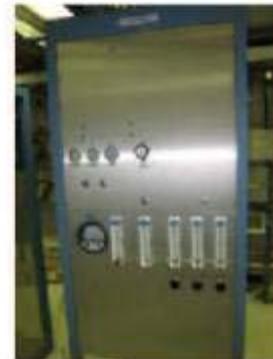
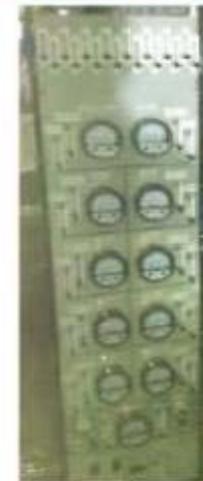
Nover 7200 Chiller

Sketch is for South the VTX/FVTX
Shows one loop
We have a low temp and High temp loop

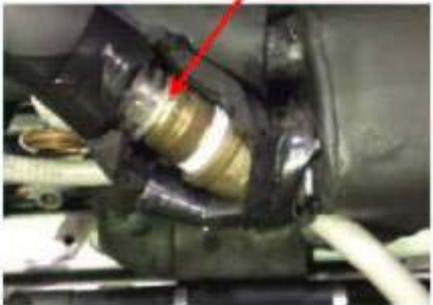
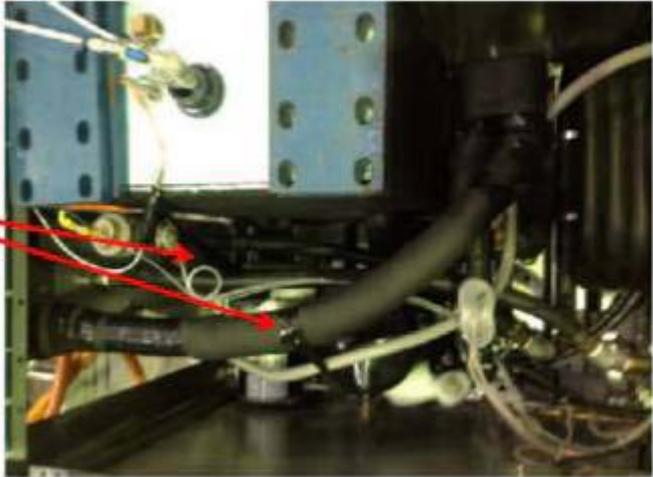
Chiller Work
•Replace nylon reinforced hose with stainless flex (2 per Chiller)
•Bring in vendor to do maintenance on units

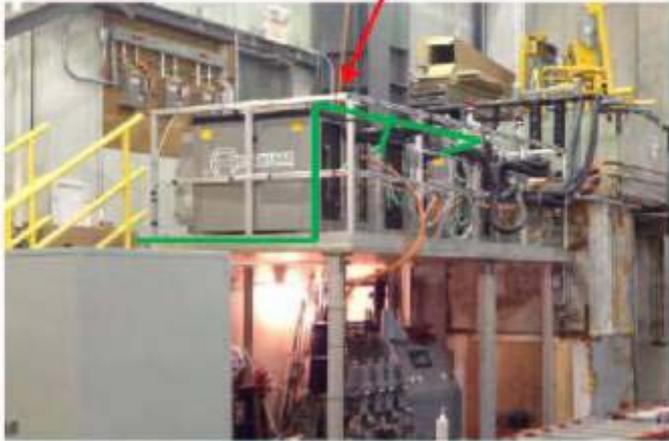
Upgrade Novec Cleaning System
•Install filters for both loops
•Run insulated stainless lines from chillers to filters

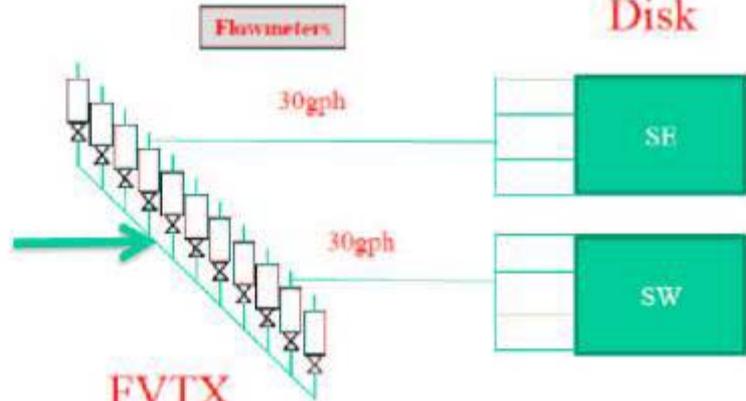
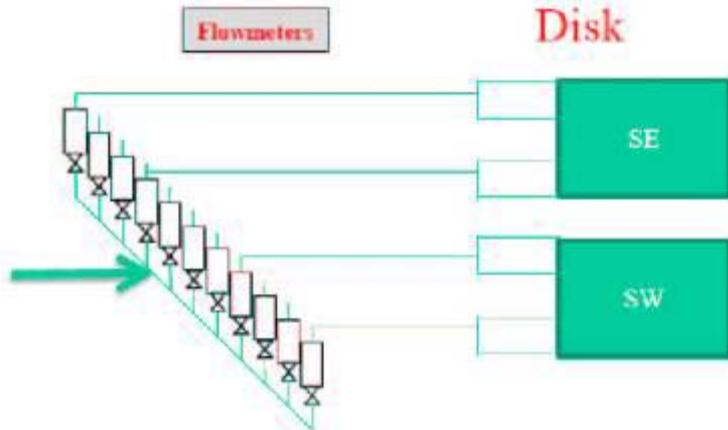
Planned change to FVTX

- 10 Flowmeters Total
- 5 Feed VTX-S
- 4 Feed FVTX
- 1 Spare From VTX-P

-3C at Manifold

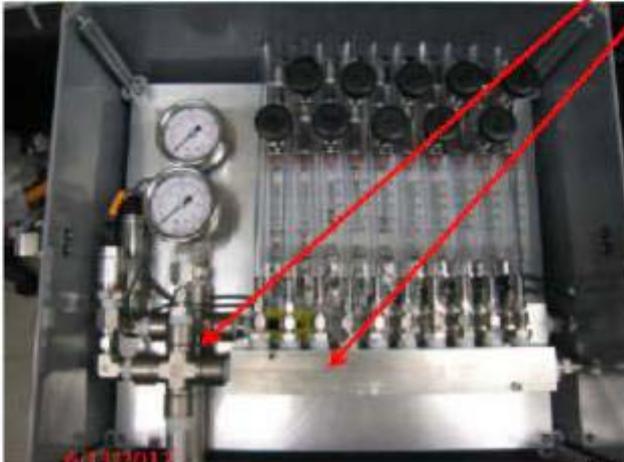
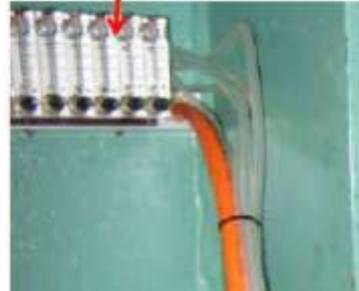
Manifolds in the IR

- Big Wheel/ Low temp chiller
 - Rebuild to increase size of manifold
 - make pixel lines permanent
- Low Temp
 - Split North FVTX feeds
 - Upgrade to $\frac{3}{8}$ " pipe from $\frac{1}{2}$ " where possible
 - Increase size of manifold to reduce restrictions
- Nitrogen
 - Add more lines for FVTX feeds

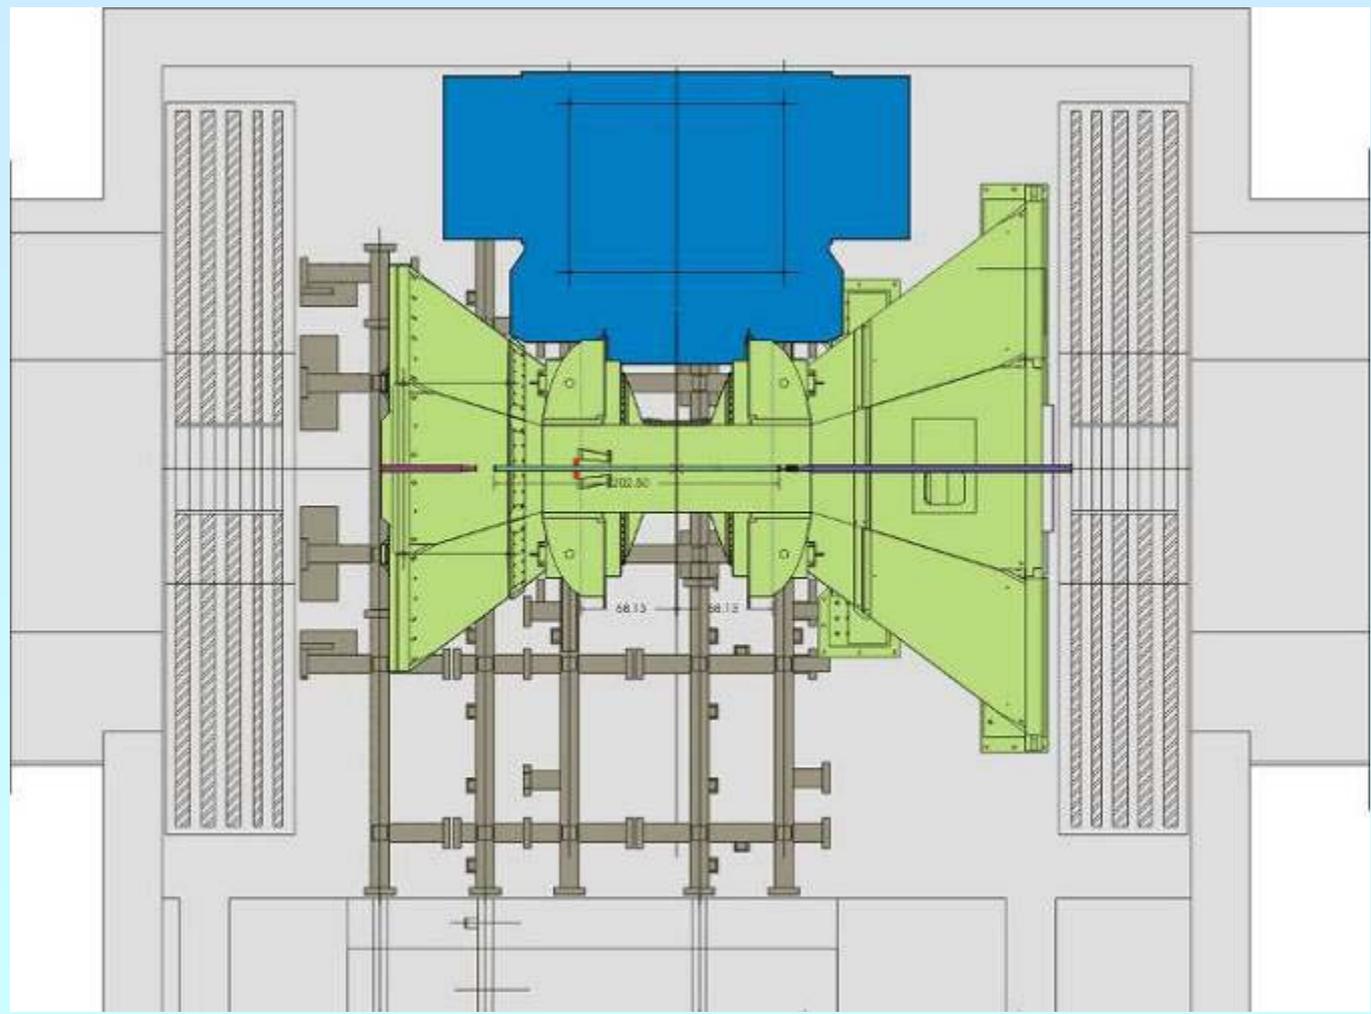
IR is currently in this (Run) configuration. (MuID collars not shown)

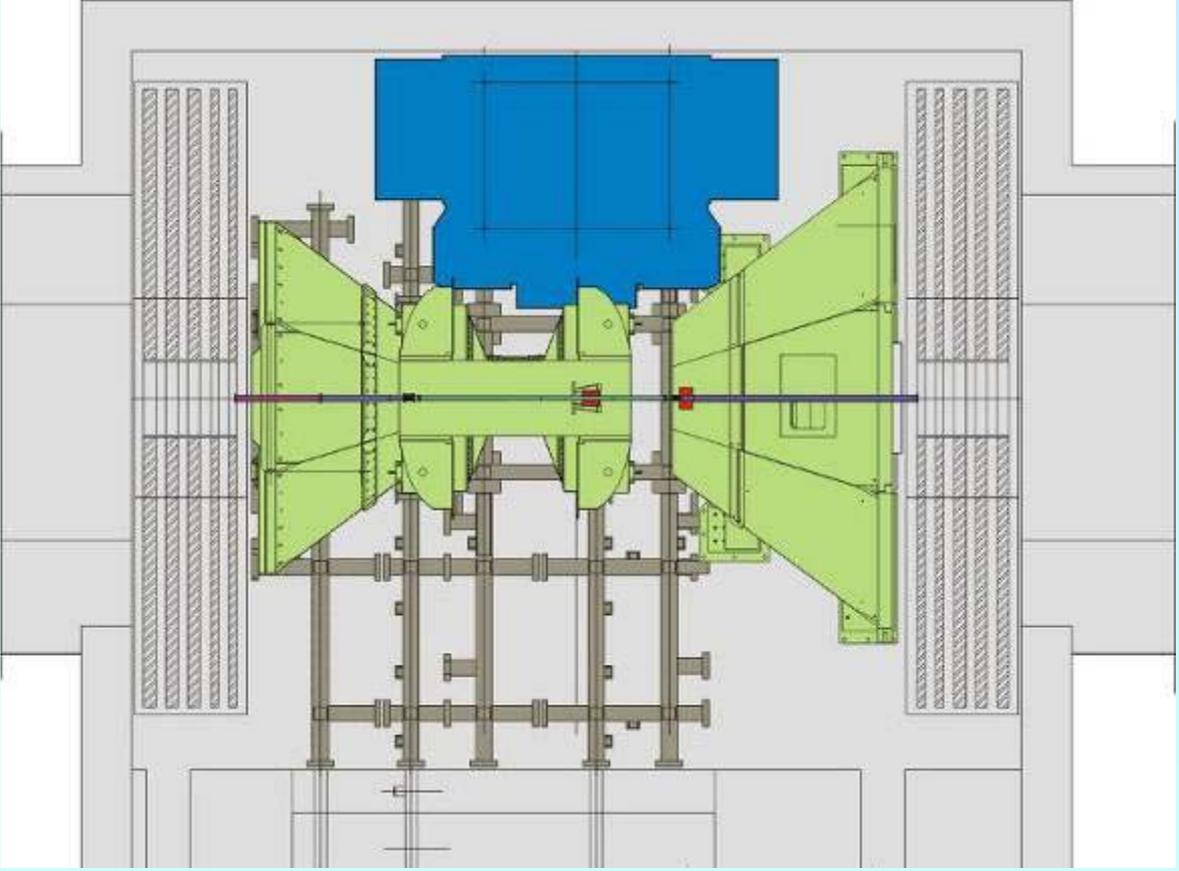
After MuID collars are removed and EC is moved to AH, MMS is moved south. CM is then moved south to gain access to Station 1 North. MPC North to be removed, RPC1 North to be addressed. (1 week)

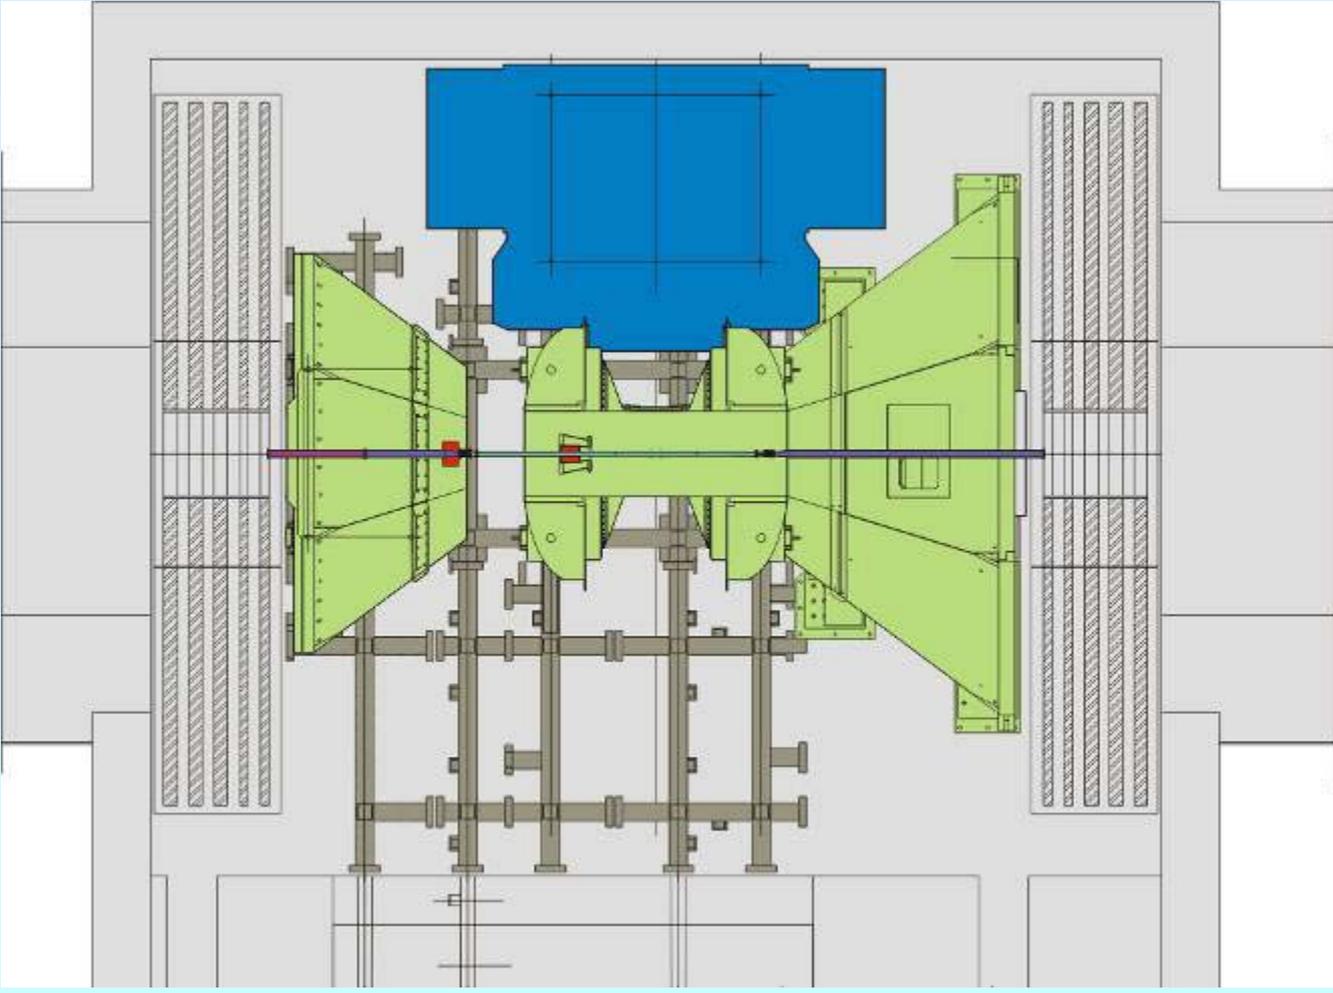
CM is then moved north to gain access to station 1 south. Work on RPC1 South, DC West, MPC South and MuTr Station 1 South. After all work finished move CM south, reinstall MPC complete RPC1 North work, survey step 1 for beampipe, then move CM north complete beampipe and CM survey. Move MMS North to run position. VTX/FVTX work may be done in any configuration.
