# PHENIX WEEKLY PLANNING

11/15/12  
Don Lynch

# RPC Station 1 North and South Cooling Upgrade & Monitoring

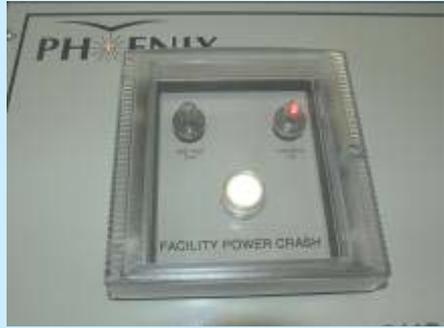
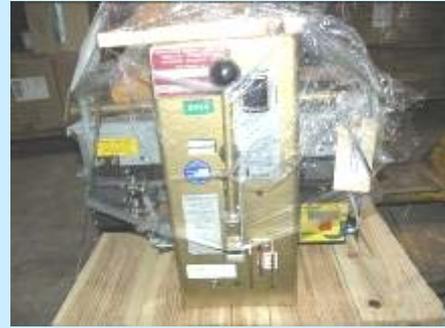
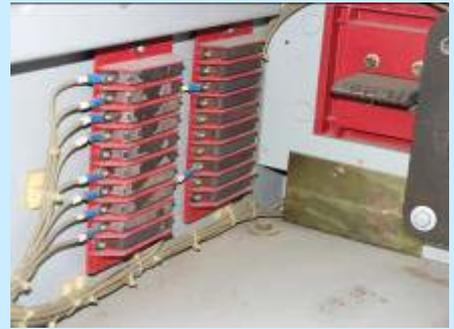
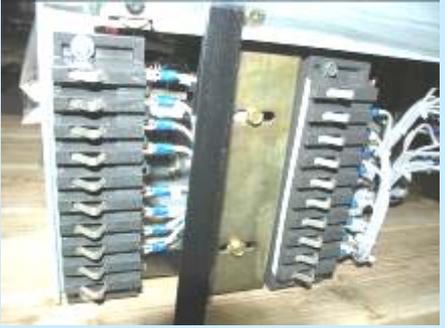
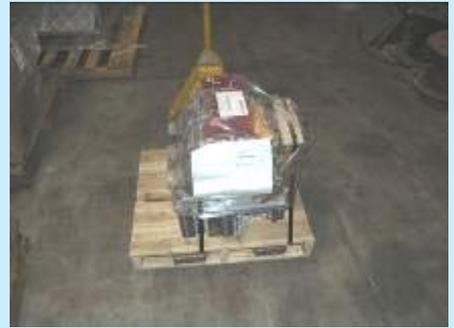
### Substation breaker upgrade/test (CAD)

Upgrade & Test to be performed ~Dec 1. Drawings/wiring schemes by P. Giannotti have been reviewed and approved by CAD. Paul will be present and work with line crew to install and with CAD to test (blue sheet test)

Ready for Installation this week (today?)

- 1. Remote breaker switch - parts ready install partially completed. Repaired broken breaker installation and blue sheet test of breaker scheduled fore Dec. 1

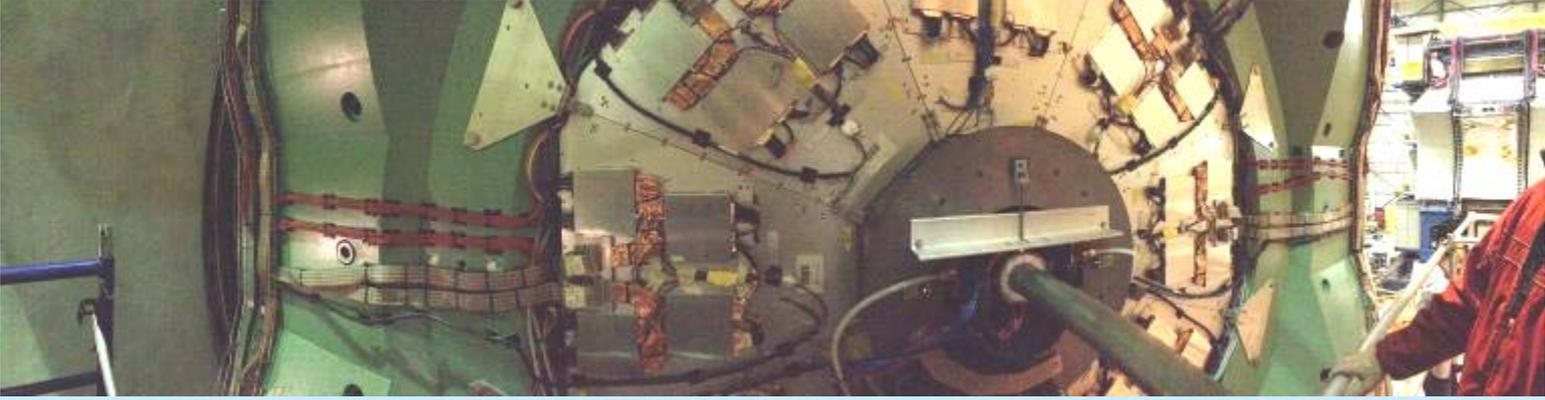
South thermocouples installed, cabled and calibrated; cooling upgrade to be completed after North Upgrade and monitoring are completed and CM is moved north to run position

Cooling Upgrade to be completed this week

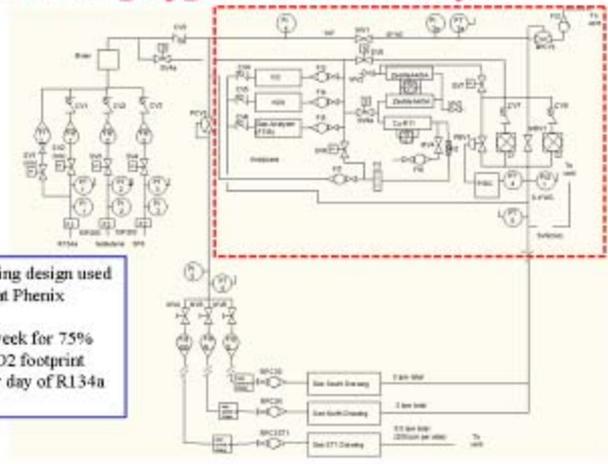
### Run 12 Shutdown Work Overview Gas/Cooling Systems Recirculating Upgrade to RPC Gas System

•Based on working design used for many years at Phenix  
•Save money  
•\$3k per week for 75%  
•Reduces lab CO2 footprint  
•60 lbs per day of R134a

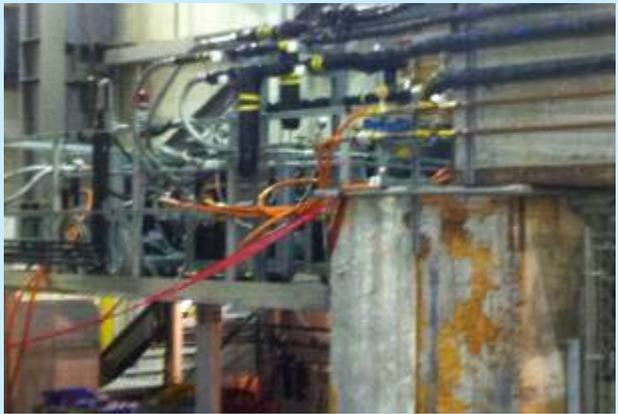
### RPC Recirculation Upgrade

Recirculation Piping installation - In Progress

GMH rack moving along Purification system controls assembly, installation and testing - D. Northacker to finish in December

PC upgrade - November

Analyzer procurement in process (~4 months)

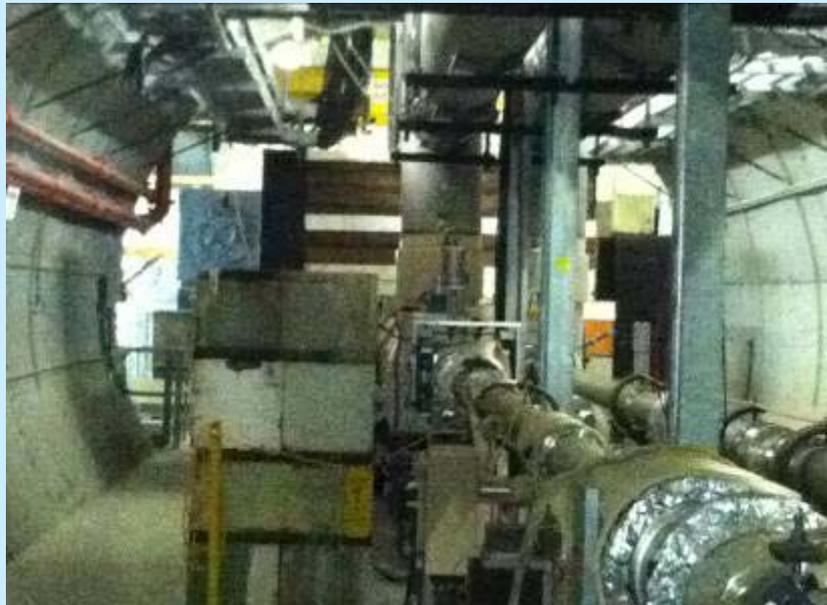
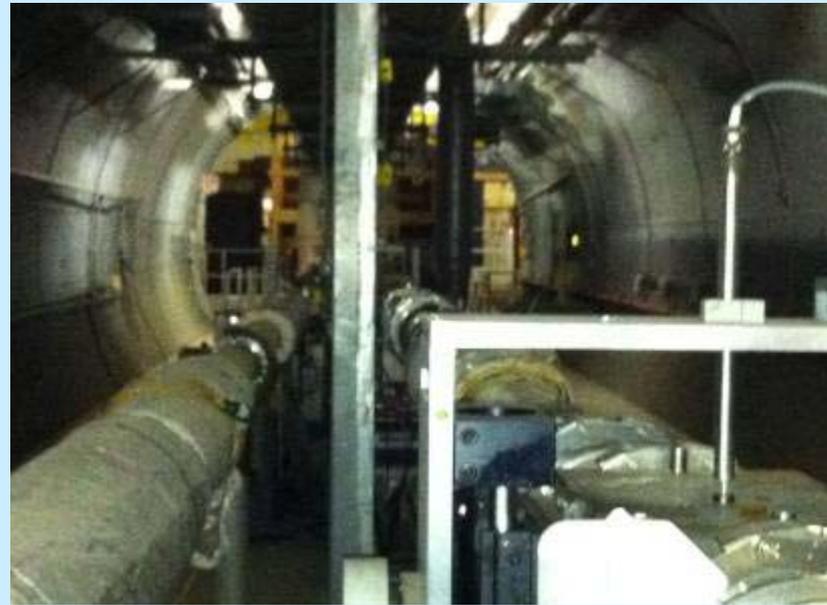
Looking towards RPC3 North  
← East                      West →

Looking towards RPC3 South  
← West                      East →

Large shielding modifications at Q2 upstream north and south to be planned and installed by CA-D (Dave Phillips) by 12/14/2012. **In progress this week**

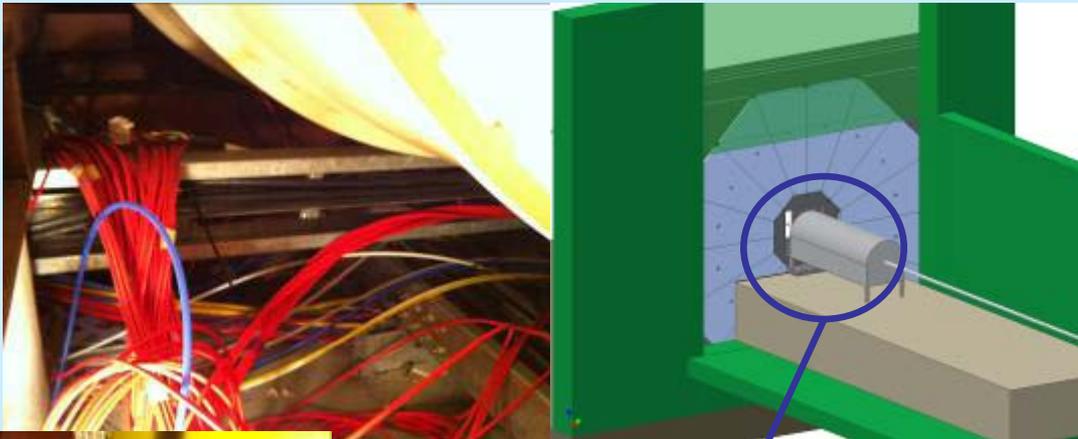
Under DX at RPC3 North  
← East                      West →

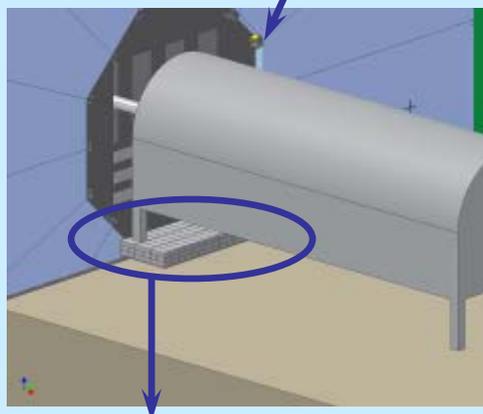
Under DX at RPC3 South  
← West                      East →

144 Steel bricks, 2x4x8,  
stacked in 3 high, 16 wide, 3  
rows, respectively by 11/21

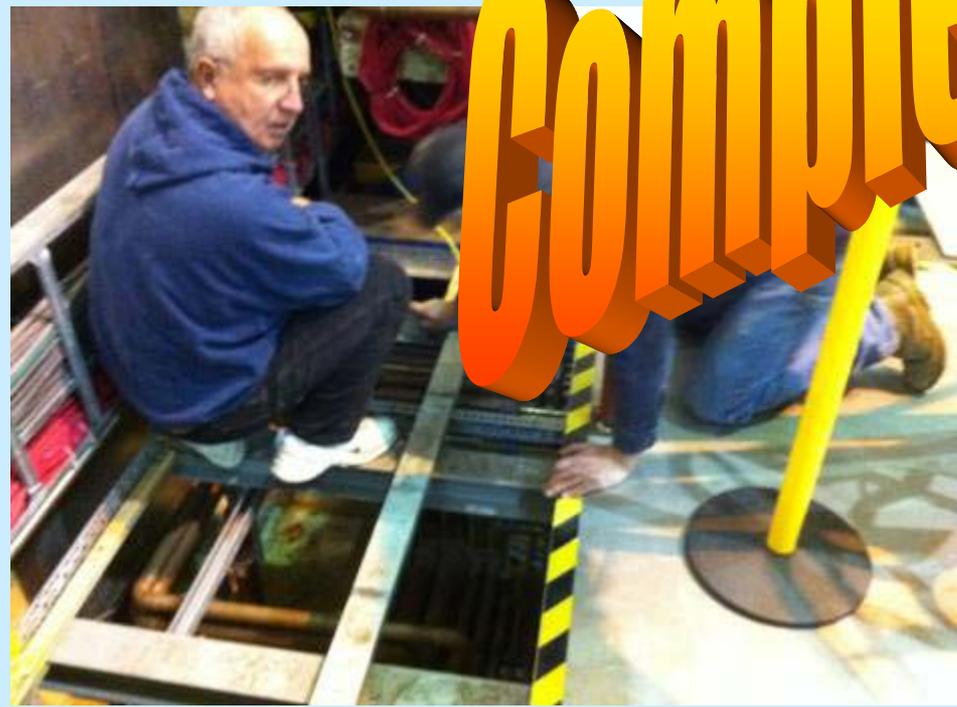
# MuID Collar IR Holding Area Support

Structural support improvements designed

Installation in progress

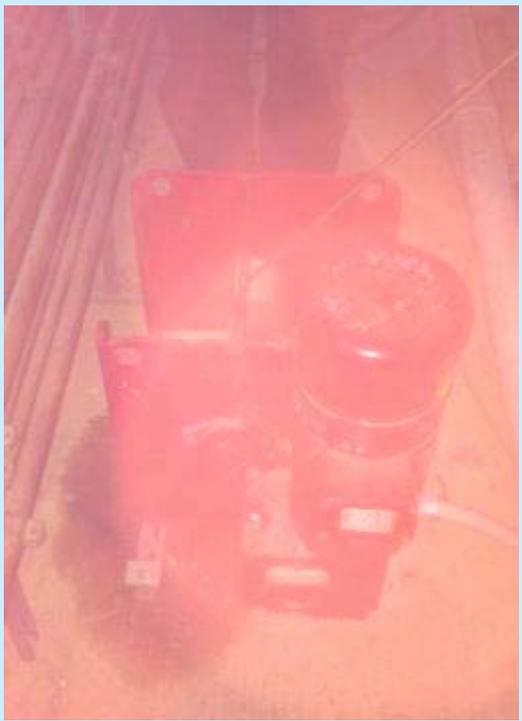
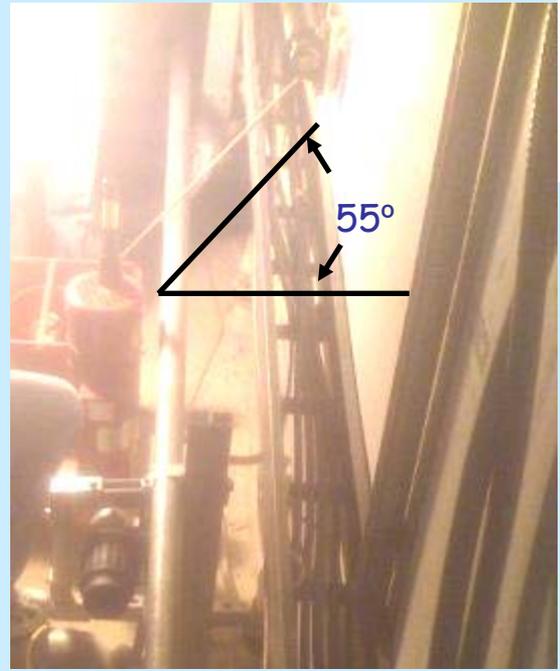
# Window Washer Remote Pin Removal and Winch/spooler safety upgrades

Space available:  
16.5" x 27" x 28" h

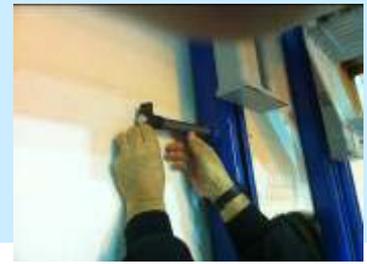
**AutoAdvance LINE SPOOLER**  
ALL FRAME SIZES

**Auto Advance Line Spoilers eliminate the need for a fixed sheave precisely located in relationship to the drum to achieve proper line spooling.**

**Auto Advance Line Spoilers work with any size of line and even with differing sizes of line on the same drum to create optimal line spooling. Large diameter sheaves in the Auto Advance Line Spooler ensure the line is not damaged by small radius bends.**

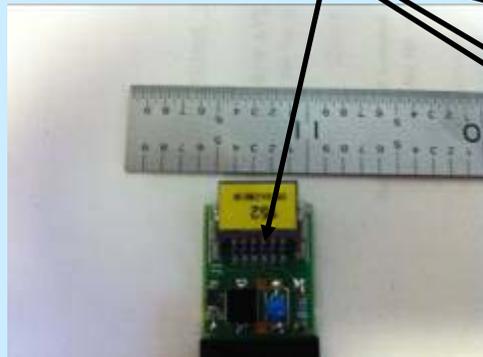
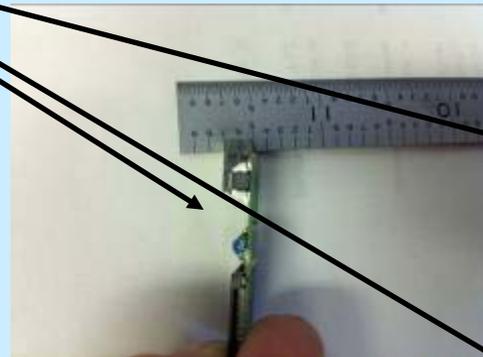
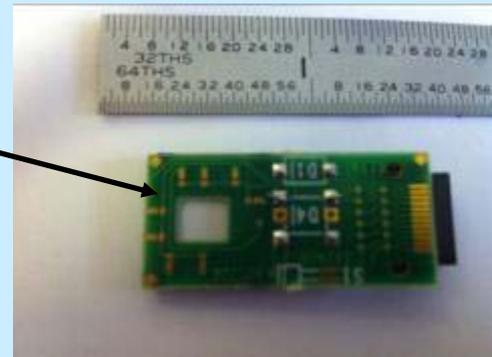
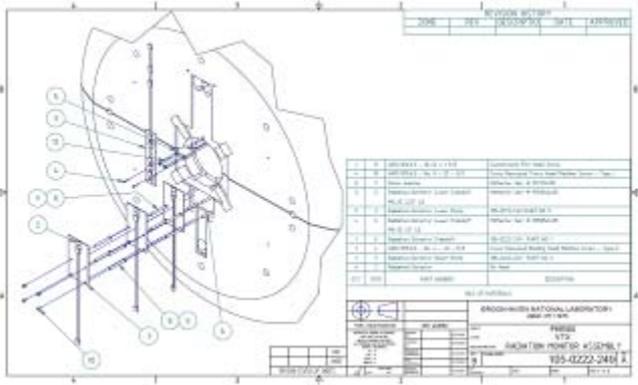
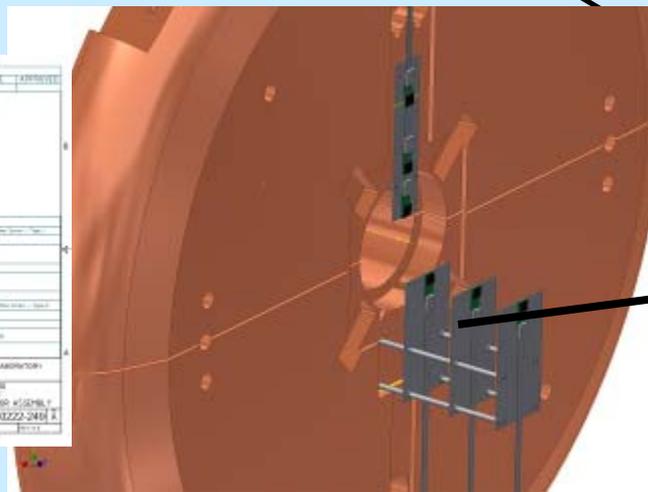
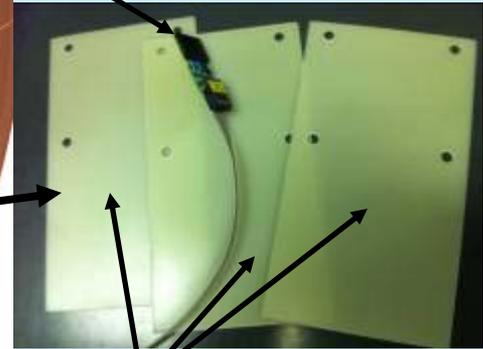
VTX/FVTX Radiation Monitoring Test

Rad monitor sensors

G-10 Sensor mounting pads

Mount 6 Rad monitor sensors in the south nosecone cavity, 2 sets of 3, 1 set at 3.5, 8.5 and 16.2 mm radially from nominal beam axis and adjacent to the nosecone, the other 3 at 3.5 mm radially and varying z coinciding with FVTX disks

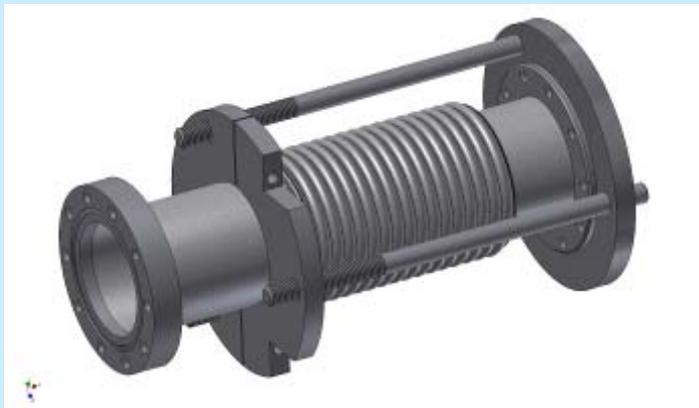
Existing vacuum bellows anti-squirm  
In MPC S Cavity

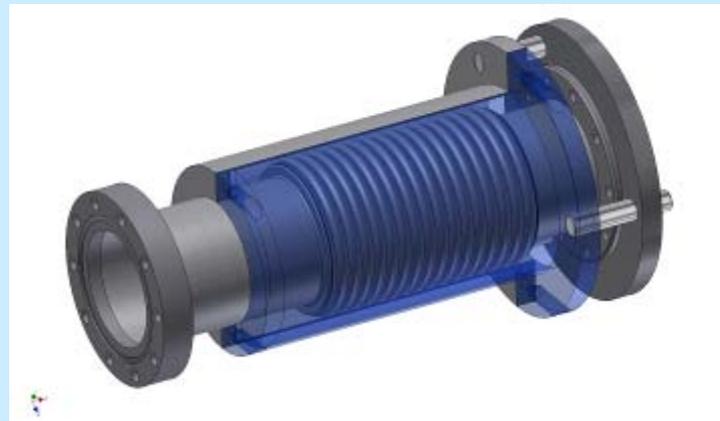
Proposed vacuum bellows anti-squirm  
In MPC S Cavity to accommodate MPC-Ex

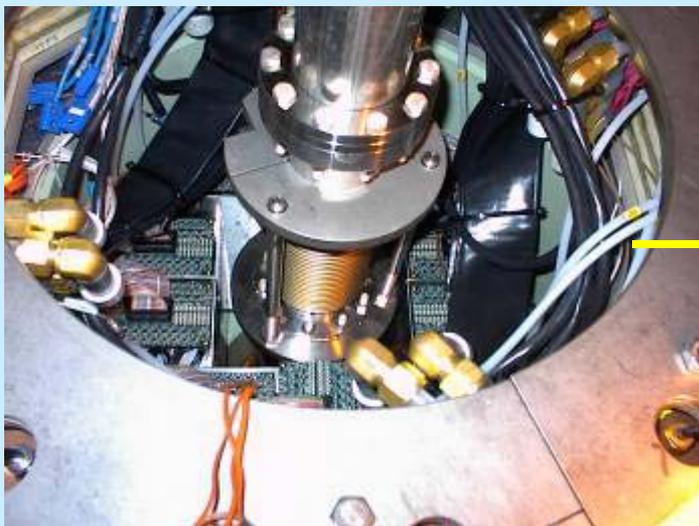
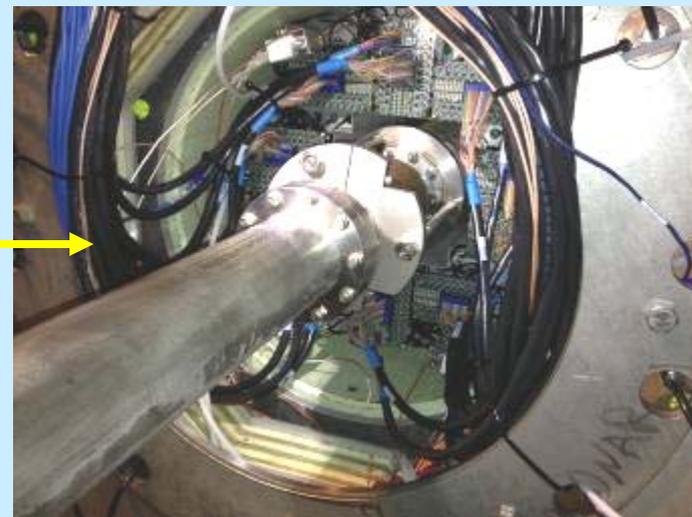
MPCS Flat cables replaced with round cables.

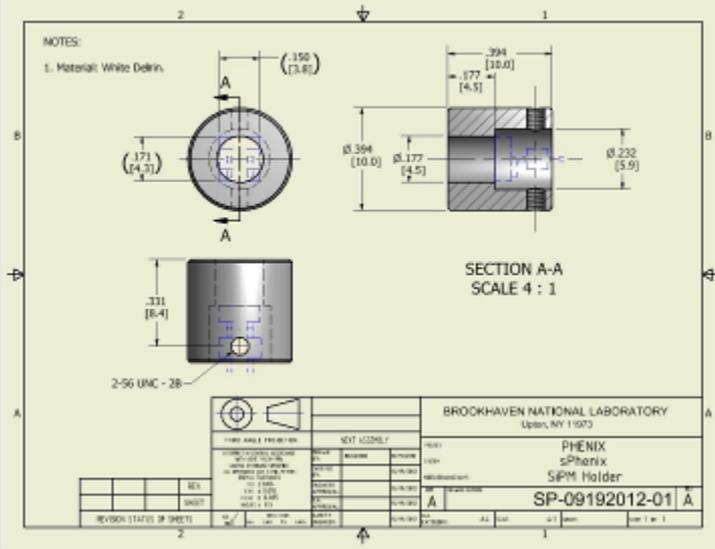
Silicon Photo Multiplier Holder
