# WBS 1.8.1 Mechanical Integration

# Outline

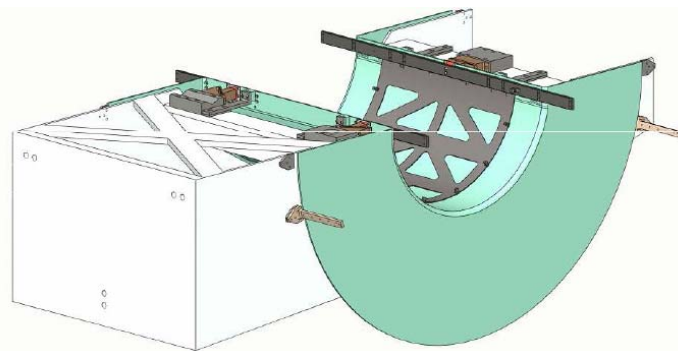
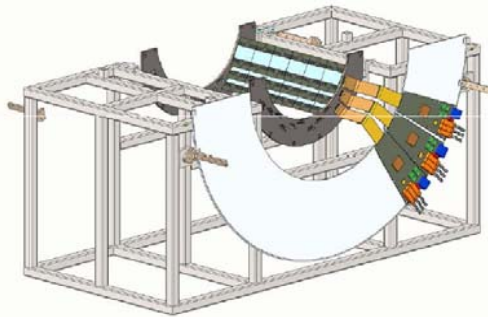
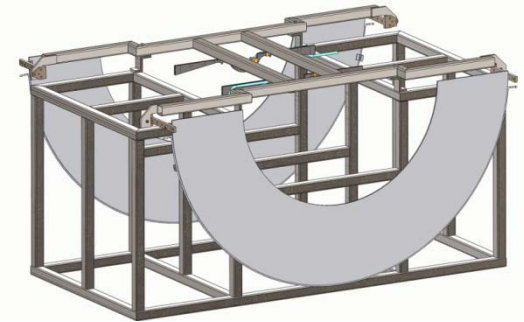
Main assembly

VTX L3/L4 assembly

VTX L1/L2 assembly

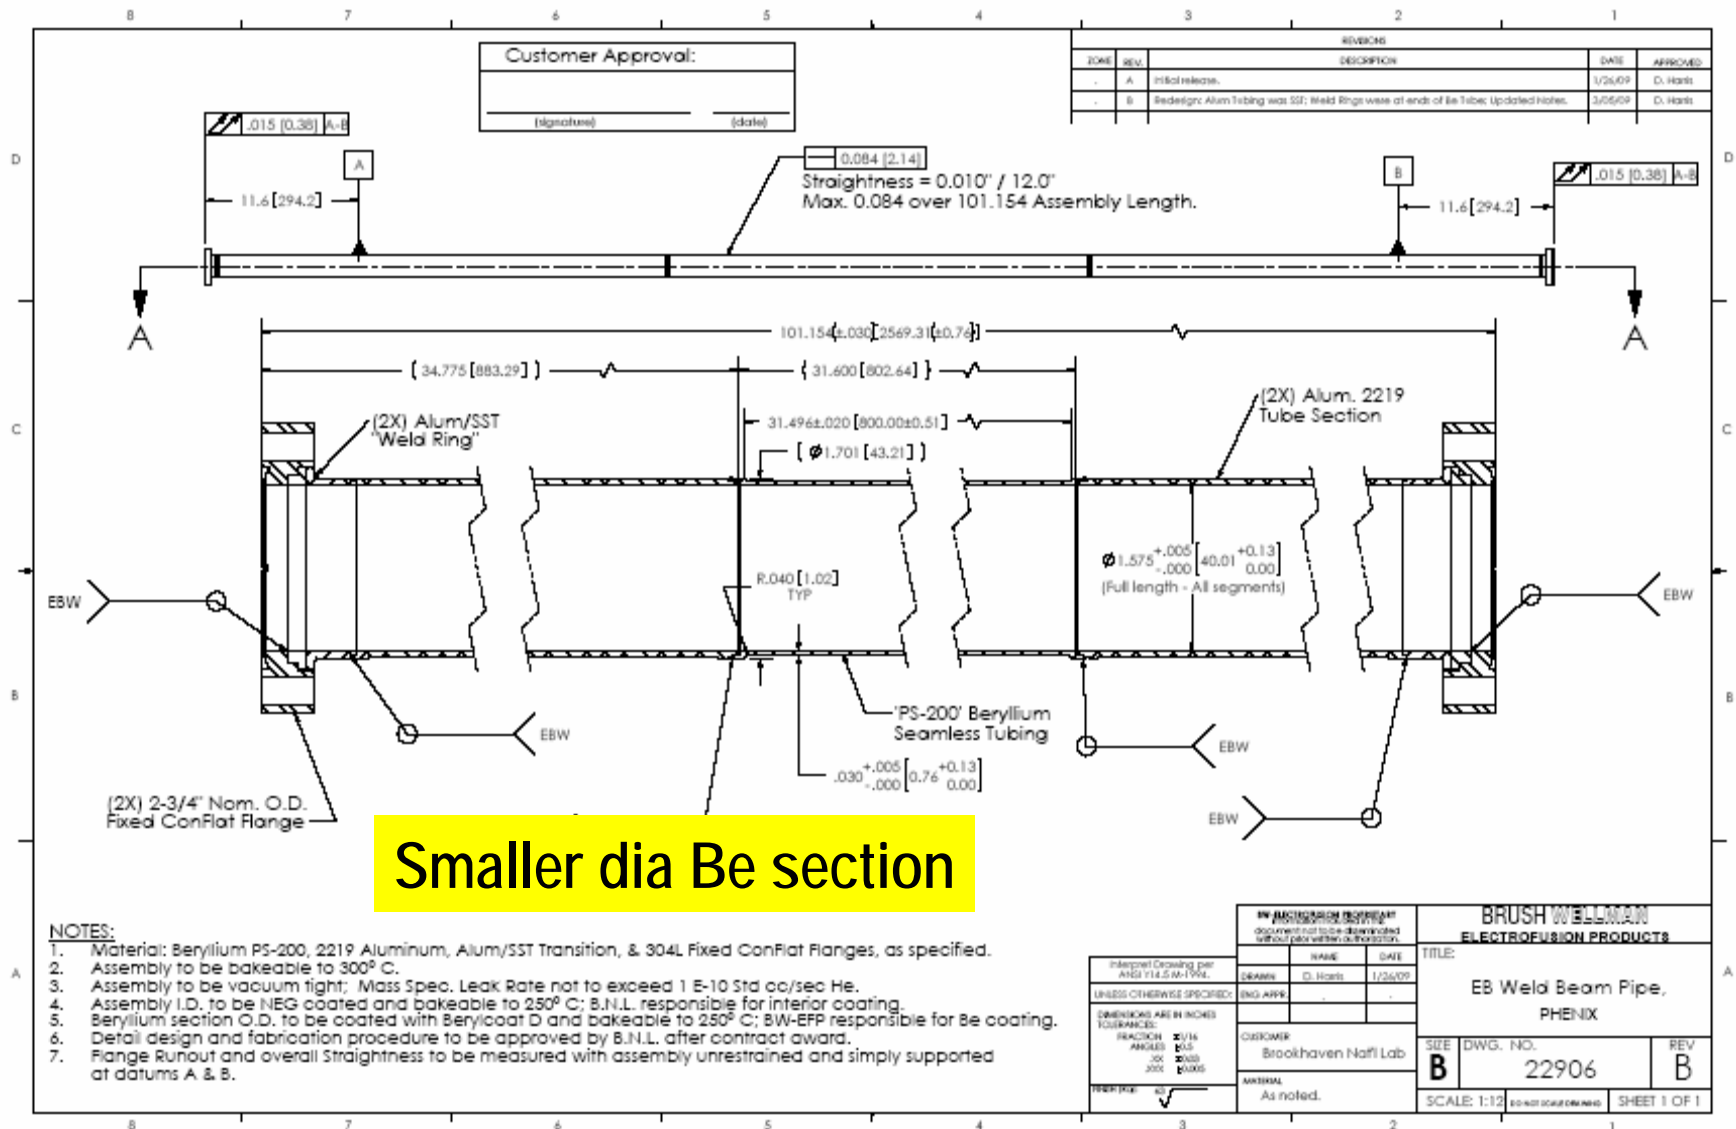
# Be beam pipe final CAP from Brush Wellman 4

- VTX, FVTX, PHENIX Management & CAD signed-off
- Current ETA from Brush Wellman:
  - 6 mos. to gun-drill Be tube (by mid-Nov. 2009)
  - Final assembly and QA (by end of Dec. 2009)
- Deliver to BNL and reship to Europe for NEG coating
  - CERN to handle Be section
  - SAES Getters does all the rest
- Install prior to RHIC Run-11 (summer 2010)

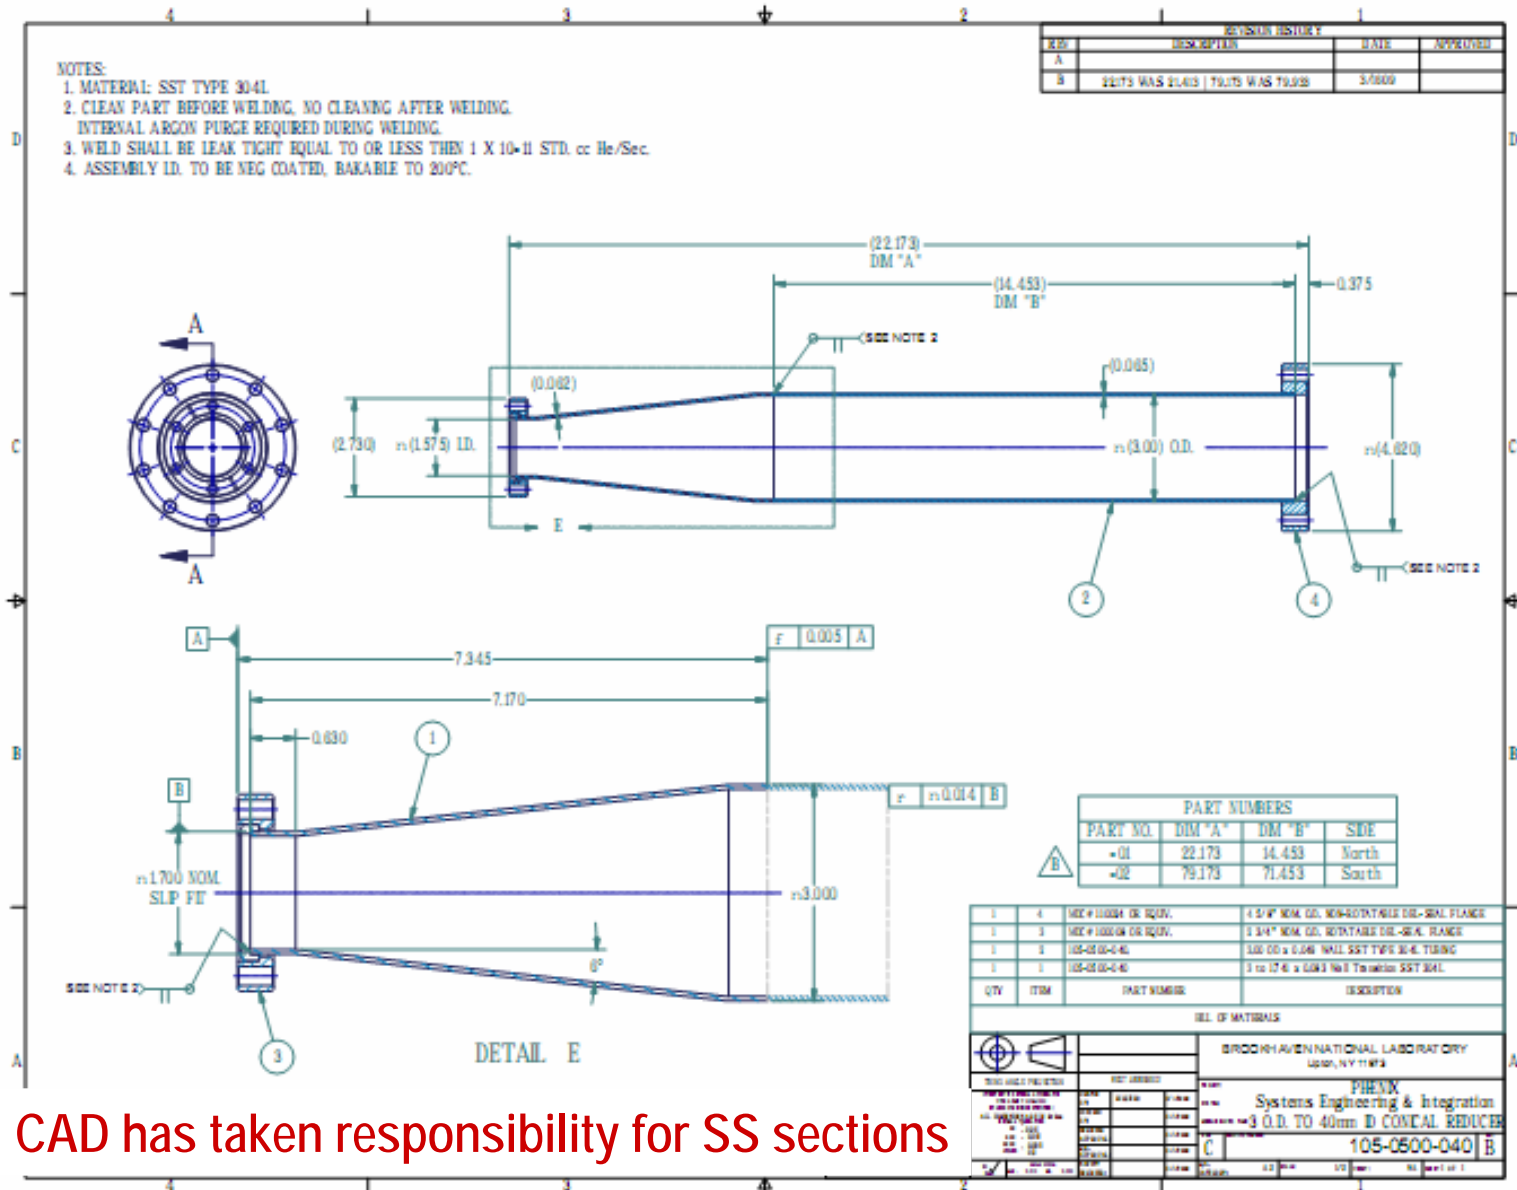
# Additional stainless transitions and spools 5

CAD has taken responsibility for SS sections

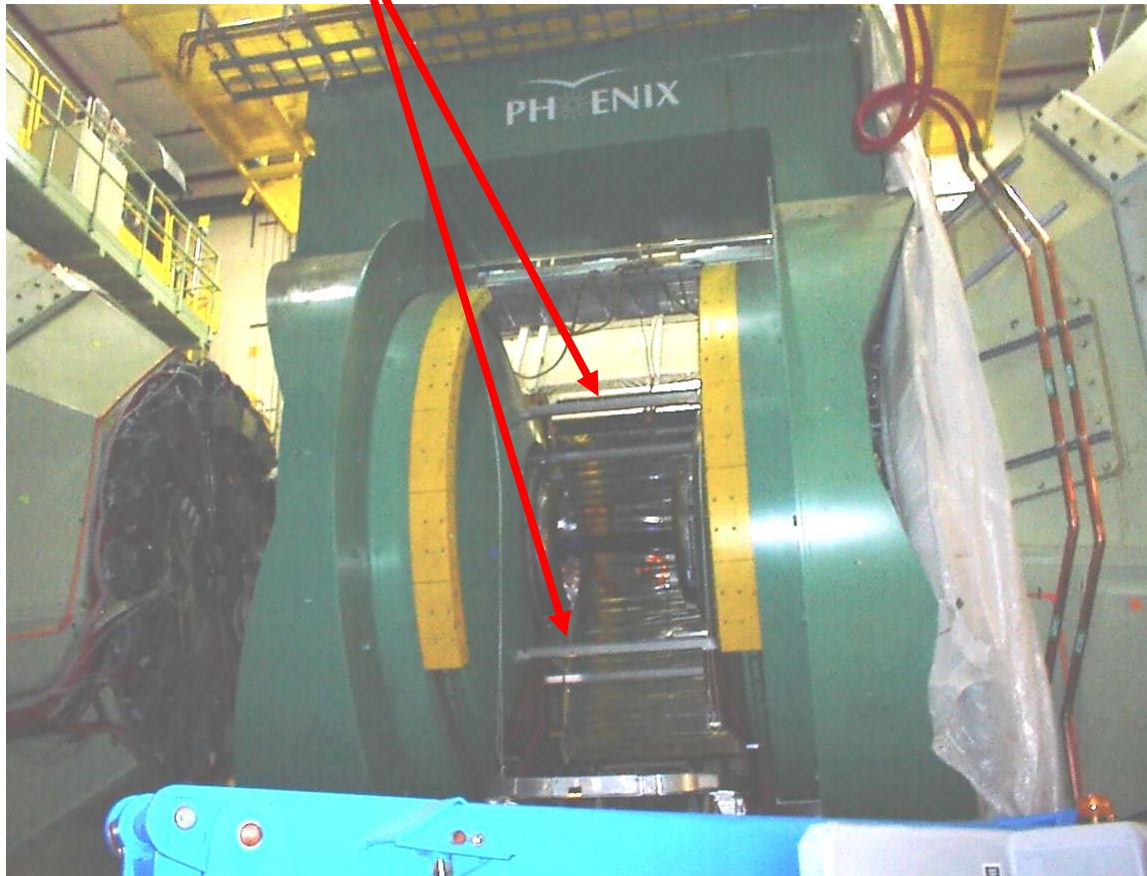
# External support installed

Electrically isolated from central magnet pole tips  
Measurement of magnet vibrations proved negligible

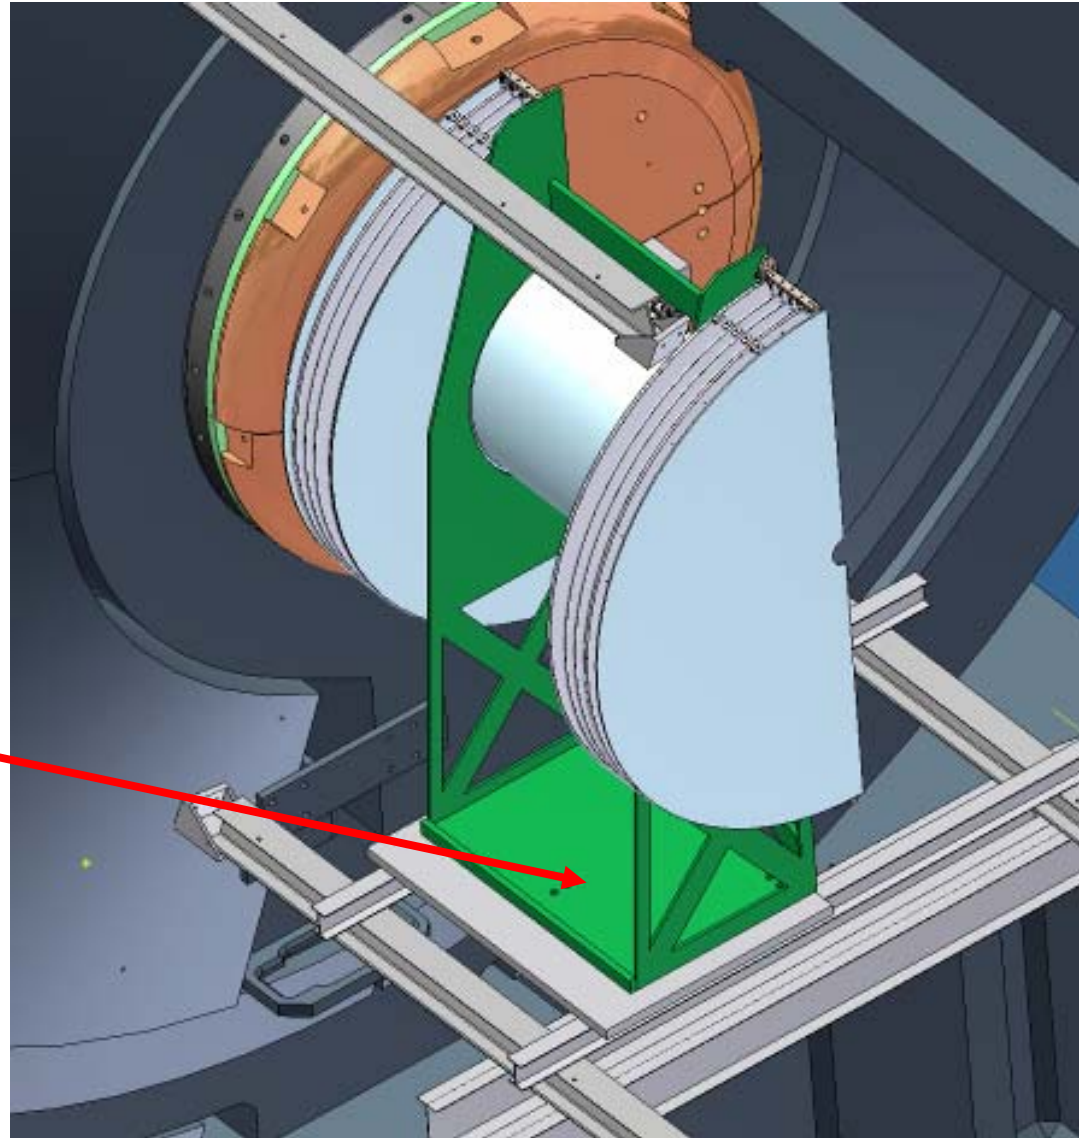
# BNL concept for support truss

- Single support structure attached at 3 points to west detector sled
- 6 degrees of adjustment
- East mirror images west

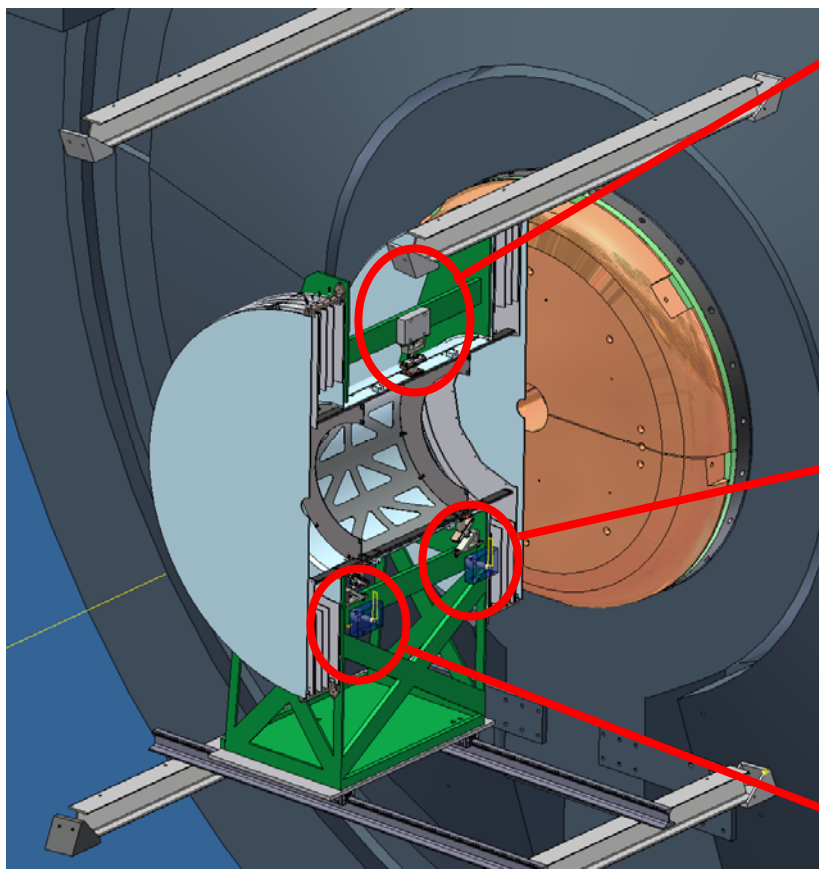
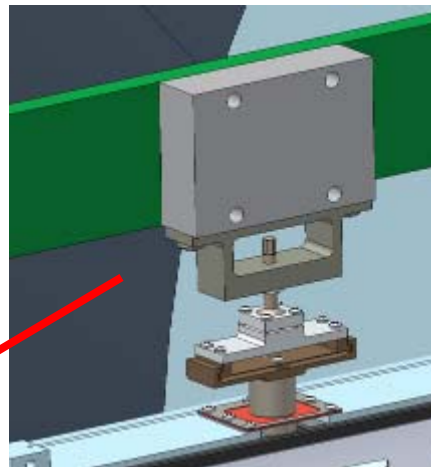
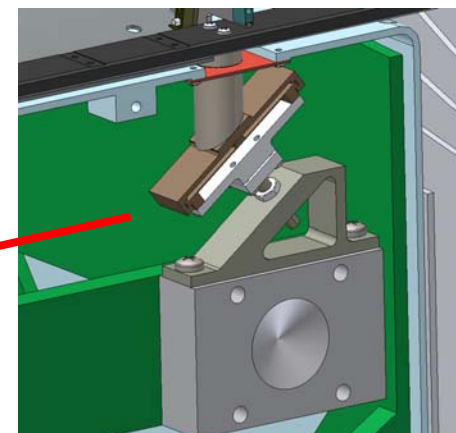
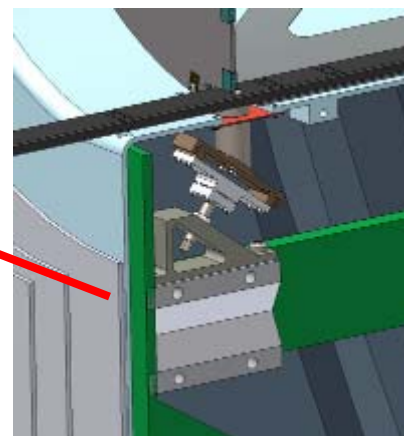
Kinematic mounts for mating  
east and west detector halves

2 DOF (Y & Z)

0 DOF

6 interface points  
w/ HYTEC

1 DOF (Z)

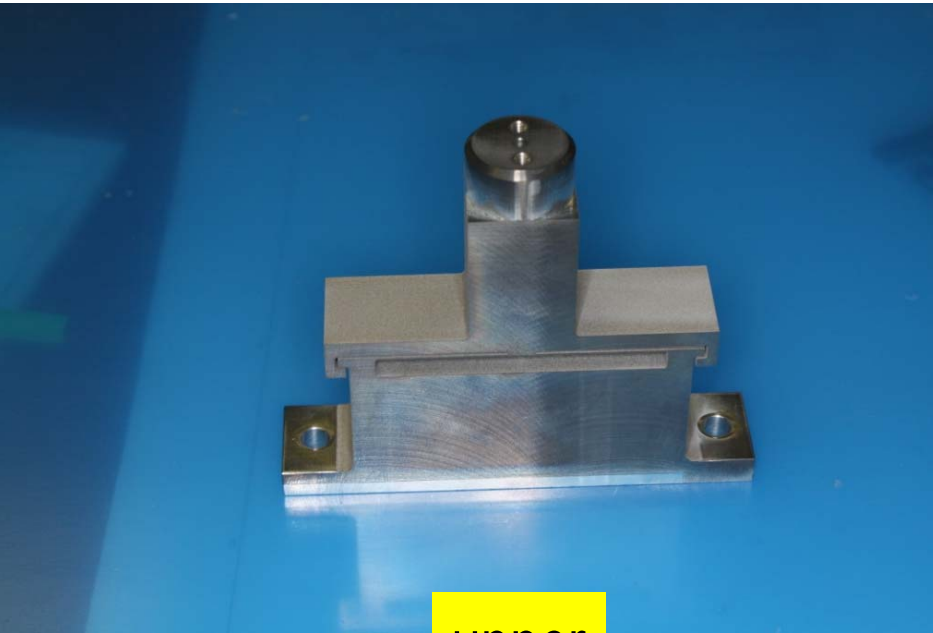
upper

- Isolation mounts penetrate gas enclosure to support space frame
- Fabrication complete, only anodizing and QA remain

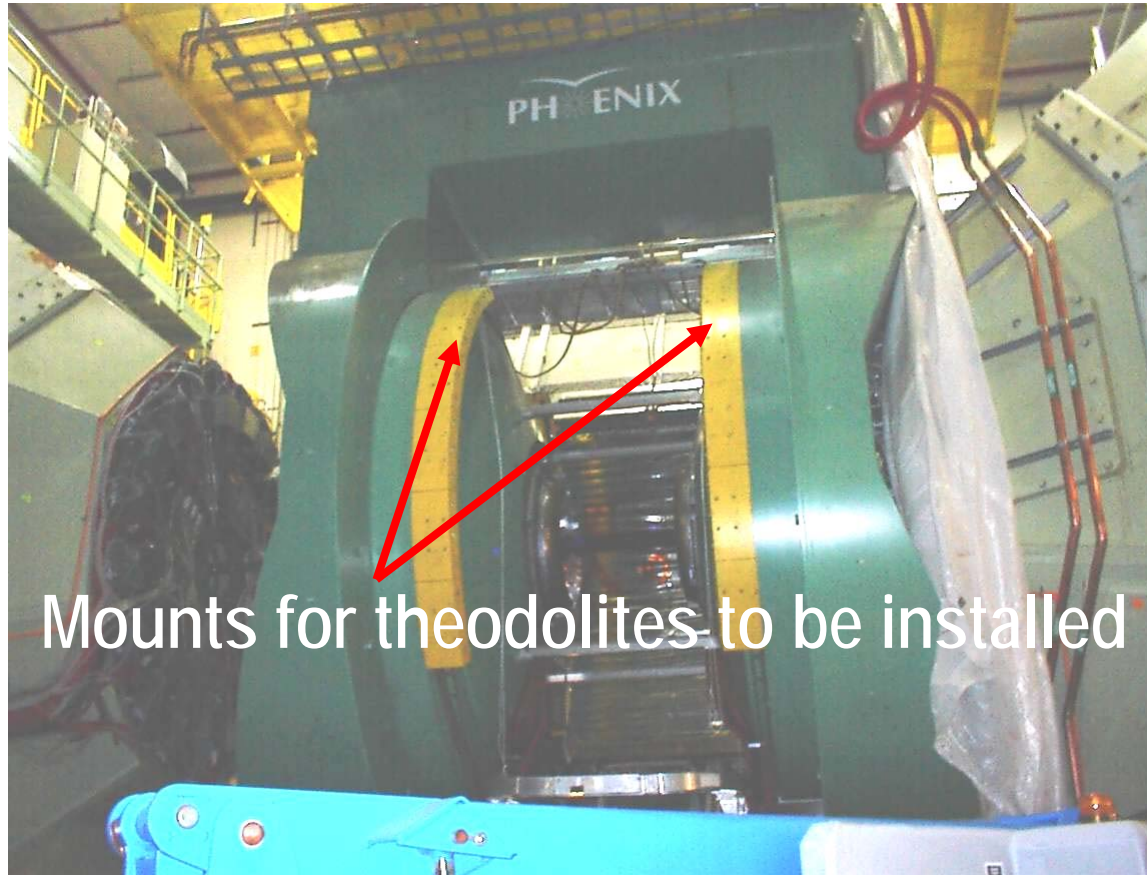
# Survey plan in PHENIX IR

Mounts for theodolites to be installed

Provide stable location above beamline to shoot targets for CAD survey

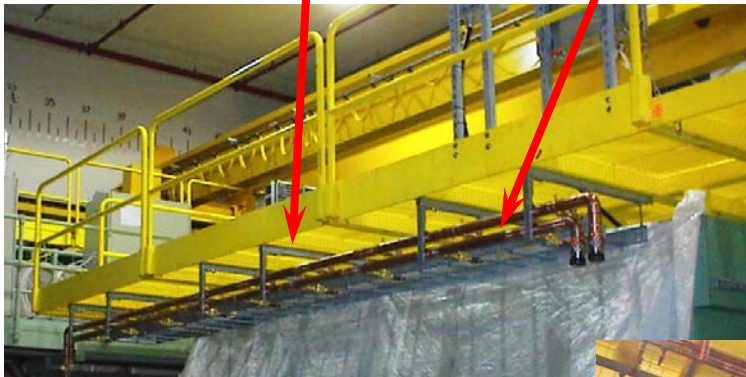
Platform water manifolds and cable trays

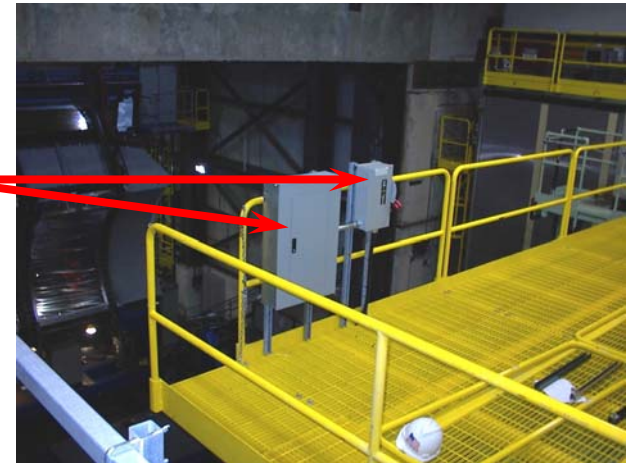
Platform electrical distribution and disconnect

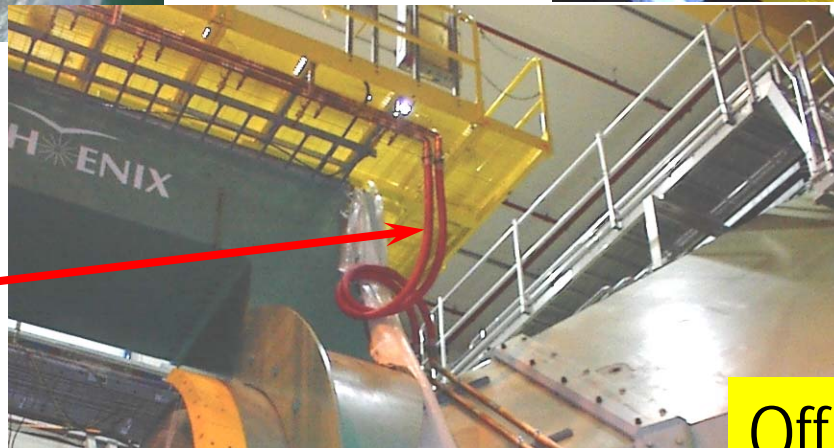
Platform water supply & return flexible connections

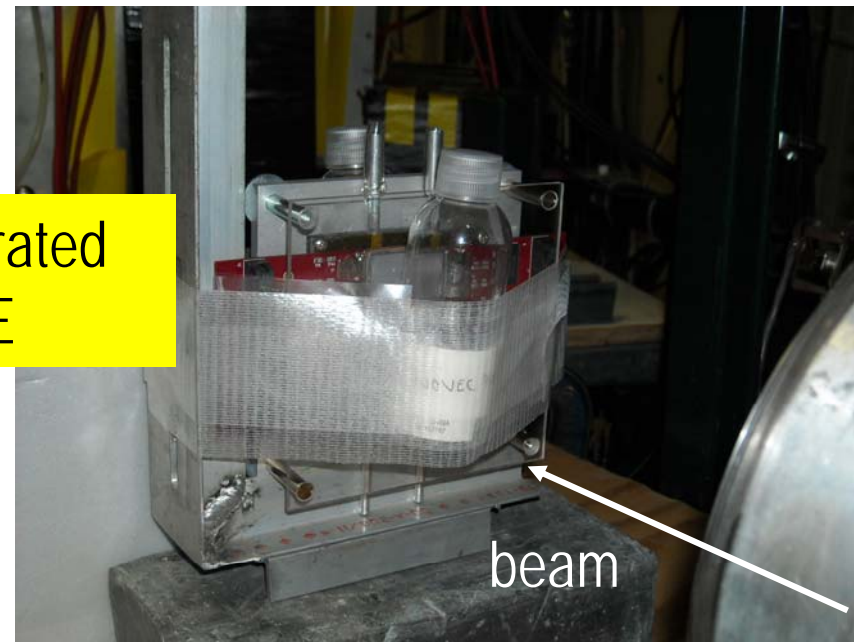
$6.7 \times 10^{11} \text{ N}_{\text{eq}}/\text{cm}^2$  integrated  
dose from LANSCE

The in-beam samples recorded average free fluoride ion concentration of ~0.03 ppm. Though these are elevated fluoride ion levels compared to the virgin samples, these concentrations are much less than 1 ppm and indicate insignificant degradation

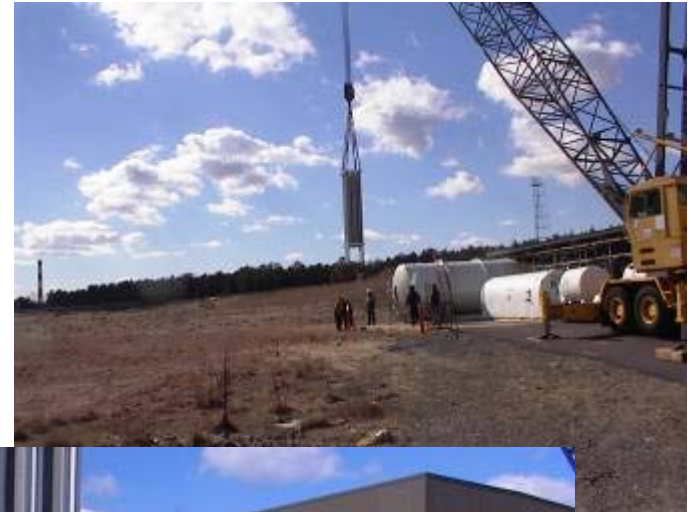
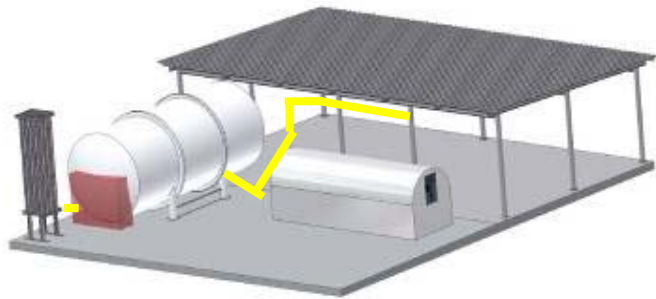
LN<sub>2</sub> Storage Dewar for Dry Nitrogen System shared by **BBC/VTX/FVTX**

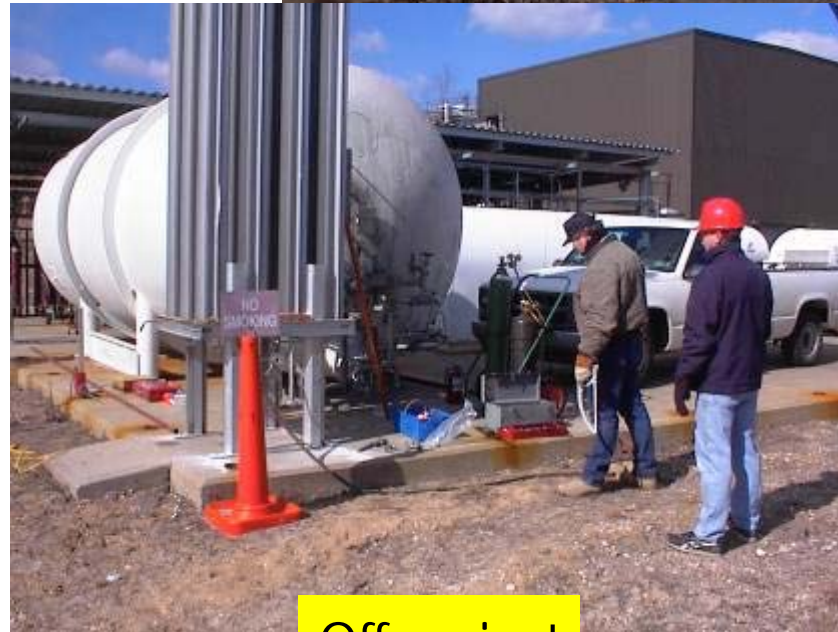
Bleed the boil-off  
5200 gal. capacity
