Findings – 5/16/2019

During the ORC review of the T1441.02 installation today at 13:00, we found:

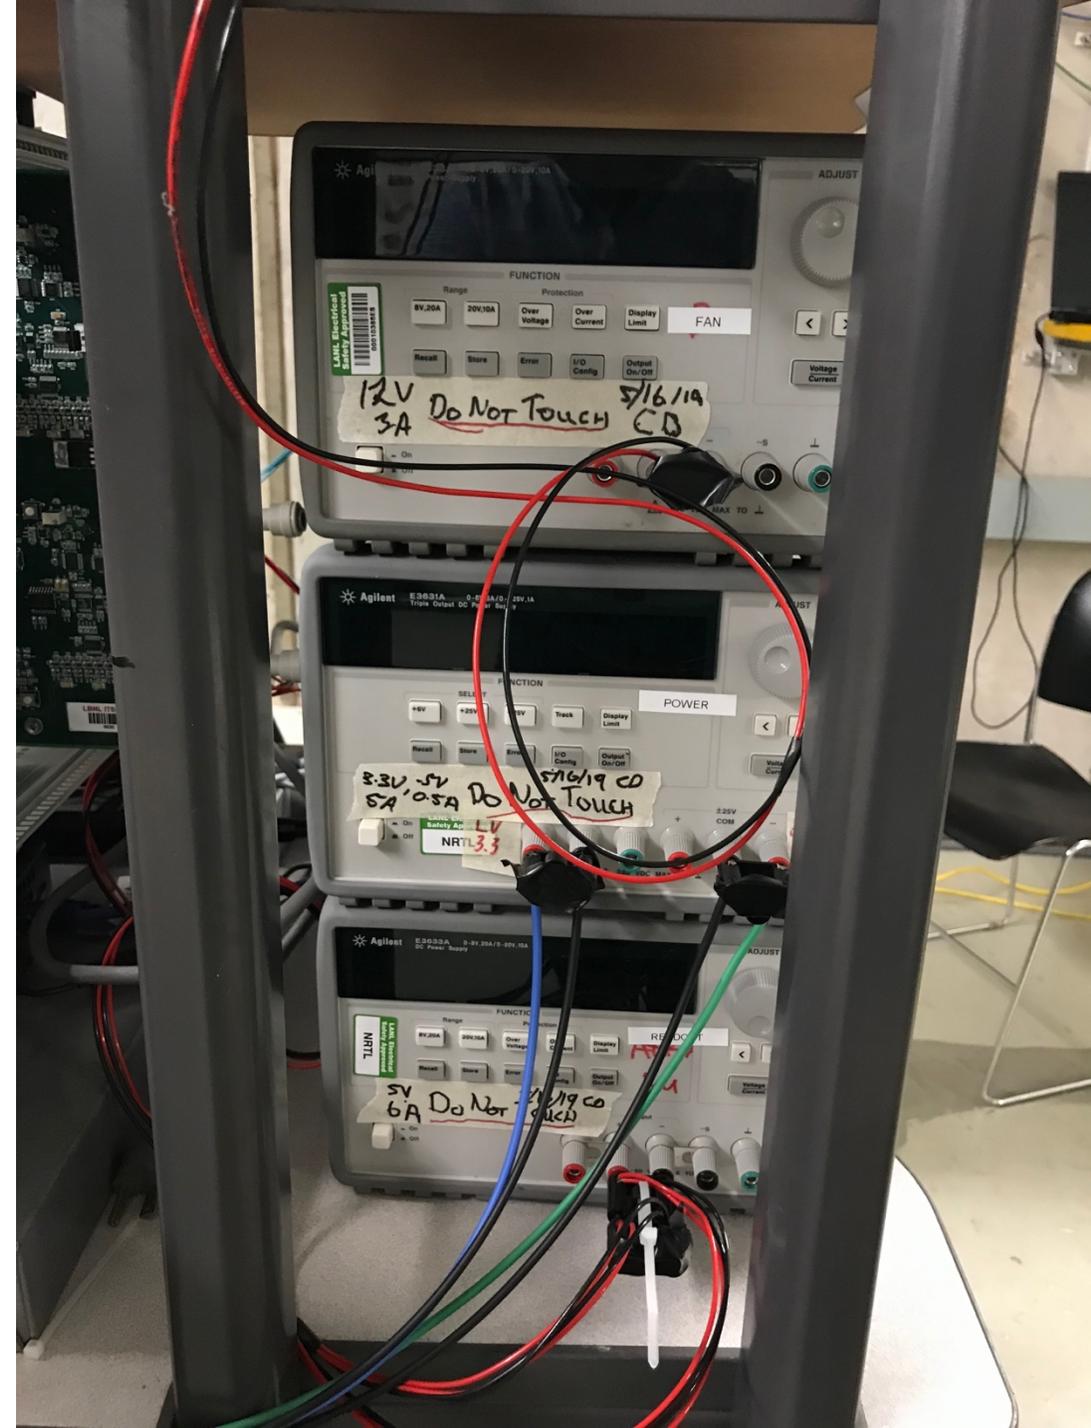
User Cameron Dean,
5/16/2019; see photo-1

- 4) The DC power distribution's fuse protection, wire sizes, etc. are sufficient for the DC power involved. --OK.
- 5) Recommend to place a tape over the power supply banana jack connections to prevent any DC shorting through these jacks. Done during the review. --OK. Also see photo-1

PS voltage and current limits
are labeled:

Top: Fan PS

- 12 V
- 3A

Middle: staves

- 3.3V, 5A
- Bias: -5V, 0.5A

Bottom: RU power
5V, 6A

- 2) The AC power cordage, plug-ins, loading looked --OK.
- 3) The DC power supplies are using the internal presets, entered into non-volatile memory, to set the DC power voltage limits and current limits. Require that the presents be indicated on the power supplies with a label to indicate their respective presets, the effective dates, and person/persons using these presets.
Done, see attached photo-1.

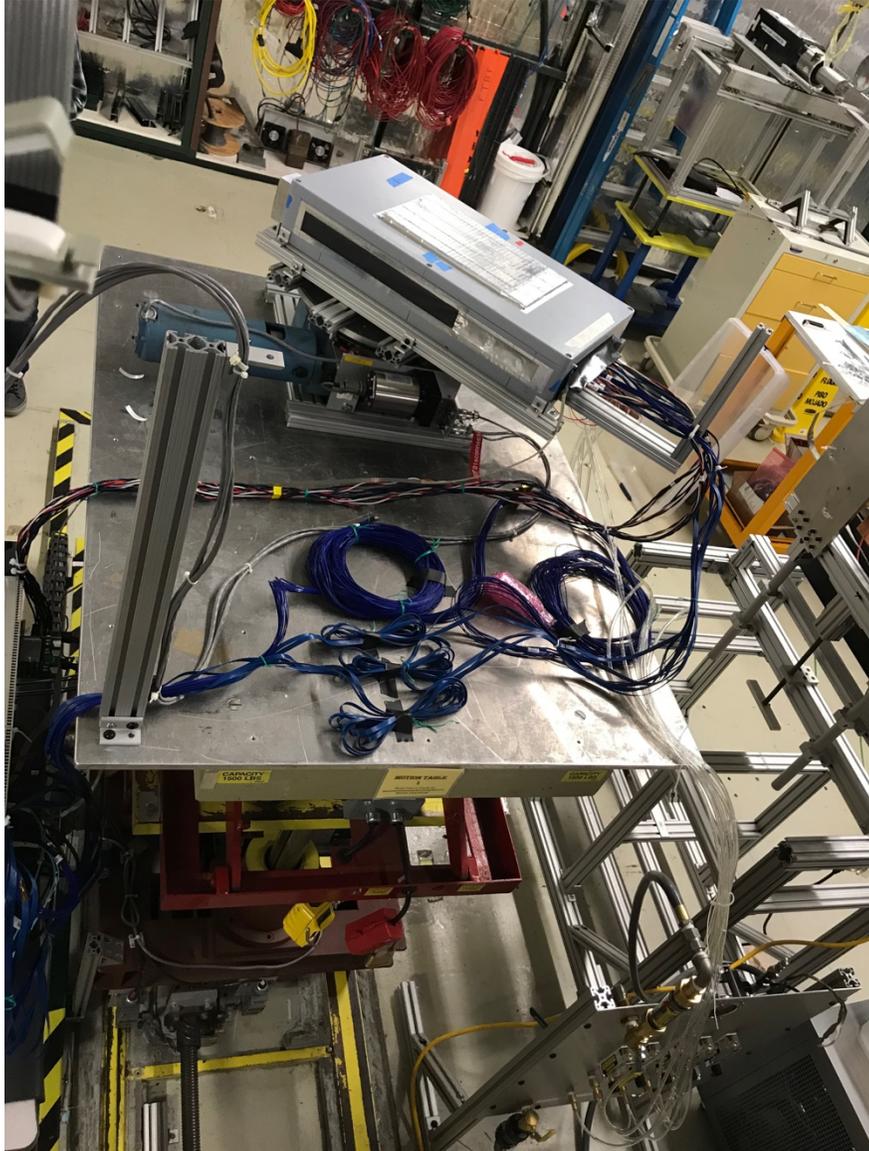
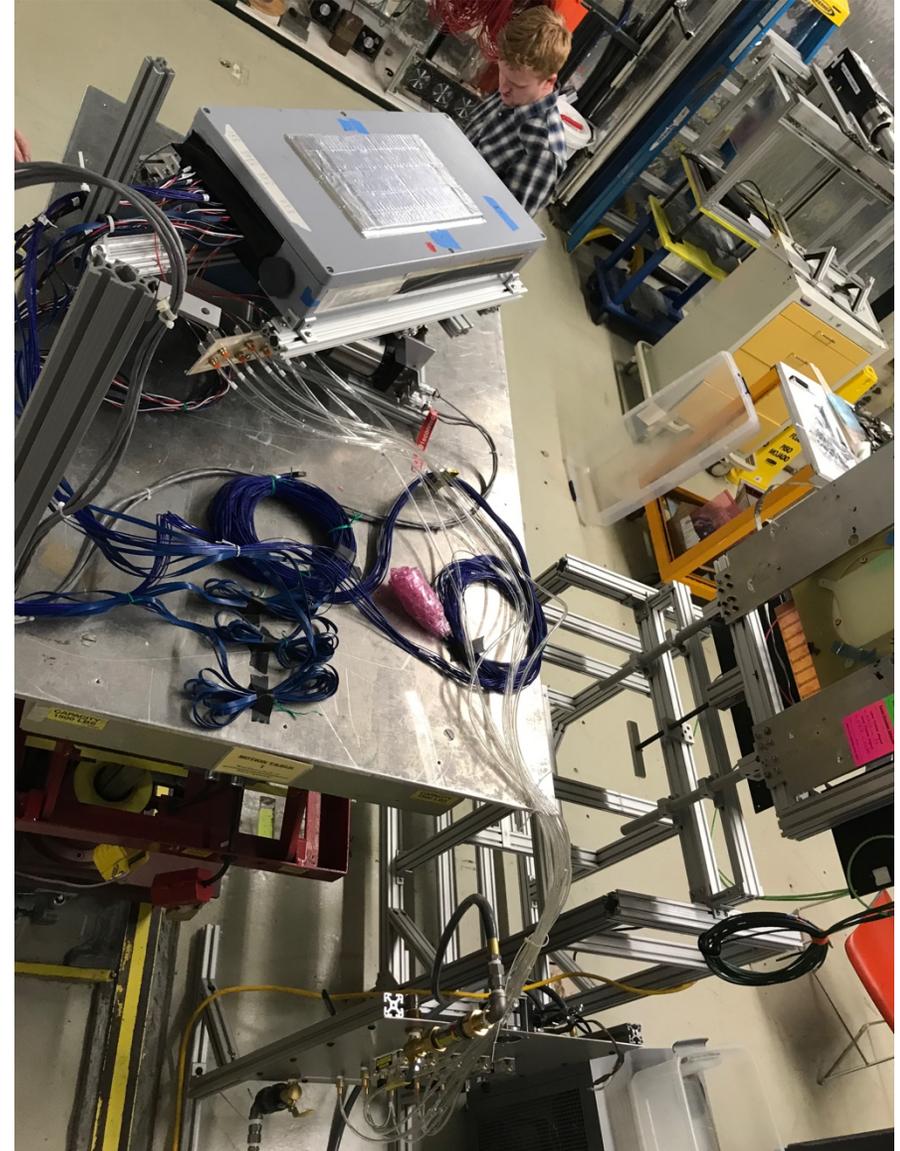
Detector with cooling tubes connected Far-end location, photo-2,3

- 8) When the detector's cooling tubes are connected and tested for leaks, the table travel and planar rotation needs to be checked for proper cable and tubing slack and restraint.
Done. 1) connected and tested for leaks, 2) cable slack and restrains see photo-2,3,4,5;

- 9) The cables to the readout crate need to be grouped and restrained properly for the table travel. Once done, this travel needs to be rechecked. Done, see photo 2,3,4,5; readout cables are also taped to the table

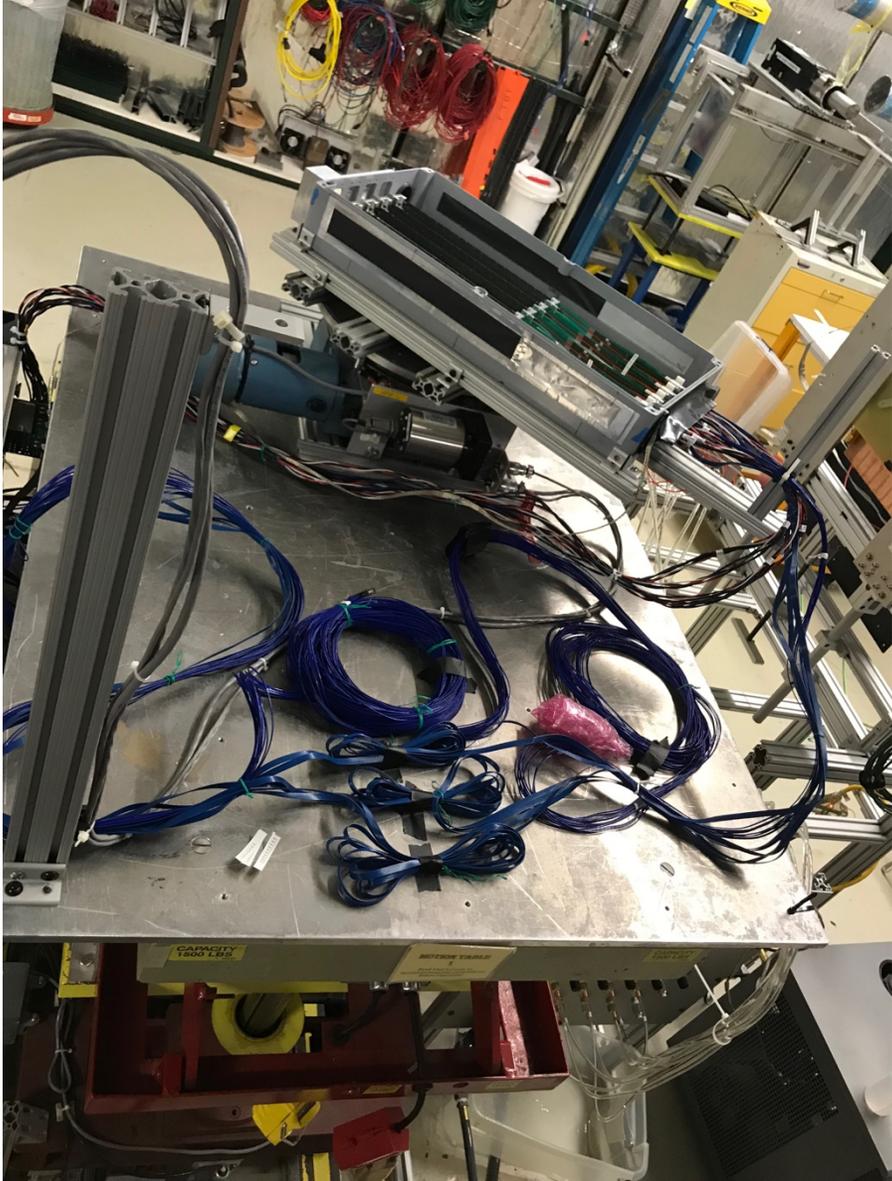
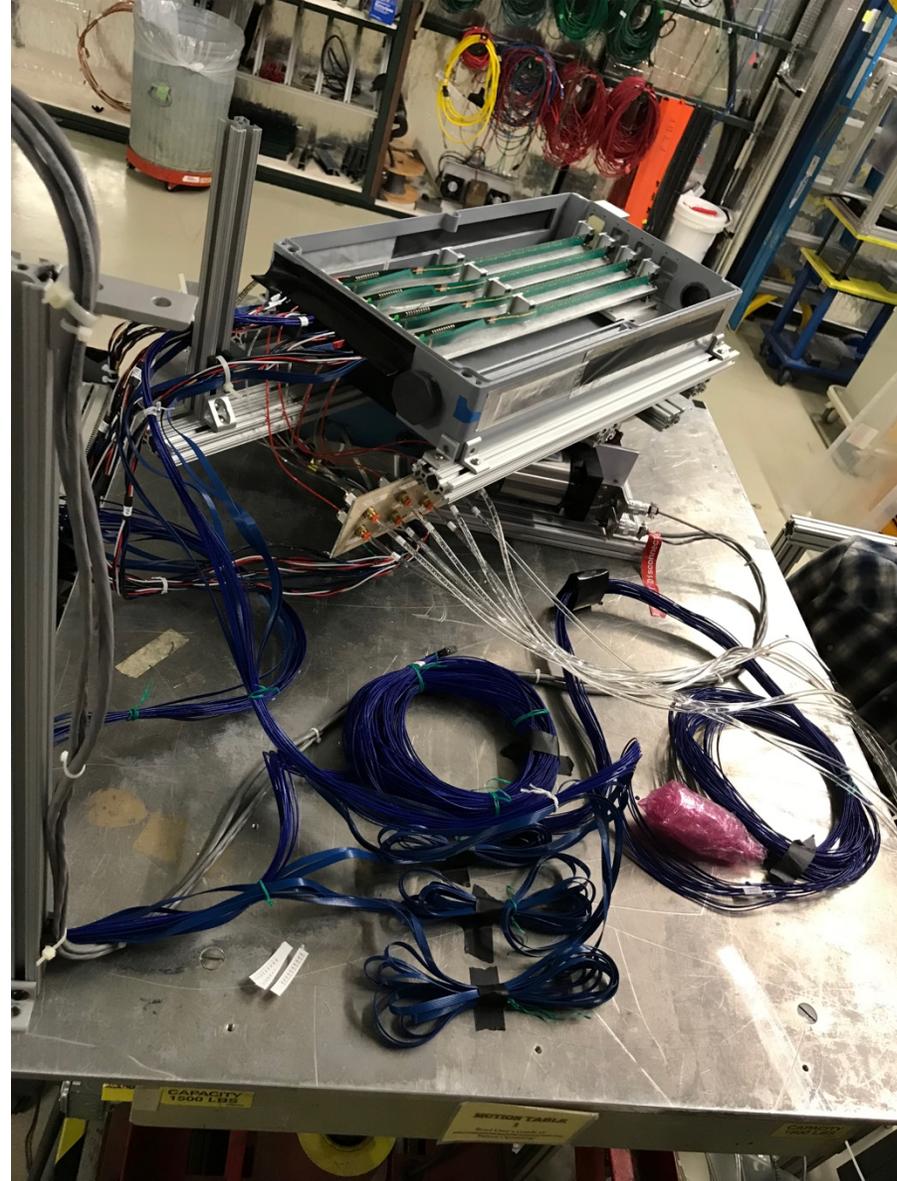
Near-end location, photo-4,5

Detector with cooling tubes

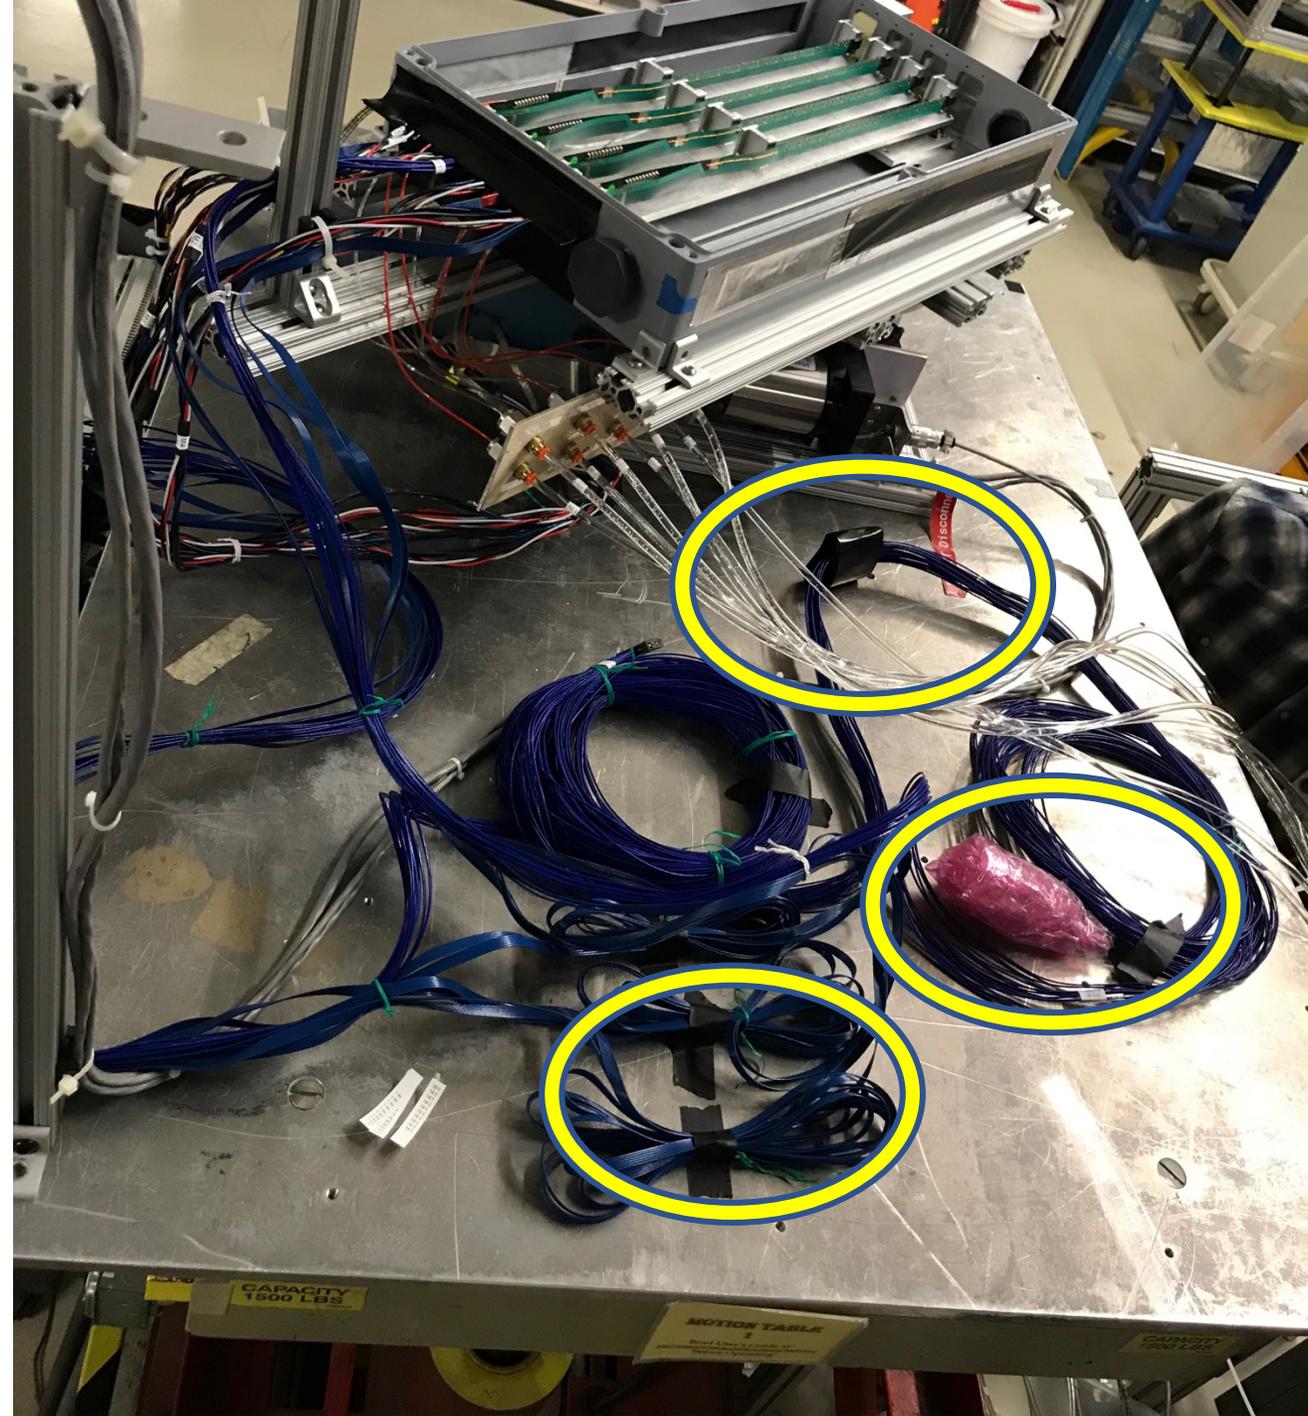
PC boards and connector
are all taped up to prevent
shorts to ground
photo-6

- 10) Recommend to tape up the exposed PC board terminals/pads, on the LVDS connector PC board, to prevent shorts to any grounded structure or component. Done, see photo-6.
