PHENIX WEEKLY PLANNING

TECHNICAL SUPPORT

9/15/2011
Don Lynch

Hodoscope for RPC3 (update)

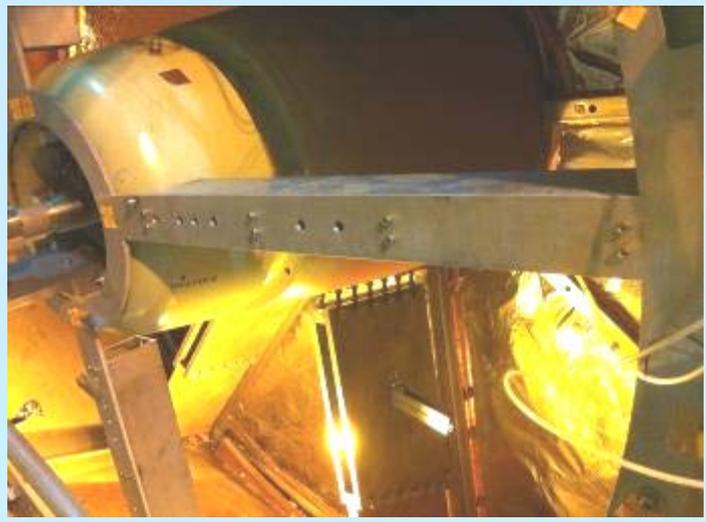
Station 2 access from station 1 side (MMS shown above MMN at left is similar in concept)

Design of access platforms is in progress

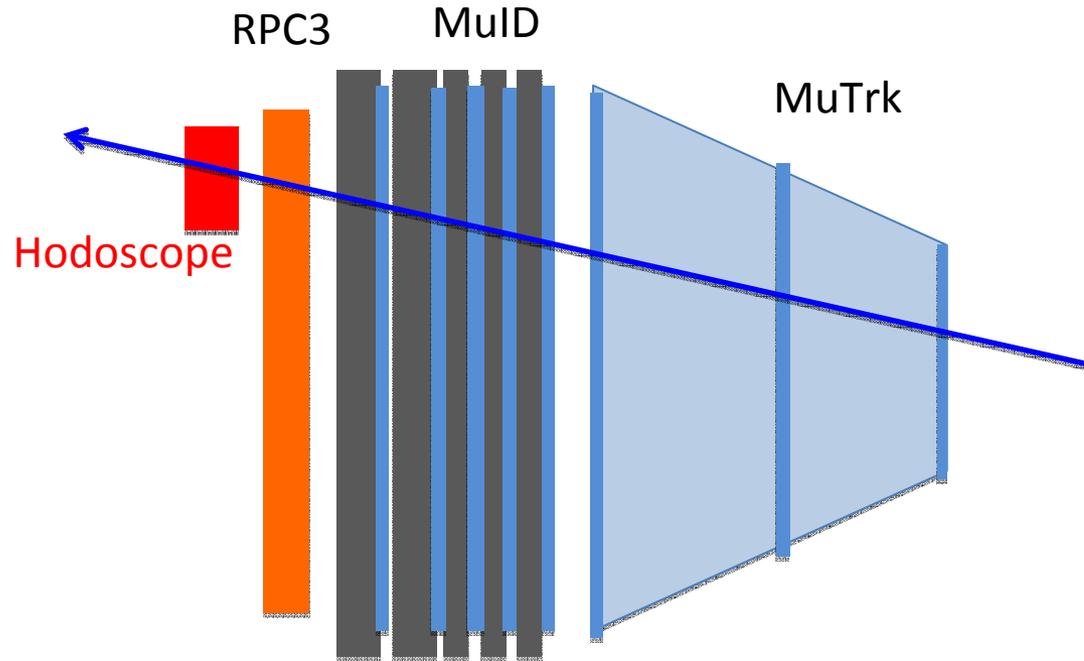
RPC3 Efficiency with Hodoscope =
of RPC3 hits / # of Muon Tracks Projected on RPC3 & **Hodoscope hit**

Extract absolute RPC3 efficiencies (Run by Run Absolute efficiency possible)

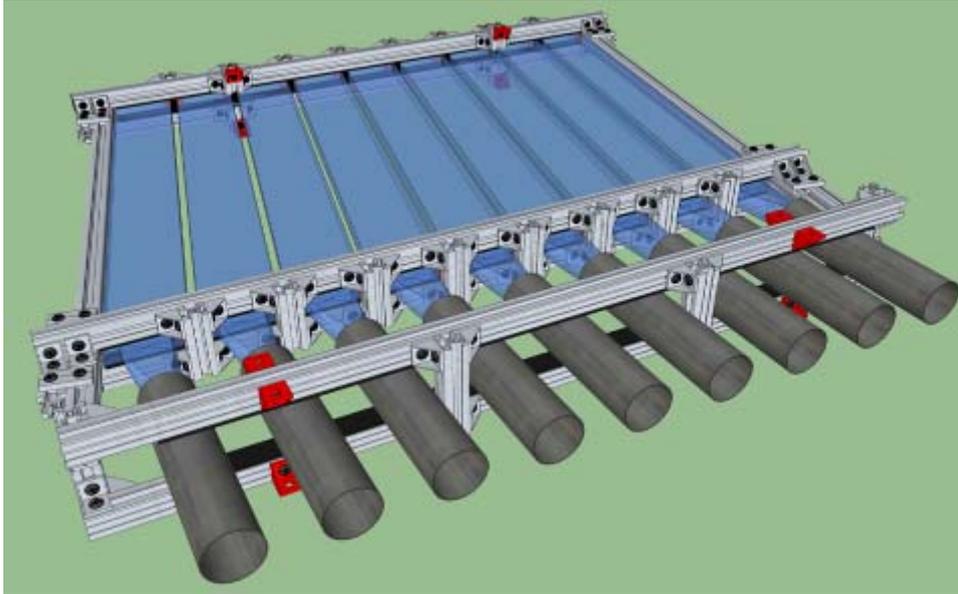
Hodoscope Design

Design by Daniel Jumper (UIUC)

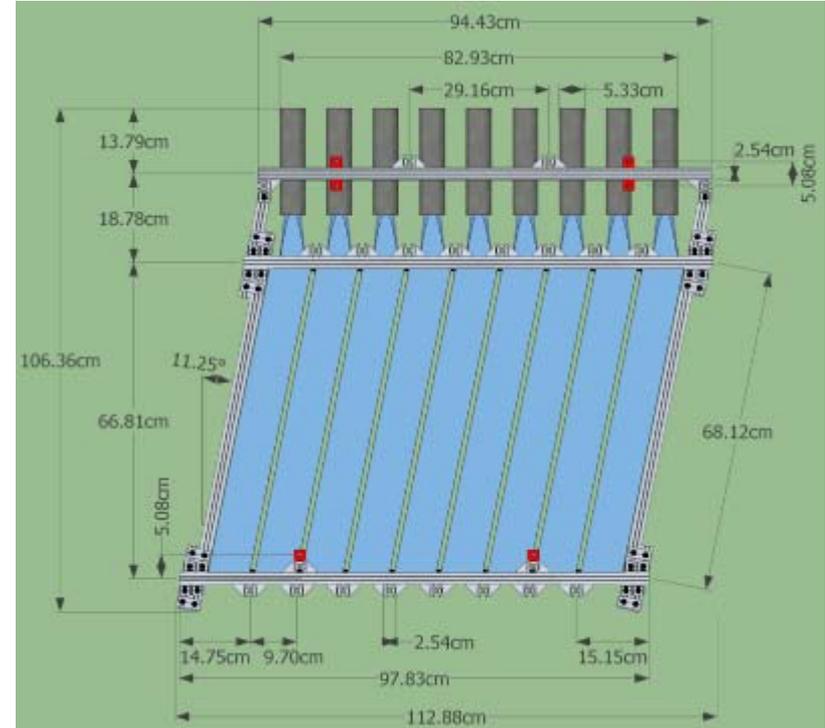
Front View

9 Scintillators + 9 PMTs

Size : 96 x 107 x 11 cm

Weight : ~ 73 lb

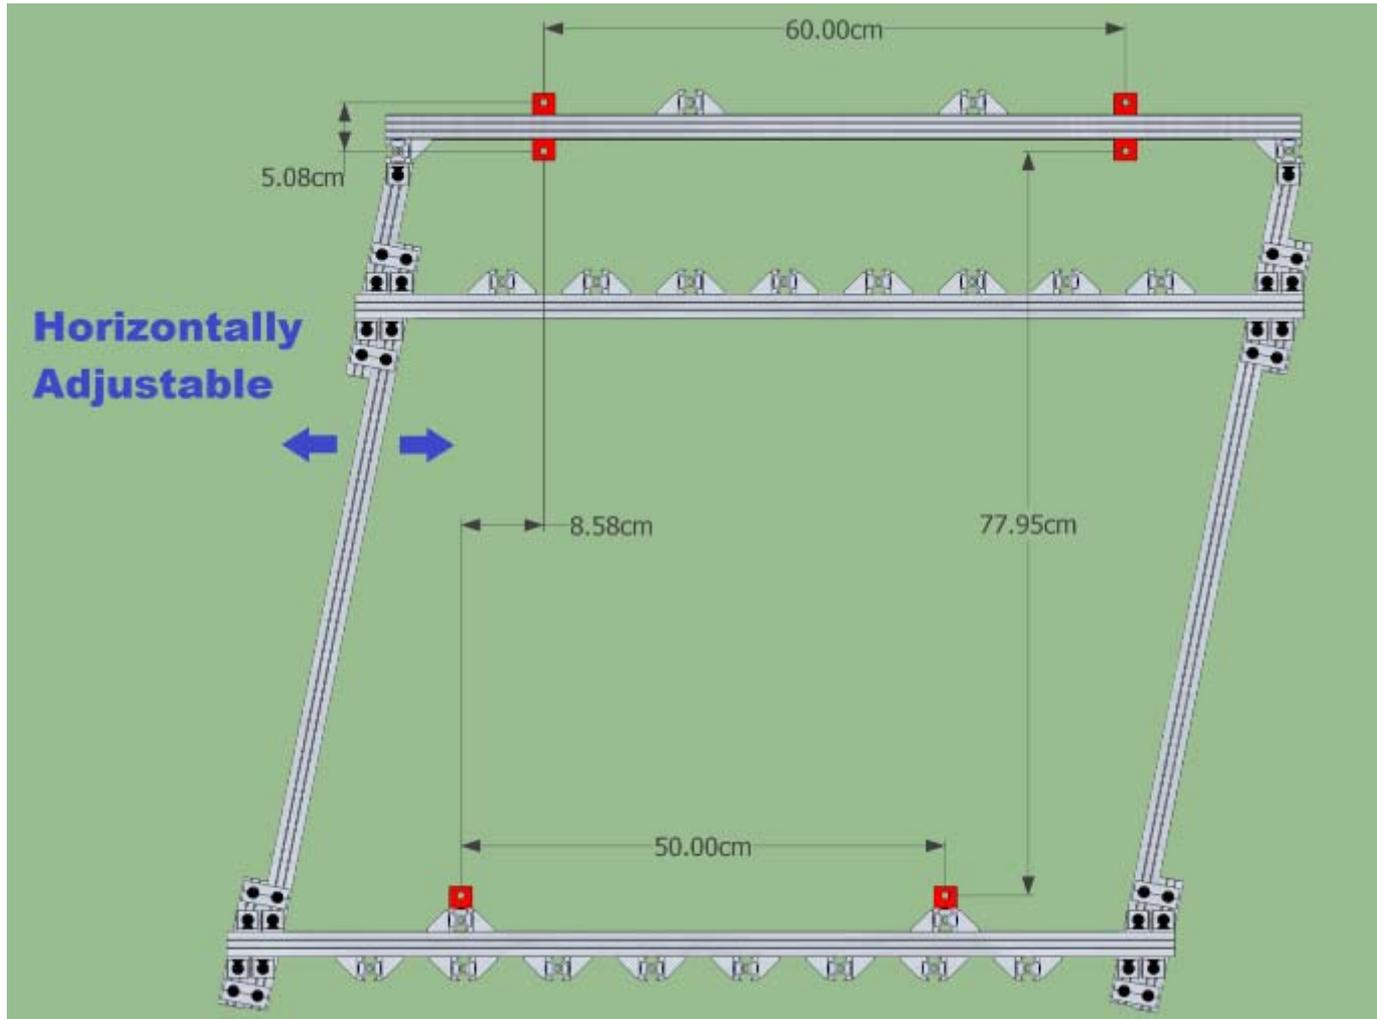
Mounting Points

NOTE: MOUNTING BRACKETS ARE SHOWN IN RED

Mounting brackets are on frame profile rails that allow 1-D alignment.
Brackets use ¼" thick bolt or screw.

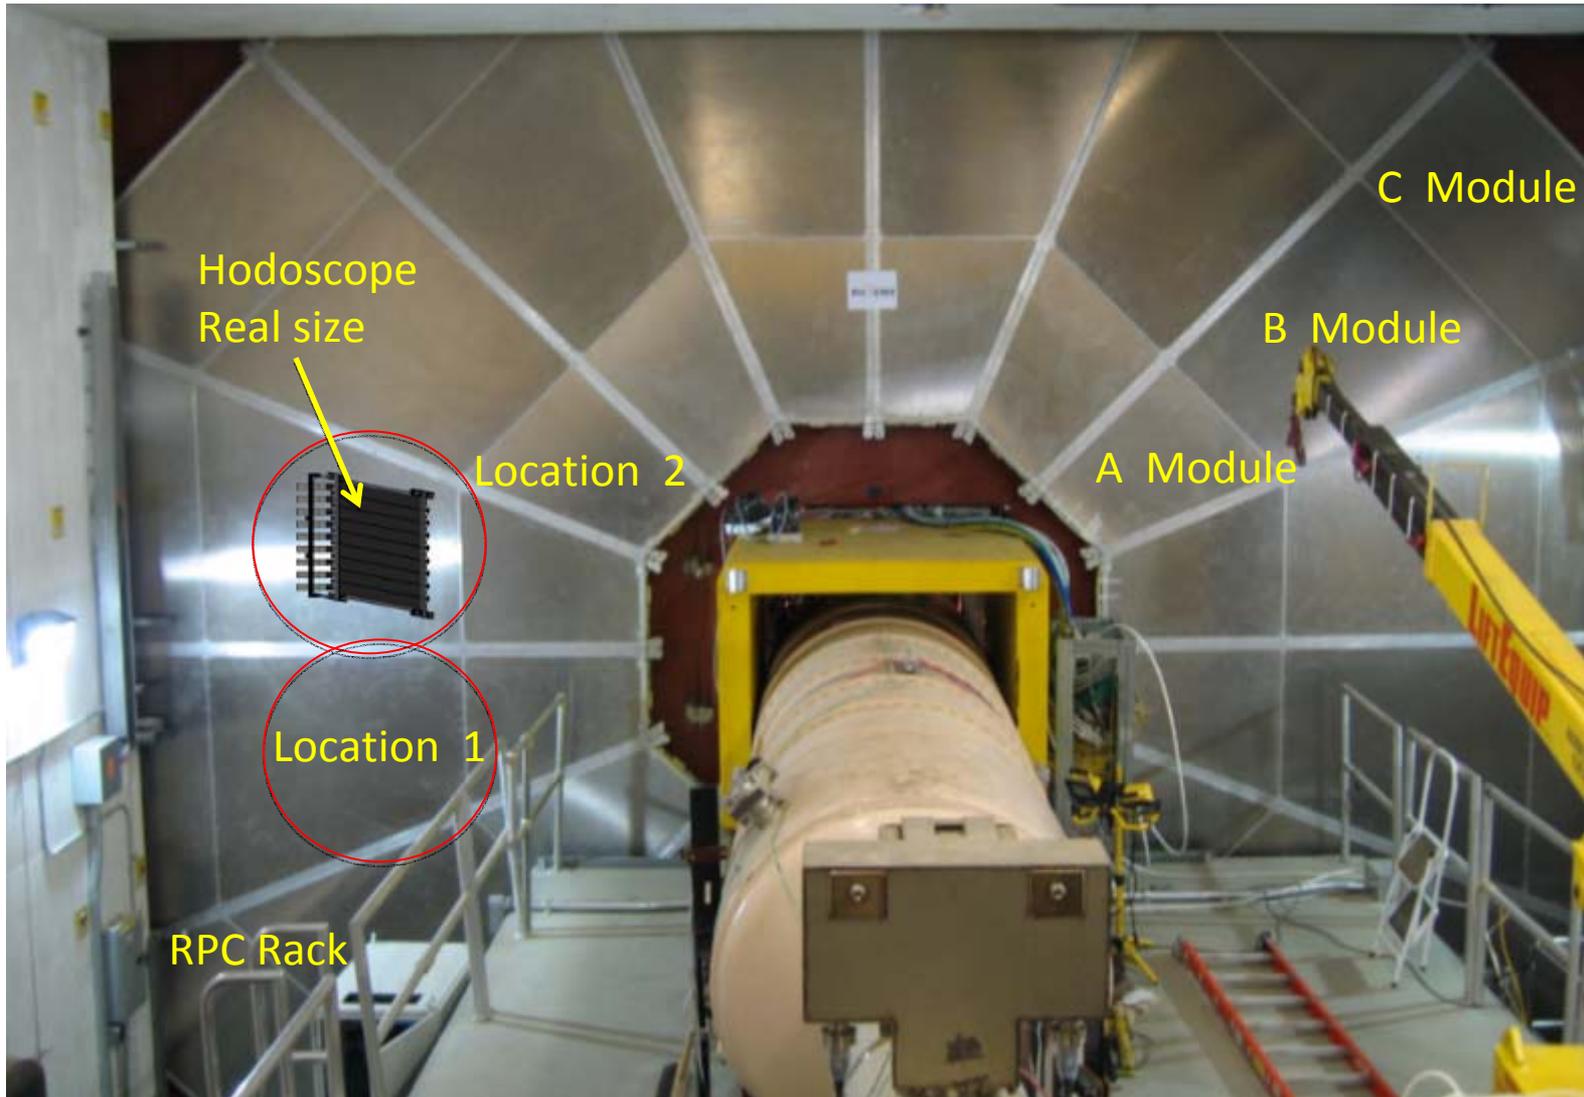
Location of Hodoscope

9/15/2011
Close to RPC3 electronics rack
Less Beam background region

Location 1 or 2 would be good position.
Install at North and South tunnel.

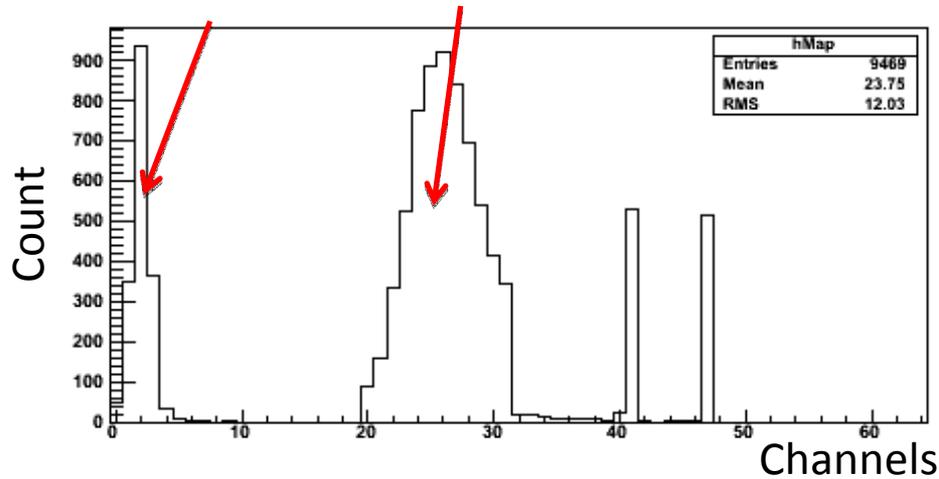
Hodoscope Cosmic ray test results

Hodoscope
scintillator

RPC hit

Hodoscope Efficiency through
RPC readout (FEE + TDC)

Efficiency = 99%

(Triggered by two small scintillators)

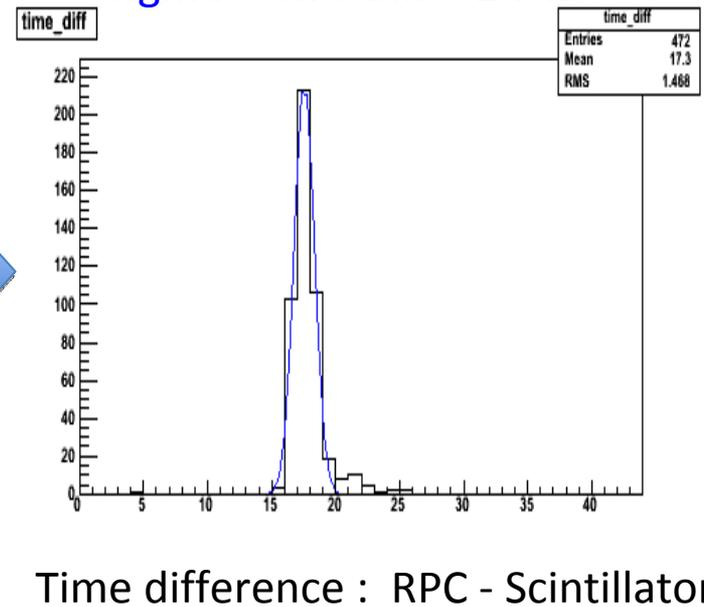
Timing : One RPC ch

Sigma = 0.78 bin = 1.7 ns

Time difference : RPC - Scintillator

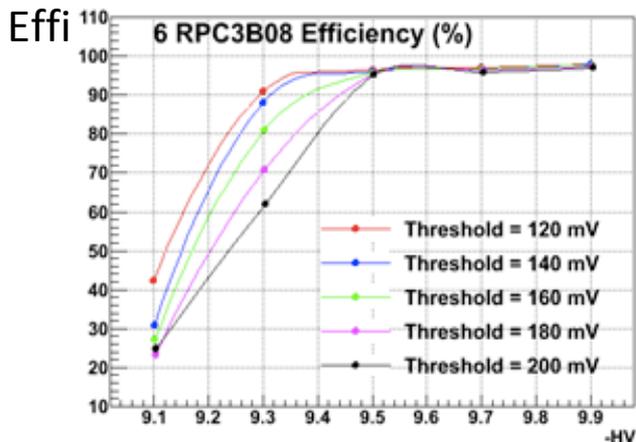
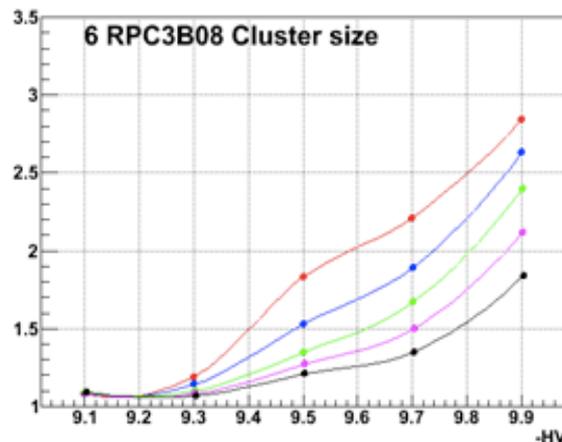
Cosmic ray test stand
In RPC Factory

$\epsilon \sim 95\%$ at the RPC factory

One B module

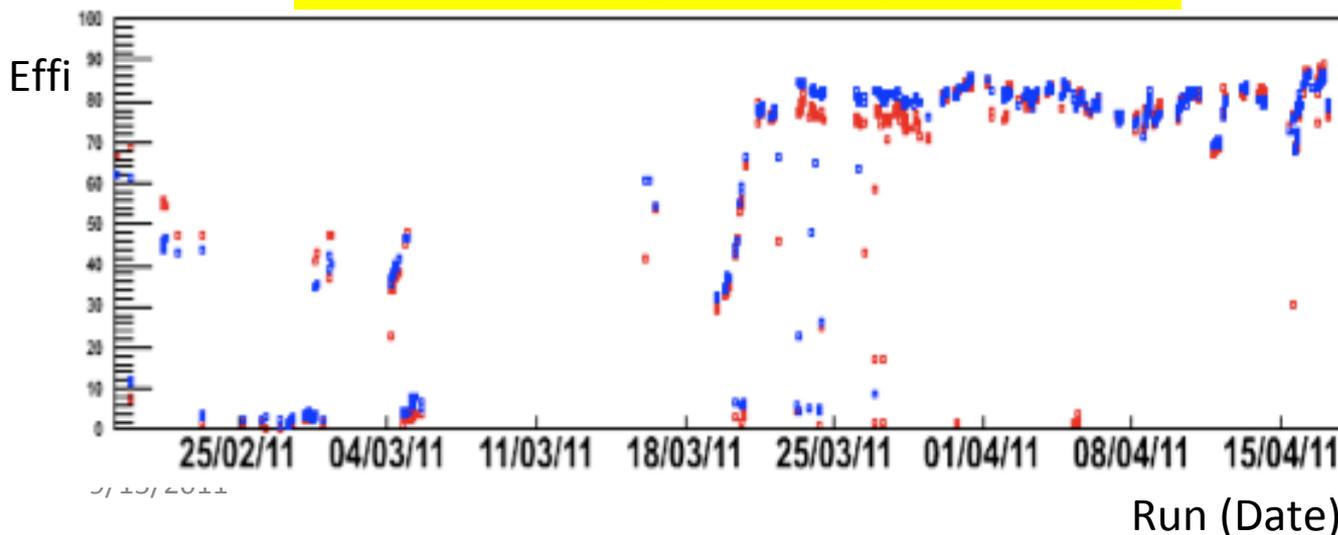
$\epsilon \sim 80\%$ During RUN 11 (500GeV PP)

From reconstructed
Muon track - Run11
500GeV PP

All modules averaged
Blue : South
Red : North

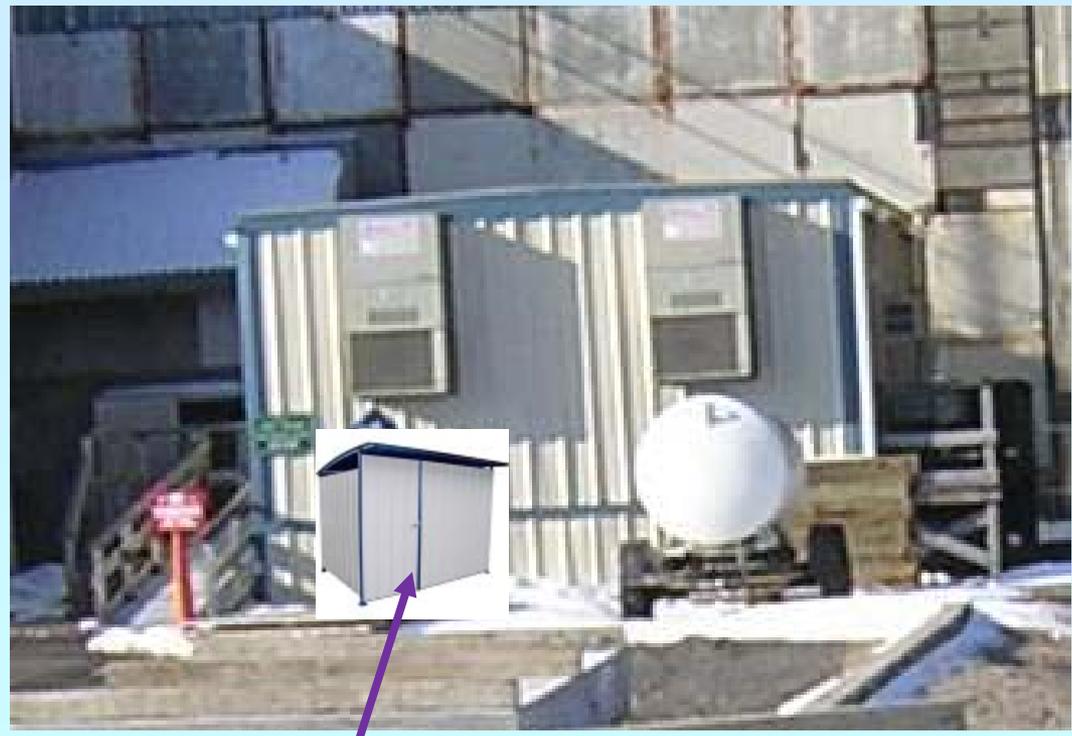
Need shed for R134A bottles close to GMH. No heating in shed (except heating blankets), lines to be insulated. Last year heating blankets kept gas warm but long length of pipe allowed gas to liquify on coldest days.

Possible location for shed 8' deep with 10' x 8' doors, and with bottom and top openings.. should satisfy ODH issues ~\$2K.

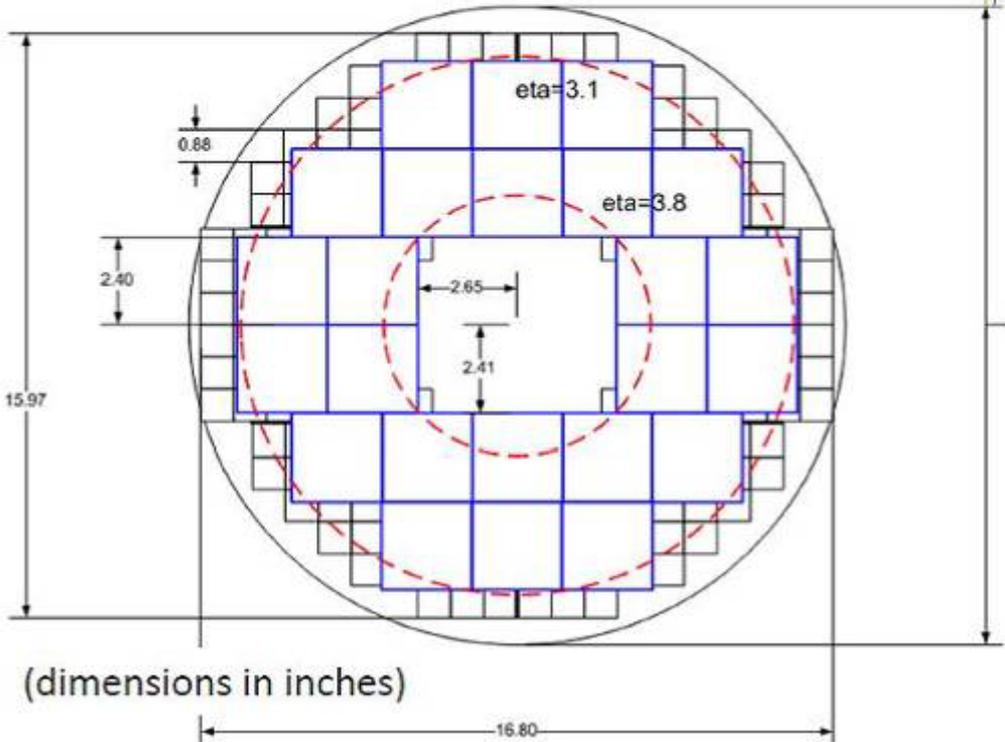
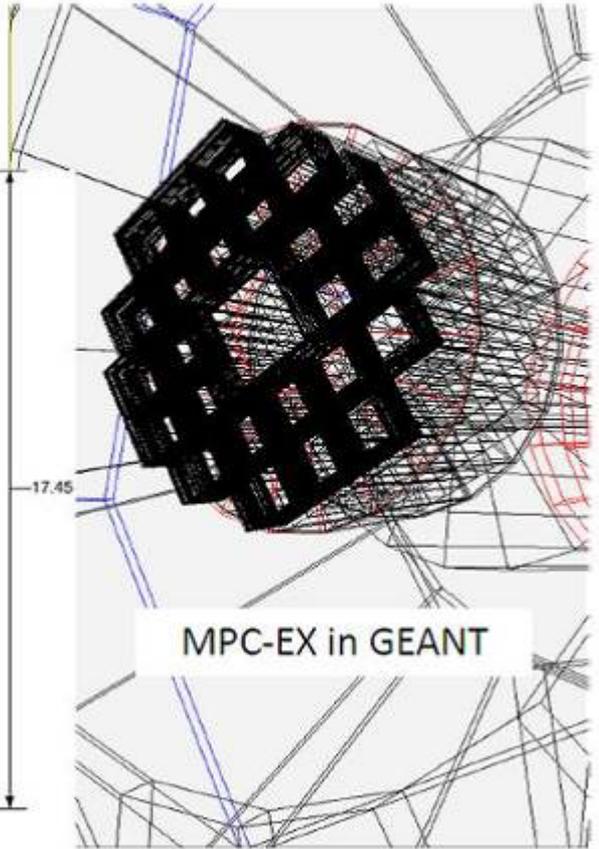
Design of the MPC-EX

Detector is designed around 6.2cm x 6.2cm modules (Si pad or strip detectors) separated by 2mm tungsten plates.

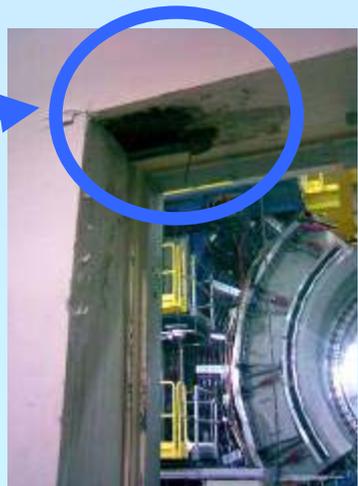
- Roof leaks in utility bathroom at northwest corner behind tech offices, over door between rack room and assembly hall, over door between control room and elect. ass'y room, southeast corner of IR and laser room.
