PHENIX WEEKLY PLANNING

TECHNICAL SUPPORT ZONE

10/25/12
Don Lynch

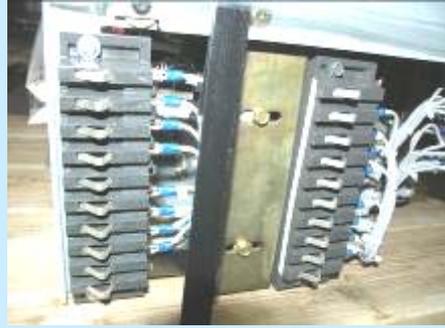
Substation breaker upgrade/test (CAD)

Upgrade & Test to be performed 10/21-22. P. Giannotti to prepare drawings/wiring schemes to CAD for review and config manag. Paul will be present and work with line crew to implement. CAD witness for test?

Upgrade partially implemented;
Waiting for new breaker to finish job, test not yet performed

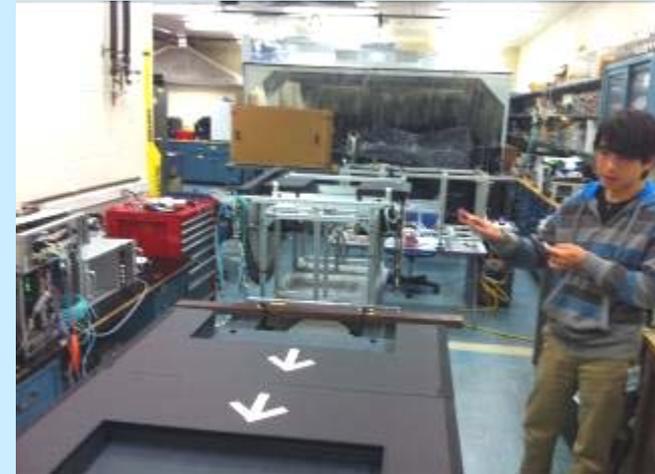
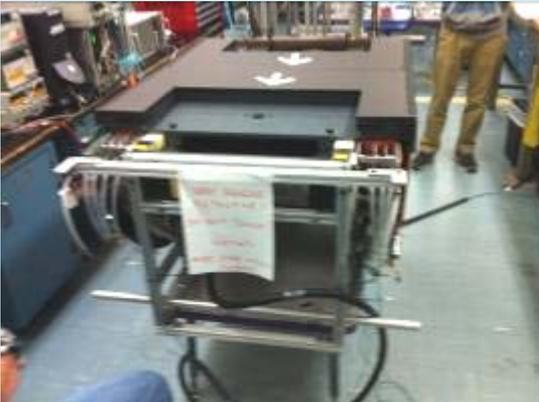
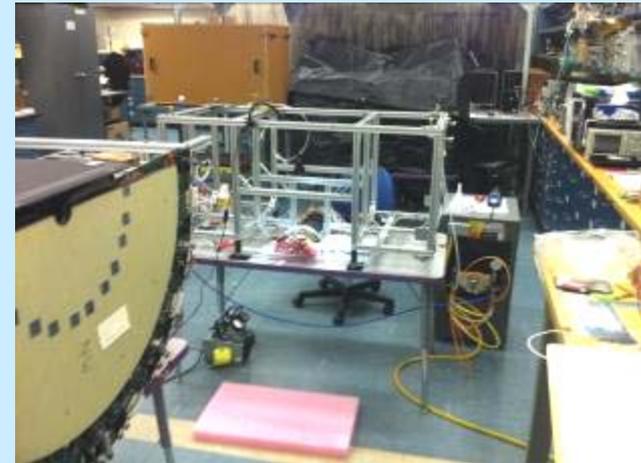
VTX/FVTX

- This week: Install Cooling manifolds and TC's, Test B1 west, Mate BO & B1, Mate West Pixel barrels with strips, Attach and Test bigwheels
- Next Week: Install FVTX cages, Test FVTX west, prep for survey
- Week of Nov 5: Survey get ready to move to 1008
- Week of Nov 12: Install at 1008.
- Week of Nov 19: Survey and services

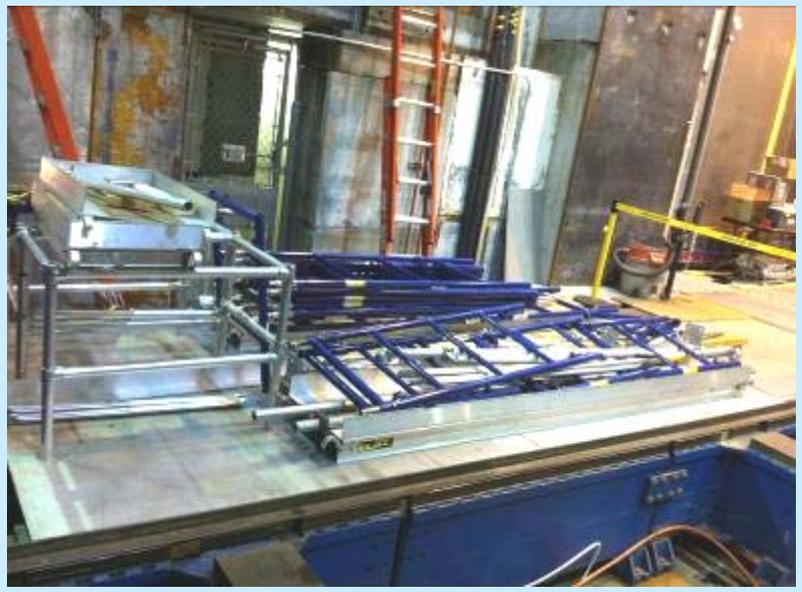
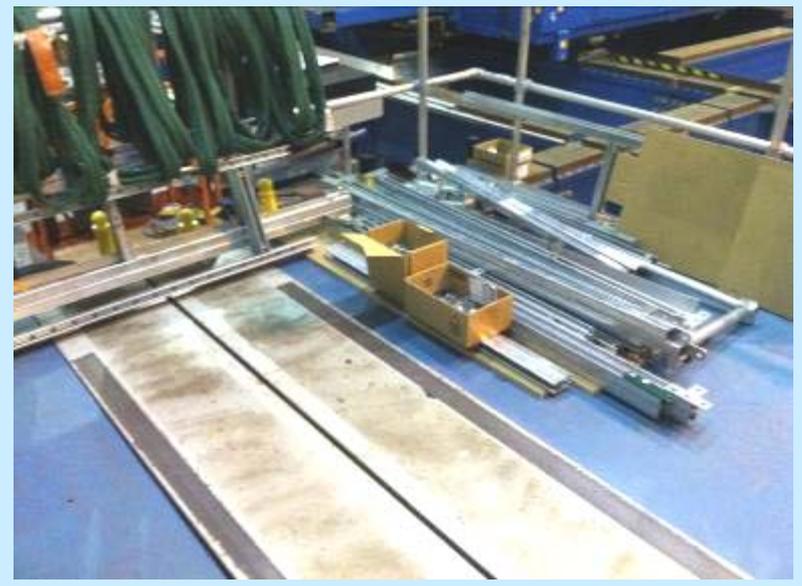
Clamp-on Terminator Installation on North & South Station-3

Lower clamp-on terminators already installed for both north and south sta-3 (bottom 4 octants)

With new work platforms that reaches all of sta-3; install remaining (upper) clamp-on terminators. **South Done, North In Progress**

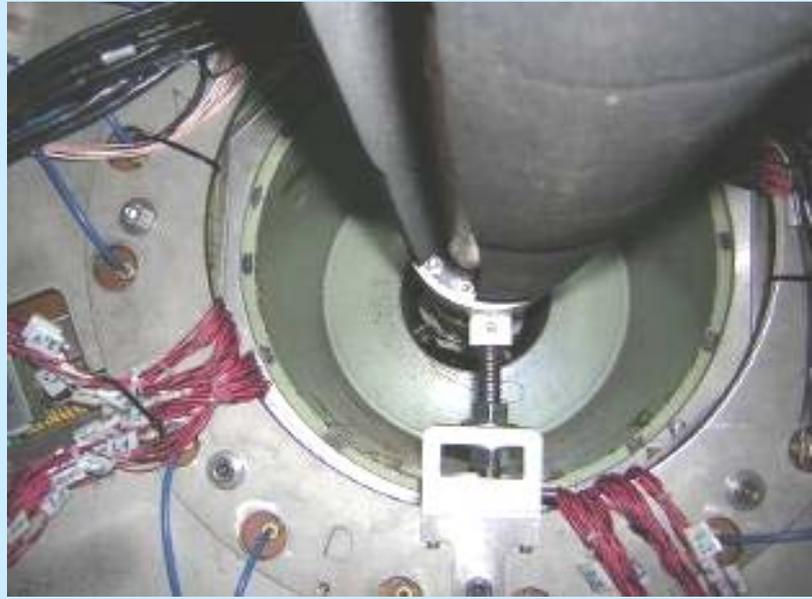
MPC Repairs -

North MPC: At PHYSICS for repairs
To be reinstalled by 10/26

South MPC: Repairs completed,
reinstalled, testing and new cables in
progress

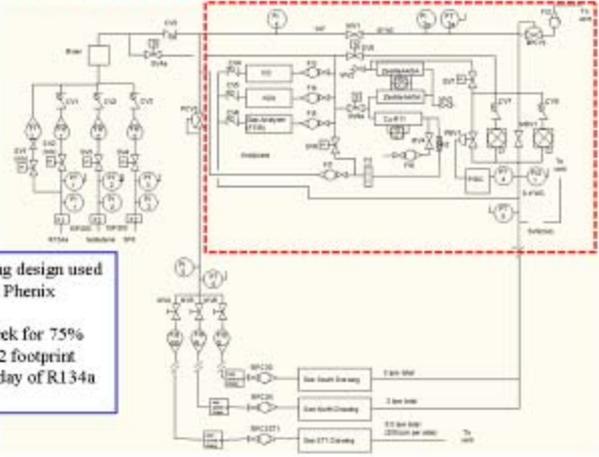
Run 12 Shutdown Work Overview Gas/Cooling Systems
Recirculating Upgrade to RPC Gas System

- Based on working design used for many years at Phenix
- Save money
 - \$3k per week for 75%
- Reduces lab CO2 footprint
 - 60 lbs per day of R134a

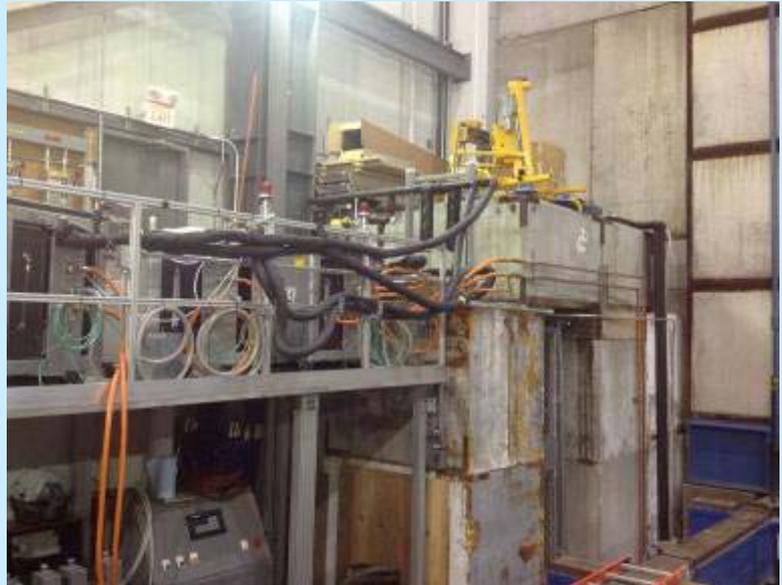
VTX/FVTX Cooling Upgrade

- Piping 90% done
- New filtration system in place, neds to be connected
- Big Wheel manifolds assembled ready for installation
- Chiller 1 repair parts here, need AC tech to Distribution upgrade

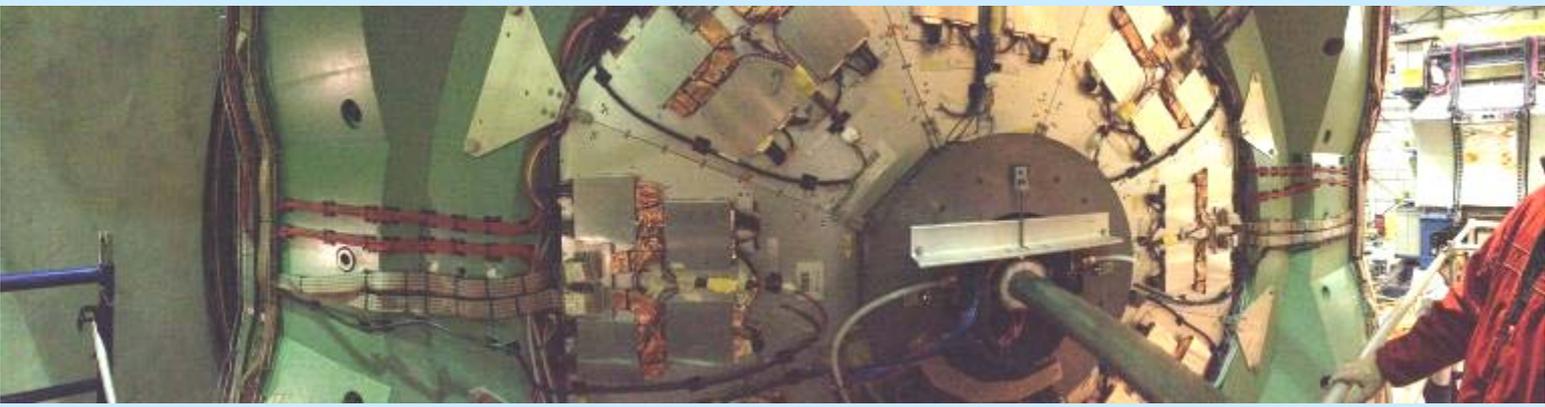
RPC Station 1 North and South Cooling Upgrade & Monitoring

South to be completed after North, Start on North next week

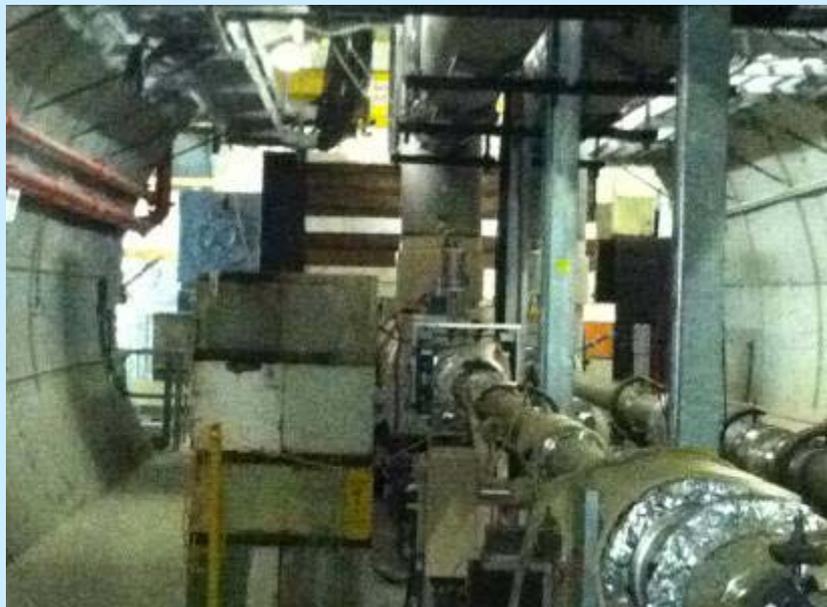
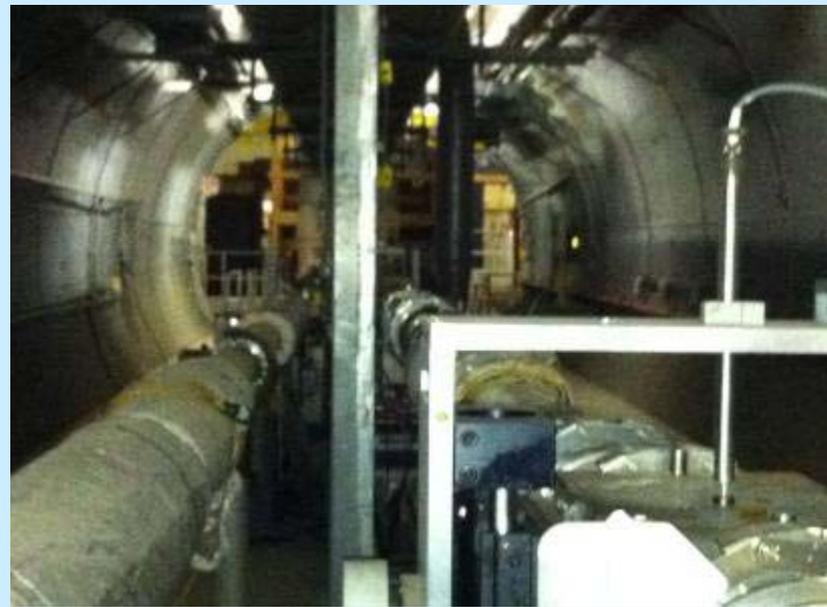
RPC Background Attenuation Project

Looking towards RPC3 North
← East West →

Looking towards RPC3 South
← West East →

Large shielding modifications at Q2 upstream north and south to be planned and installed by CA-D (Dave Phillips) by 12/14/2012

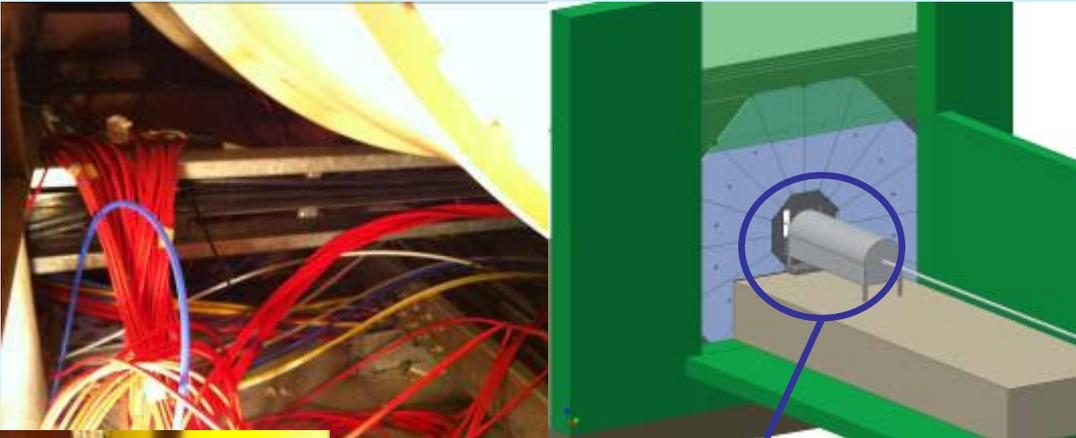
Under DX at RPC3 North
← East West →

Under DX at RPC3 South
← West East →

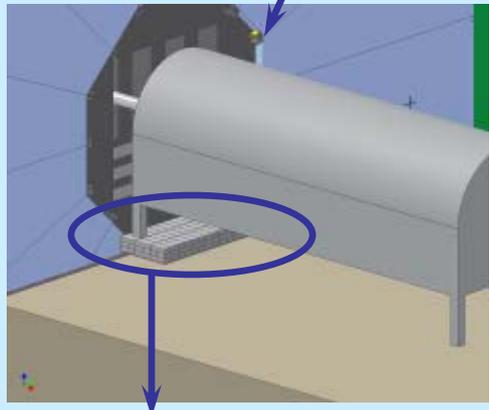
144 Steel bricks, 2x4x8,
stacked in 3 high, 16 wide, 3
rows, respectively by 11/21

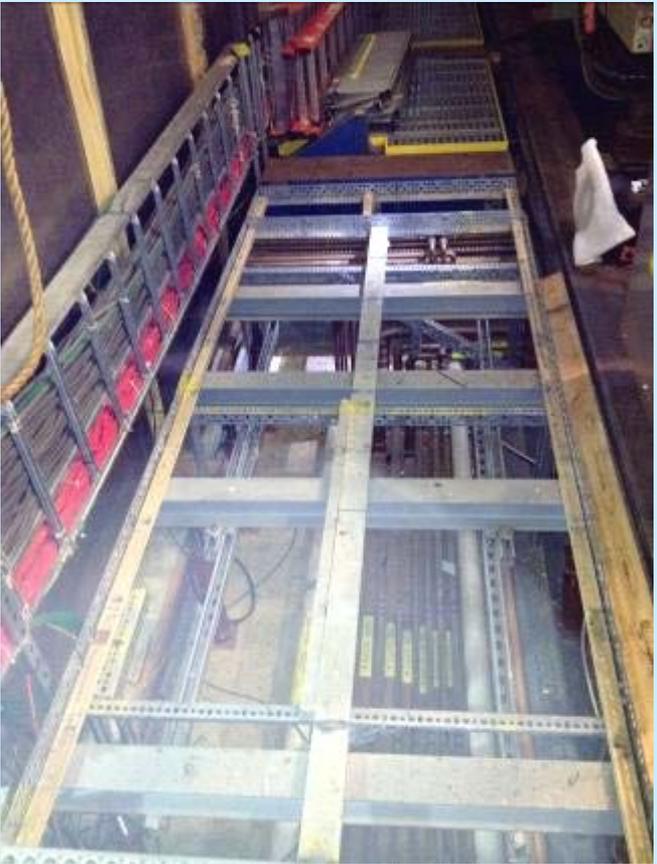
MuID Collar IR Holding Area Support

- Structural support improvements designed
- Parts to be ordered
- Installation this fall prior to EC roll in

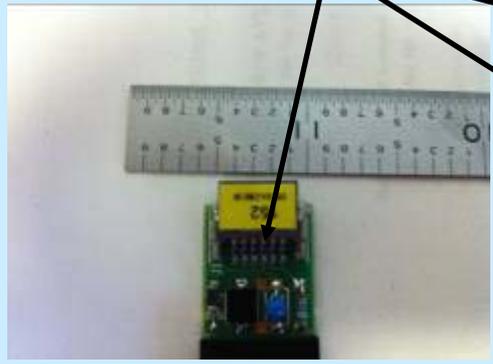
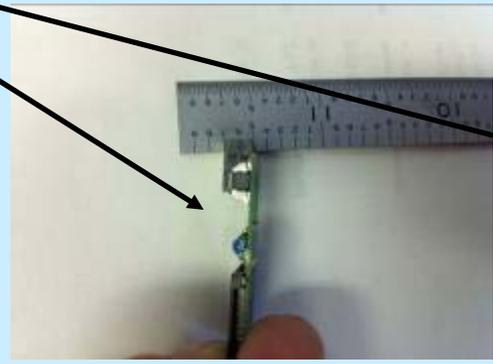
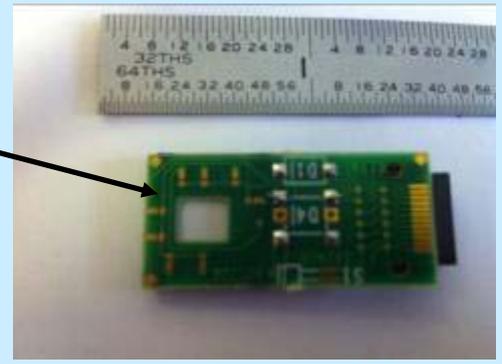
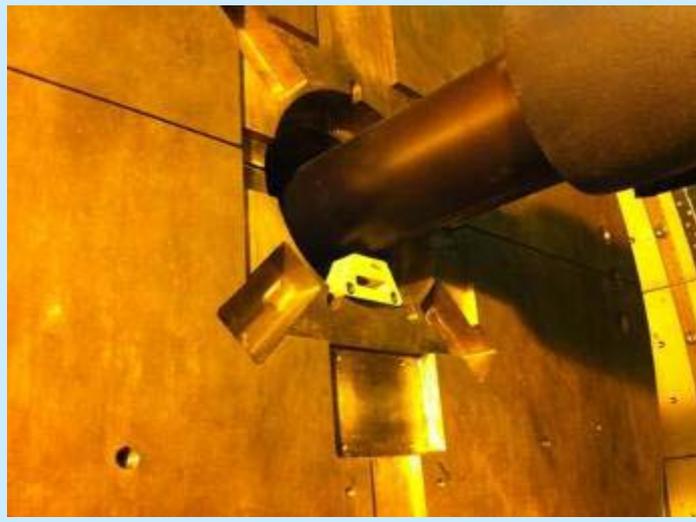
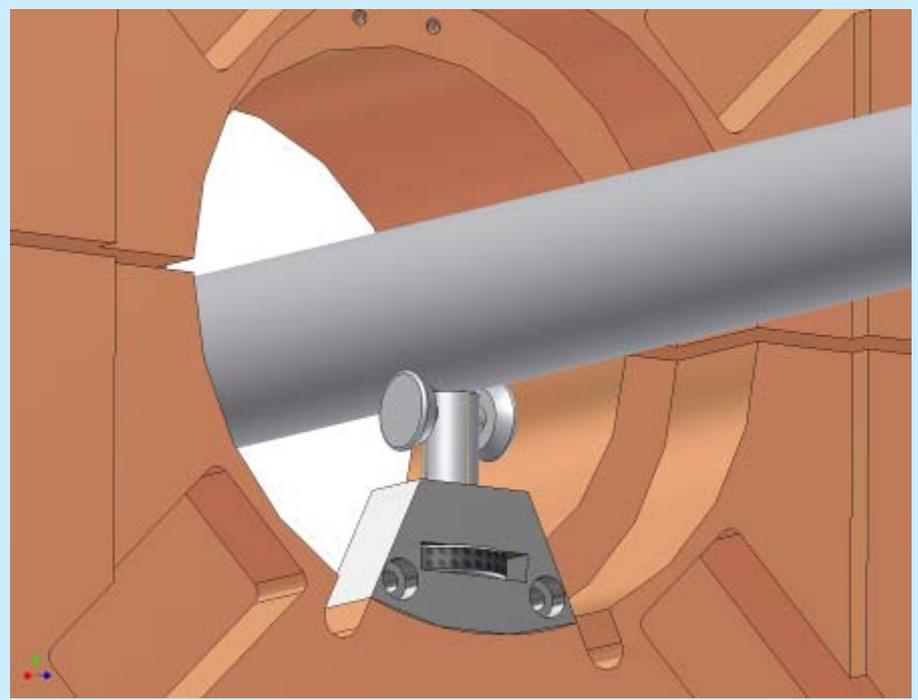
VTX/FVTX Radiation Monitoring Test

Rad monitor sensors

Mount 6 Rad monitor sensors in the south nosecone cavity, 2 sets of 3 at different z, at 3.5, 8.5 and 16.2 mm radially from nominal beam axis

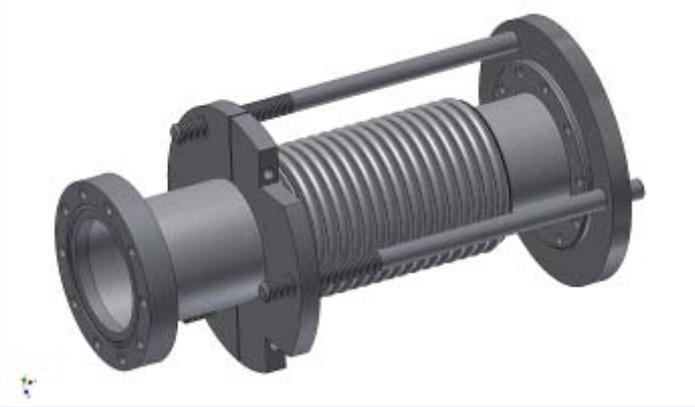
Existing vacuum bellows anti-squirm
In MPC S Cavity

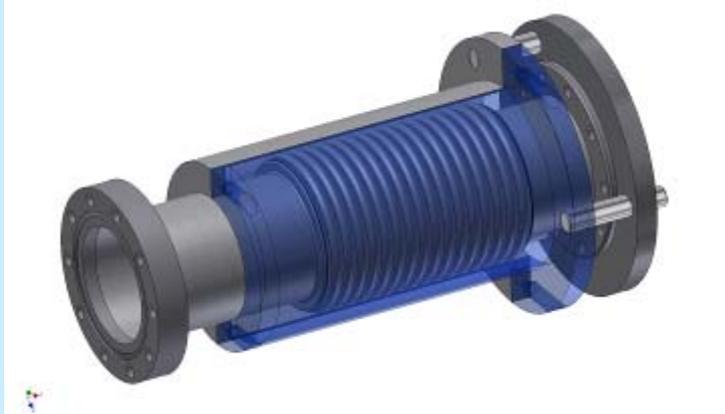
Proposed vacuum bellows anti-squirm
In MPC S Cavity to accommodate MPC-Ex

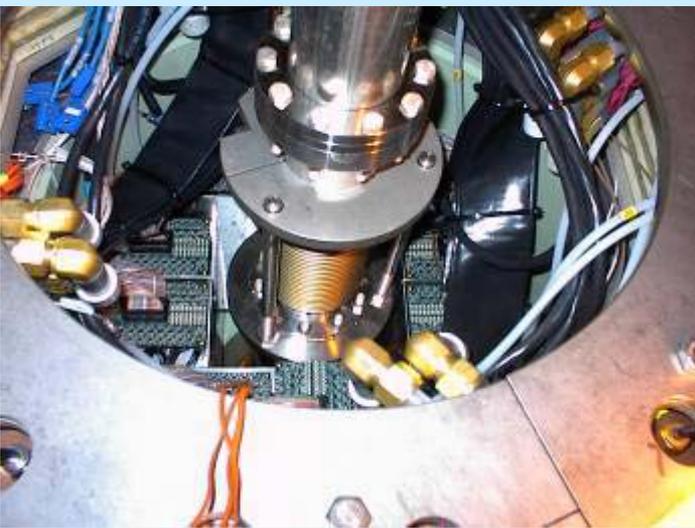
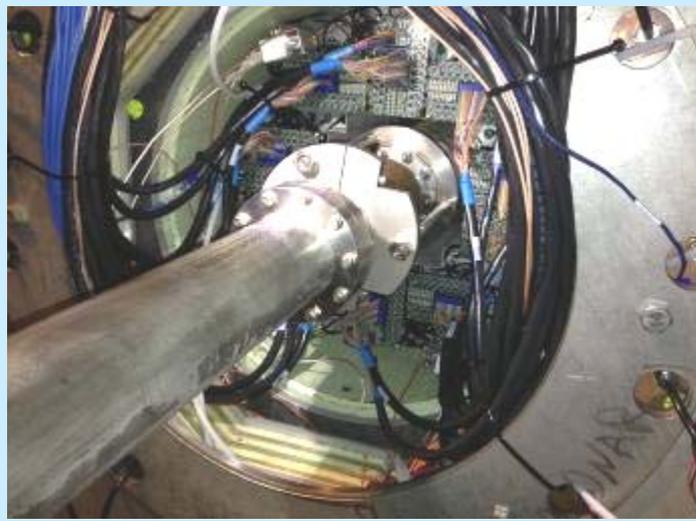
MPCS Flat cables replaced with round cables.
