Muon Tracker Electronics Performances and Issues

Vi-Nham Tram & Olivier Drapier, LLR, Ecole Polytechnique, France

Muon Tracker Electronics

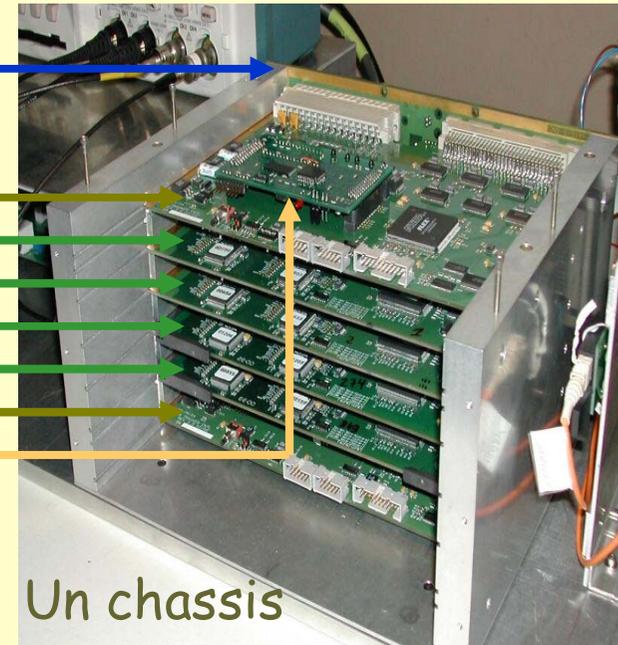
During repairing/installation

Replaced	Backplane	FEM	CROC	ArcNet
South	5	9	27	2
North	1	9	15	1

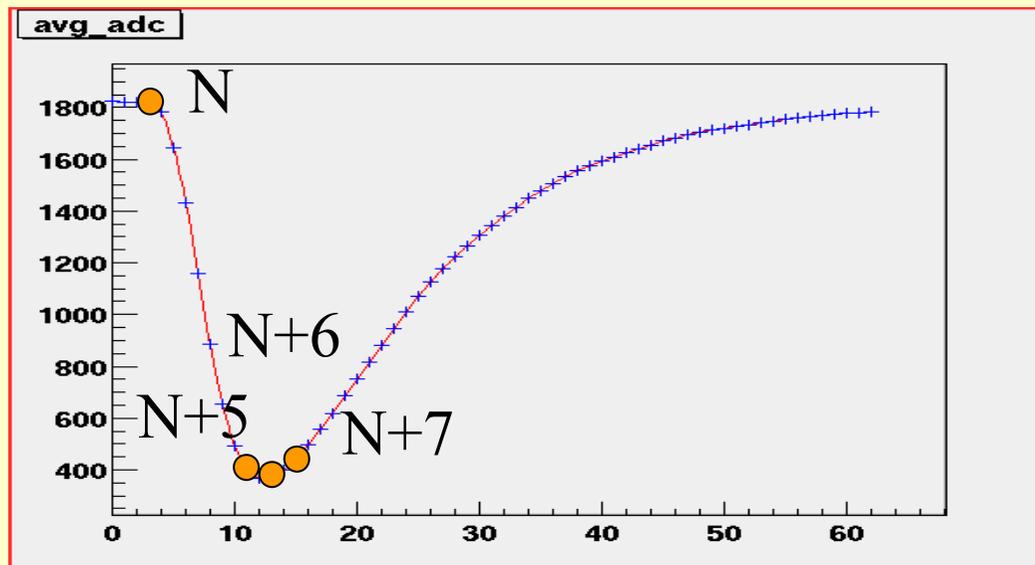
- Strip charges stored in the AMU (64 Cells)

- 4 time samples/event

Cell addresses are written in the packet header

Some packets (~ 10 FEMs) have wrong cell addresses

- * either global shift : $k, k+5, k+6, k+7$ ($k \neq N$)
 - * or bad cell sequence : $N, N+5, N+7, N+8$
 - * total: $\sim 60\% - 100\%$ events in the worst FEMs
- \Rightarrow Artifact or real problem ?
