PHENIX WEEKLY PLANNING

August 21, 2014
Don Lynch

PHENIX
REPORT
NORTH

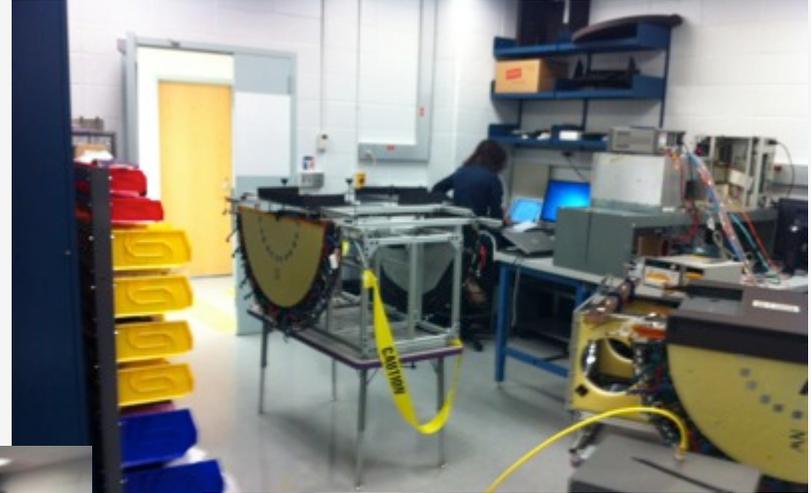
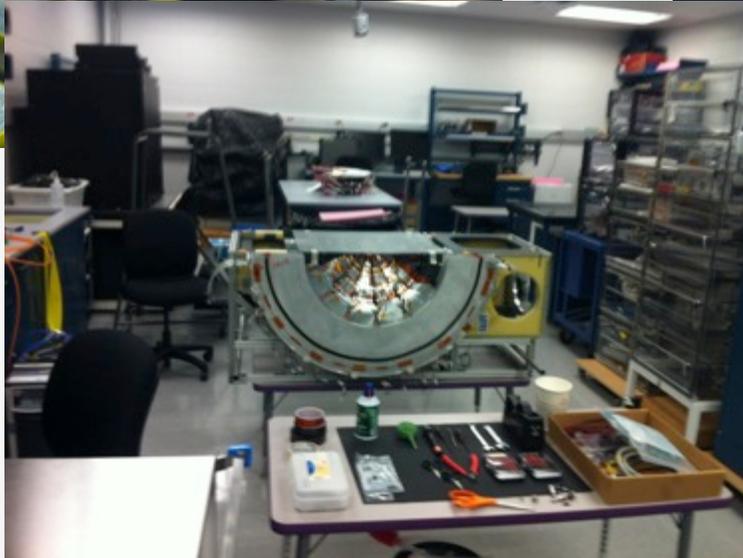
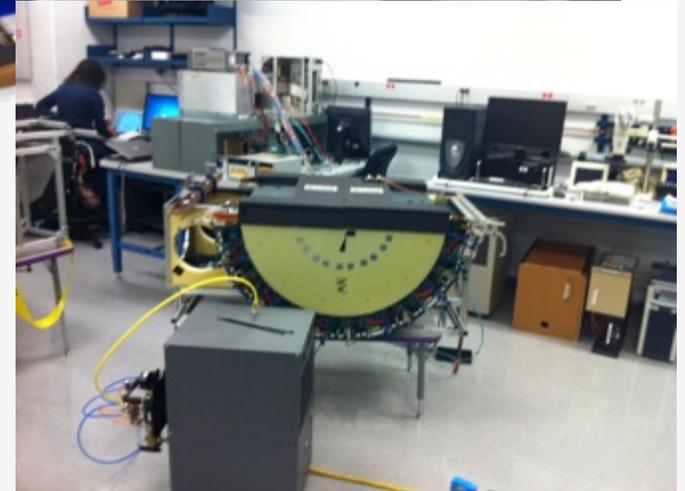
VTX/FVTX east & west repairs/
upgrades under way

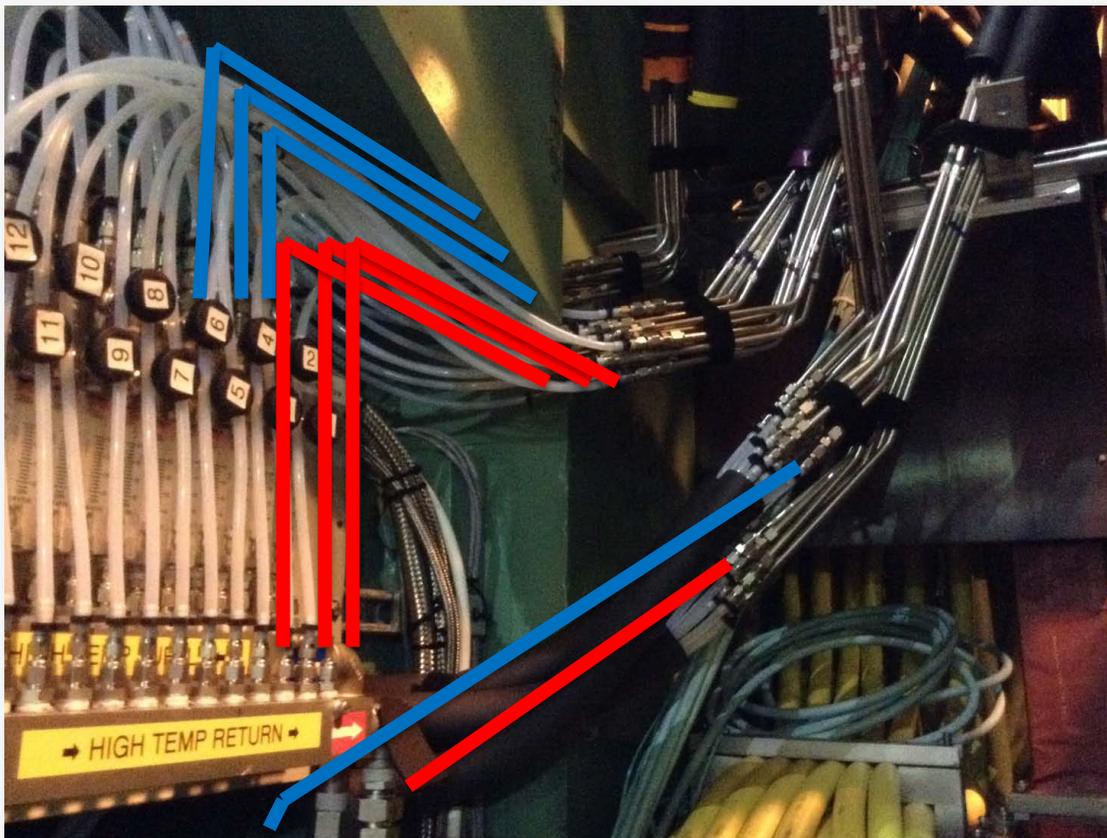
Top manifold has 13 Supply and 13 return lines.
Both North and south need to be replaced.

Bottom manifold has 9 Supply and 9 Return lines
Both North and South need to be replaced

Current labeling on tubes needs to be maintained and copied to new lines

Bends need to be done carefully so not to restrict flow. Swage elbows can also be used for sharp bends

Replace All Teflon lines with 1/4" ID 316 thin walled Stainless
McMaster
Coil: 89995K82
Or Rigid with Min ID 0.21" (89995K288)

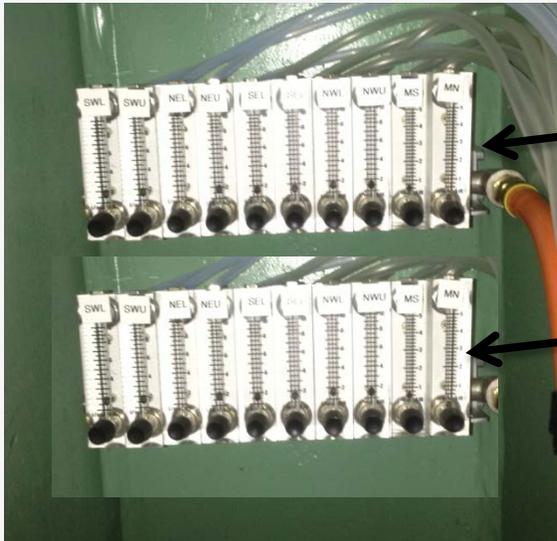
VTX/FVTX N2 Supply Manifold.
 Located on south side of central
 magnet

Original N2 Distribution Panel

New N2 Distribution Panel

- 10 flowmeters
- 0-10lpm
- Output ¼" I.D barb
- Leave about 10" space between manifolds.

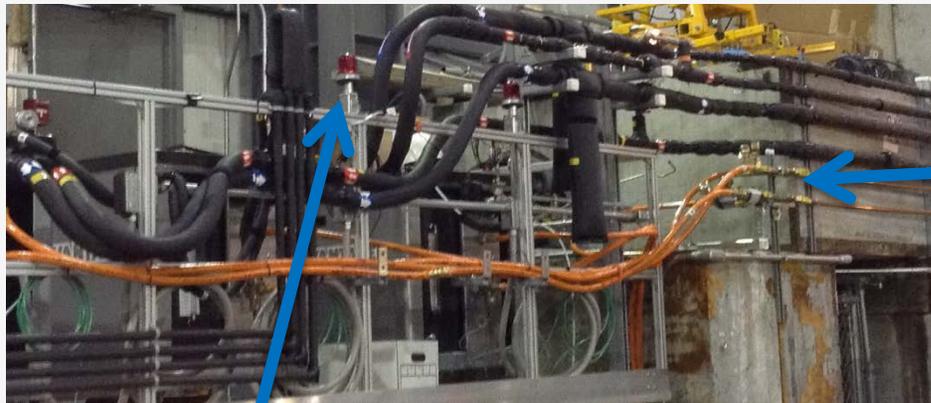
Manifold Location

Permanently connect water lines to all 3 chiller through a new 3 channel manifold. Currently the manifold only has 2 channels. It needs to have a 3rd channel added for the spare chiller. We should also replace the flowmeter s with ones that have a smaller scale.

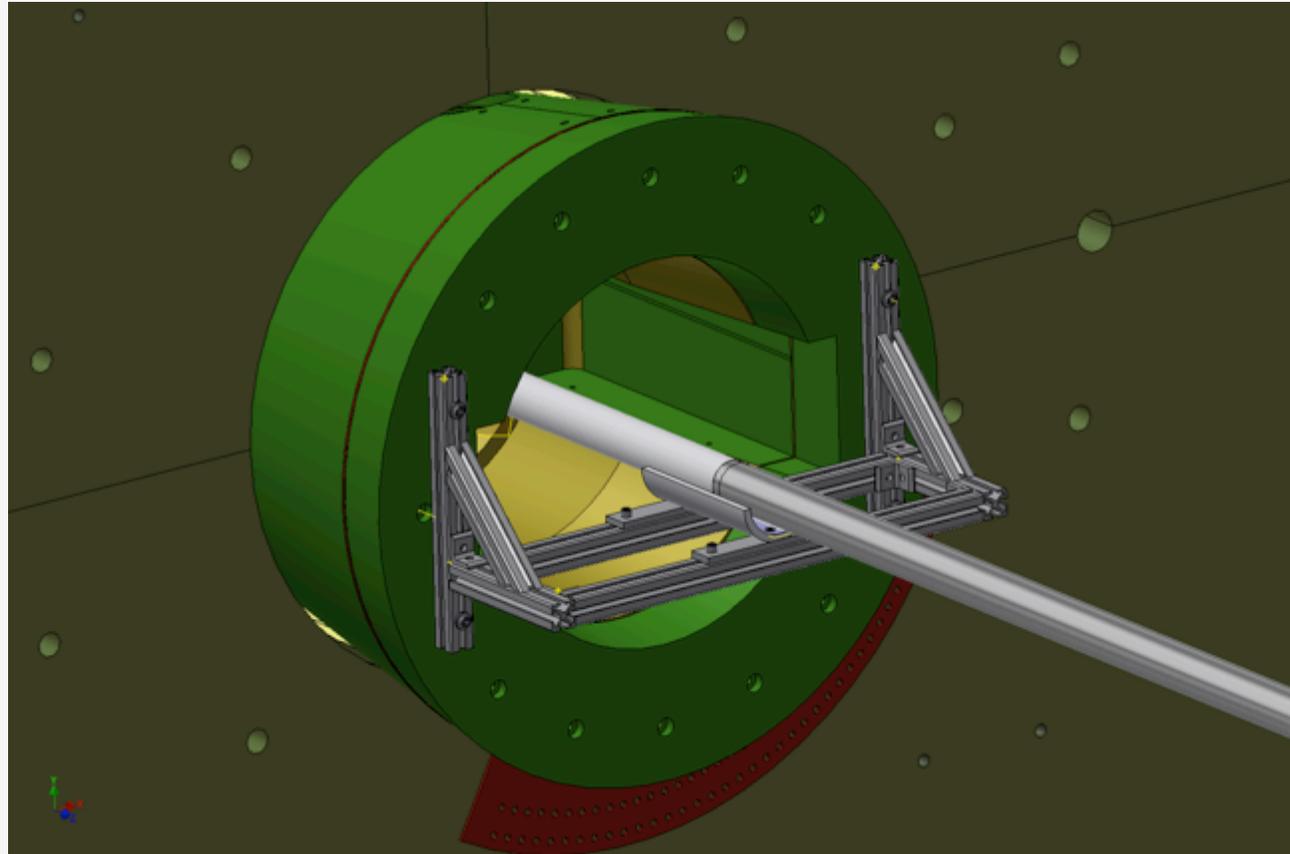
MPC-Ex North & South

MPC-Ex North Beam pipe temporary support

MPC-Ex Exploded view

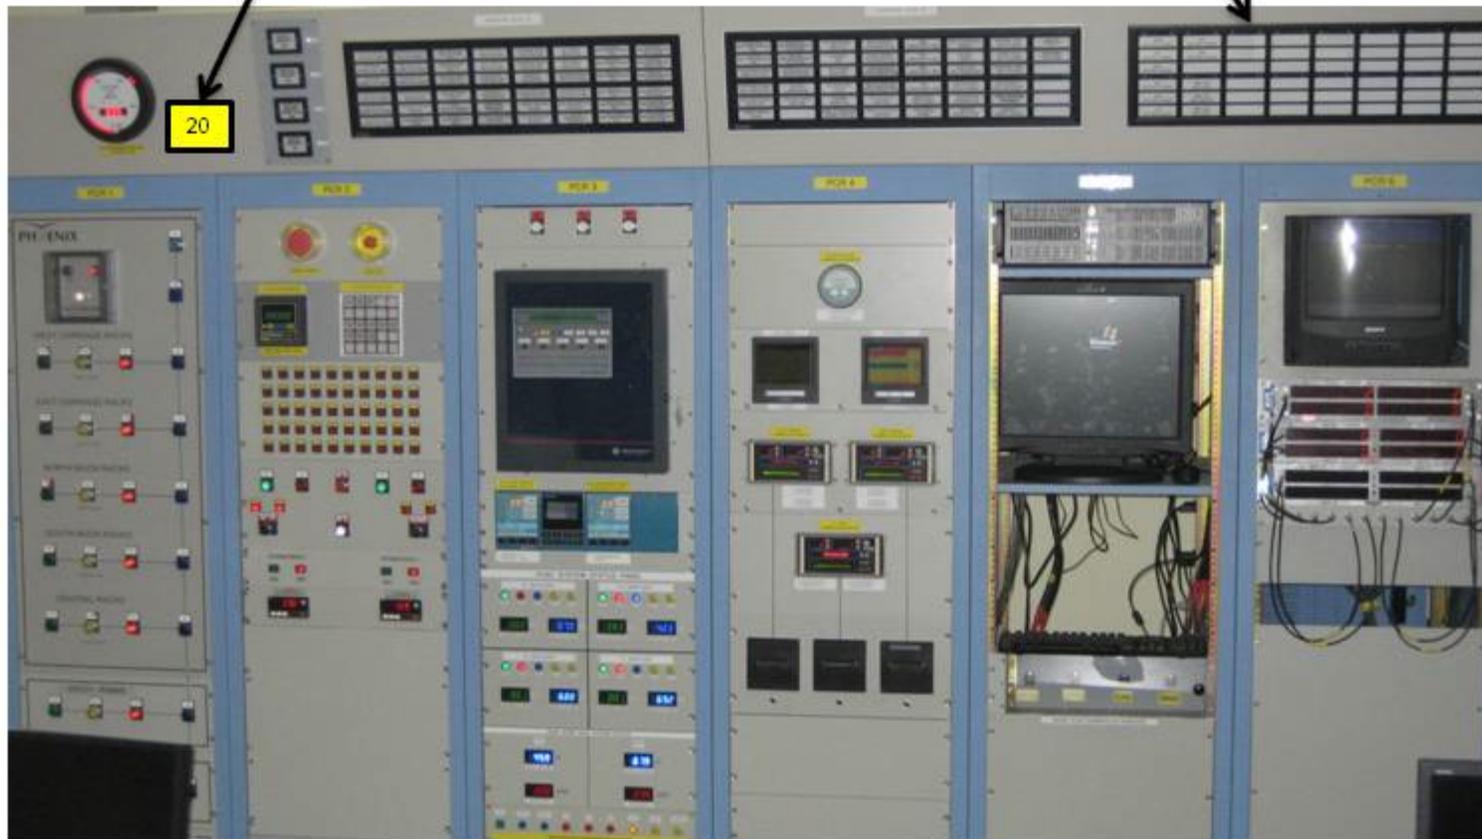
Electronics Cooling Water High Temperature Alarm

Display showing temperature of cooling water

Add Alarm to Panel

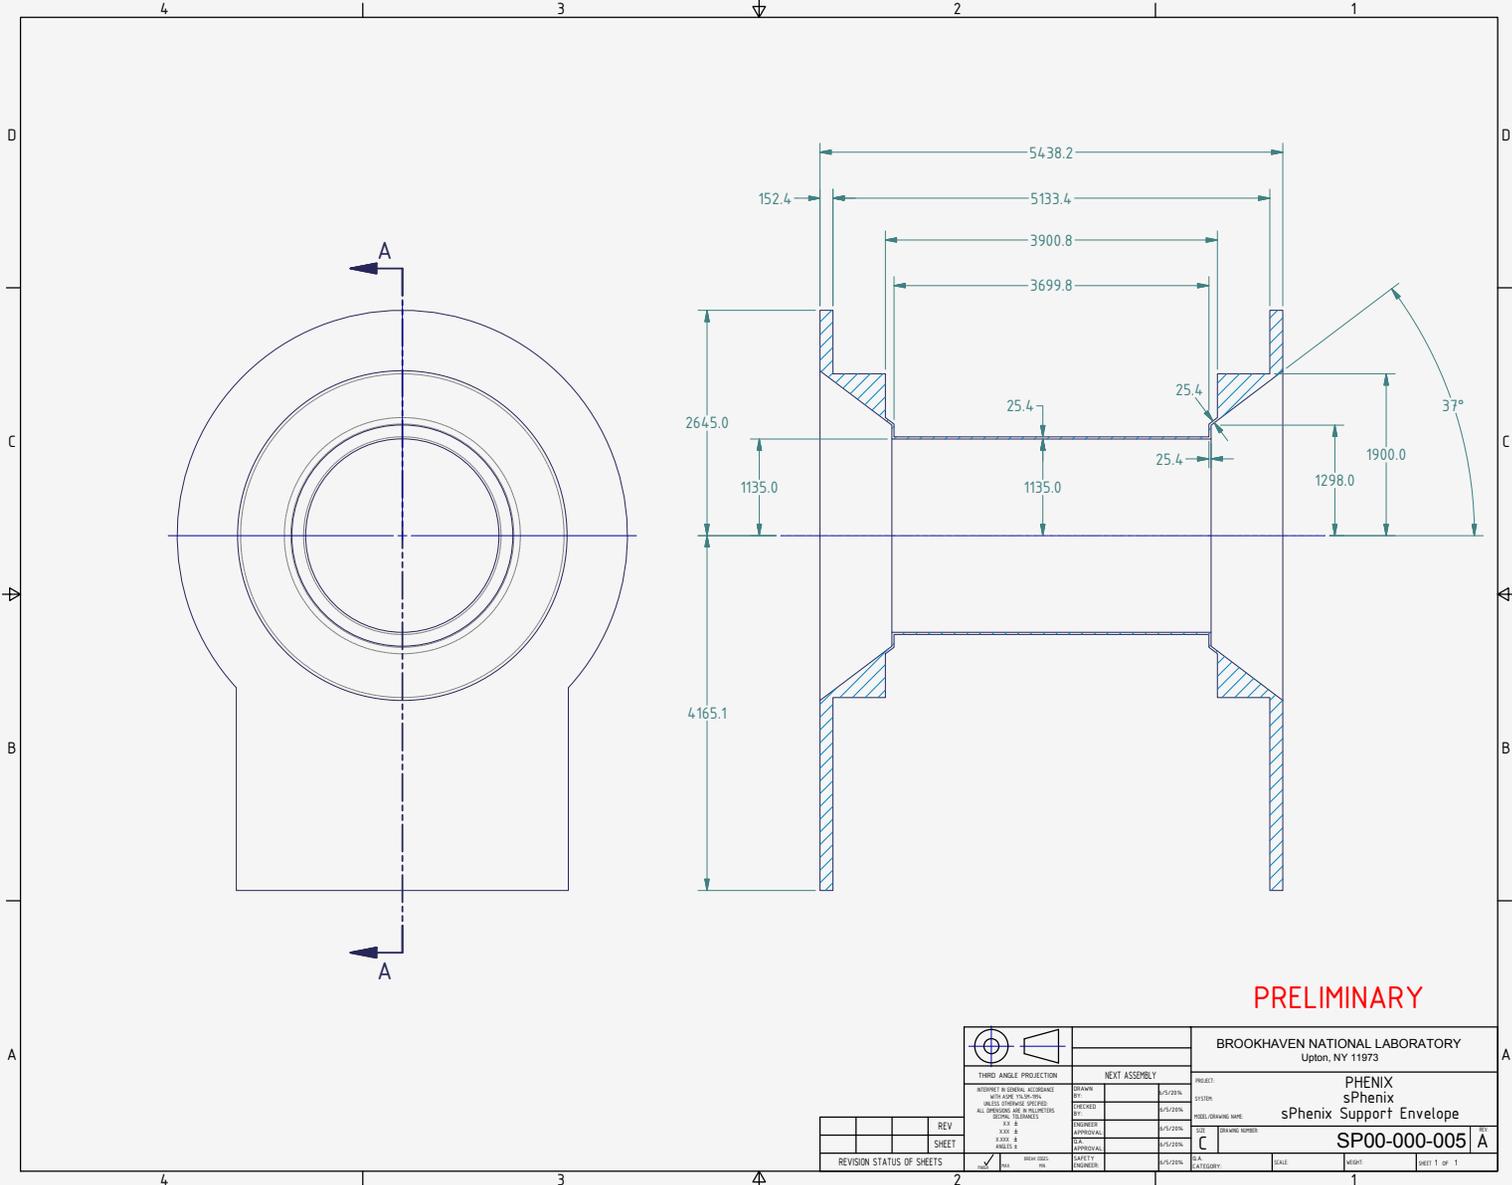
PHENIX SUPPORT ENVELOPE

BROOKHAVEN NATIONAL LABORATORY Upton, NY 11973	
THIRD ANGLE PROJECTION UNLESS OTHERWISE SPECIFIED DIMENSIONS ARE IN MILLIMETERS UNLESS OTHERWISE SPECIFIED		NEXT ASSEMBLY DRAWN BY: [] CHECKED BY: [] ENGINEER BY: [] APPROVAL BY: [] DATE: []		PROJ. DET.: PHENIX SYSTEM: sPhenix MODEL OR PART NAME: sPhenix Support Envelope DRAWING NUMBER: SP00-000-005 A	
REVISION STATUS OF SHEETS		REVISION NUMBER: [] REVISION DESCRIPTION: []		SCALE: [] SHEET 1 OF 1
