Current Status of the Re-capacitation

Quar. Meeting: Dec. 11, 2010

Yoshi(-mitsu) Imazu

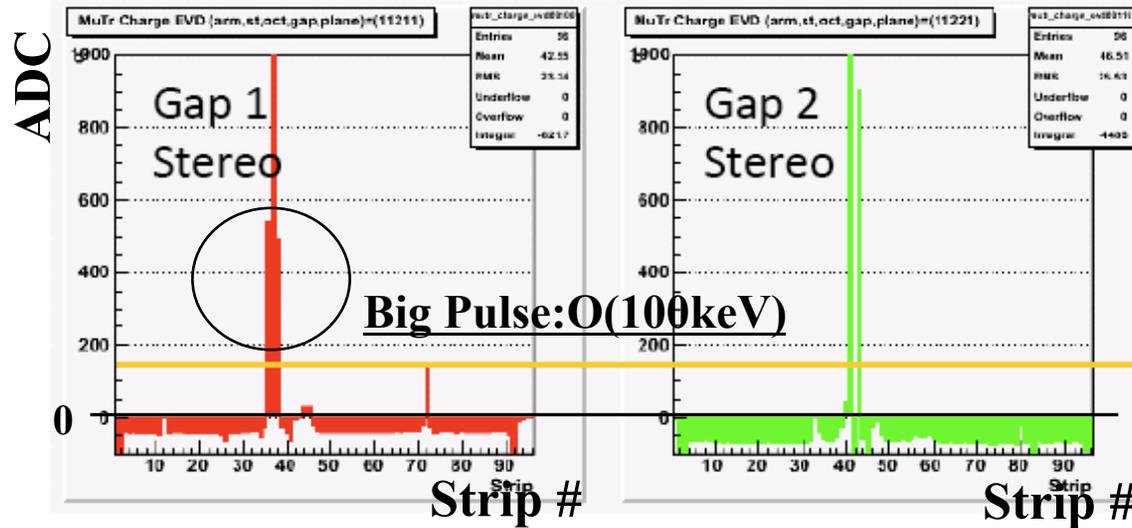
Hit Distribution w/o Zero Supp.

anode wires

- Existence of **unexpected big deposits (Big Pulse) ($\sim O(100\text{keV})$)** in MuTr exceeding those of MIP ($\sim 1.5\text{keV}$) (Contamination: supposed to be 60%)
- **Negative undershoots over whole strips accompanied by the Big Pulse**

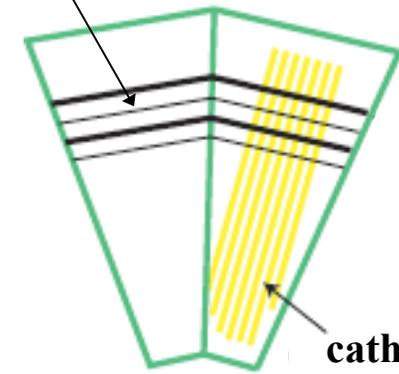
cathode strips

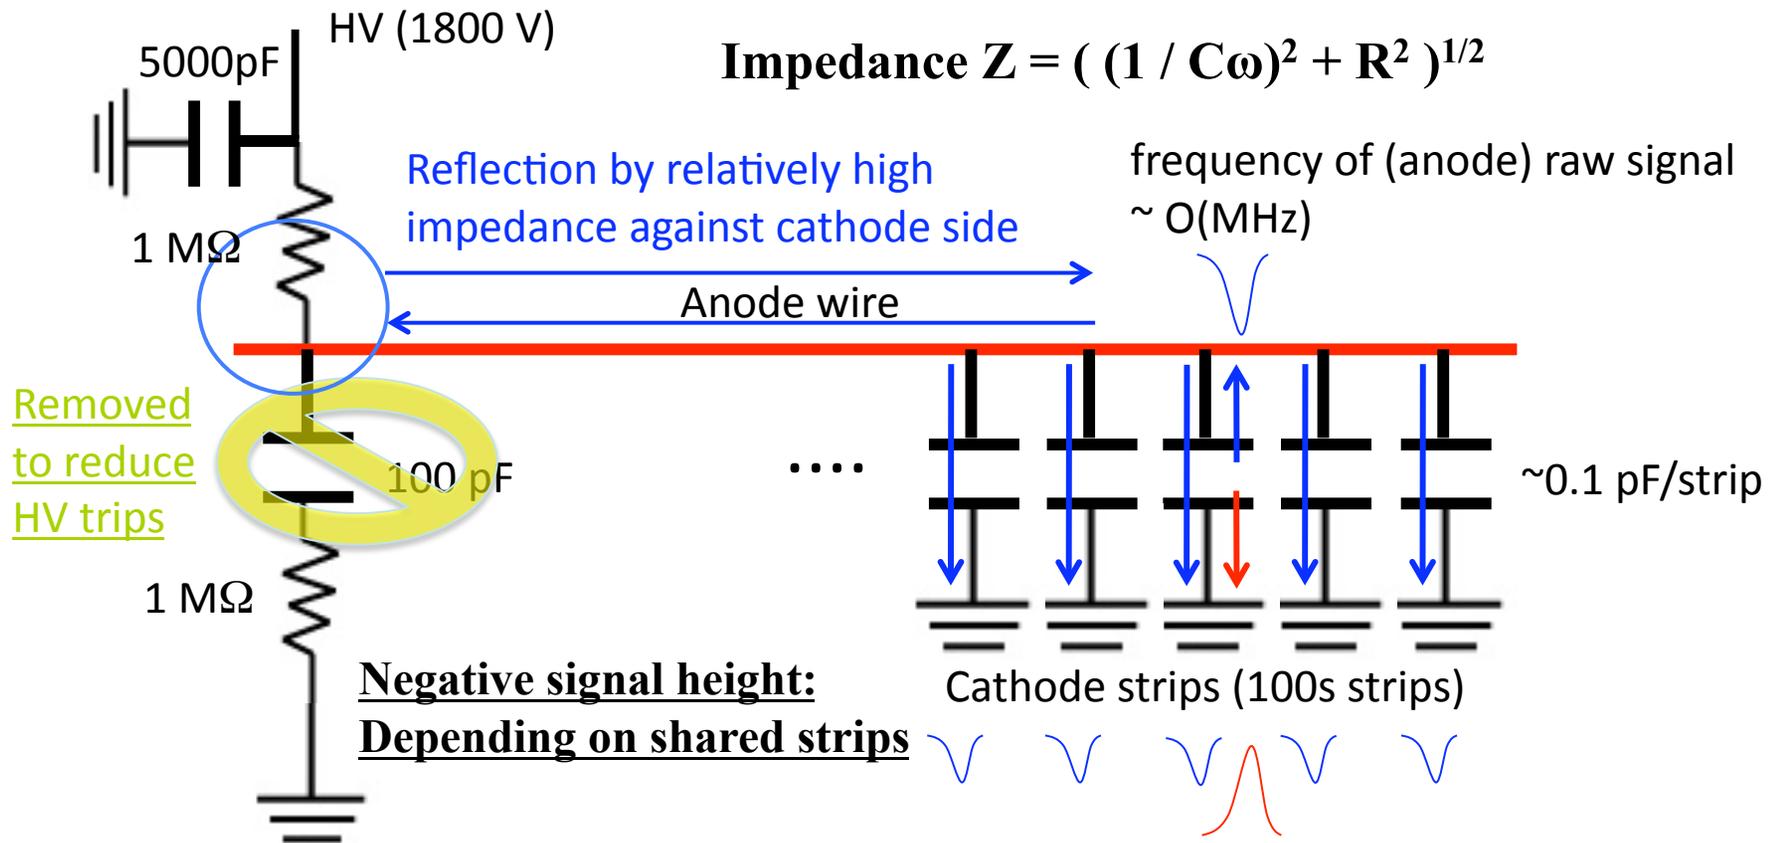
Expected Signal Structure:

Large bipolar return:
frequency dependence of the effect
(high frequency selective)

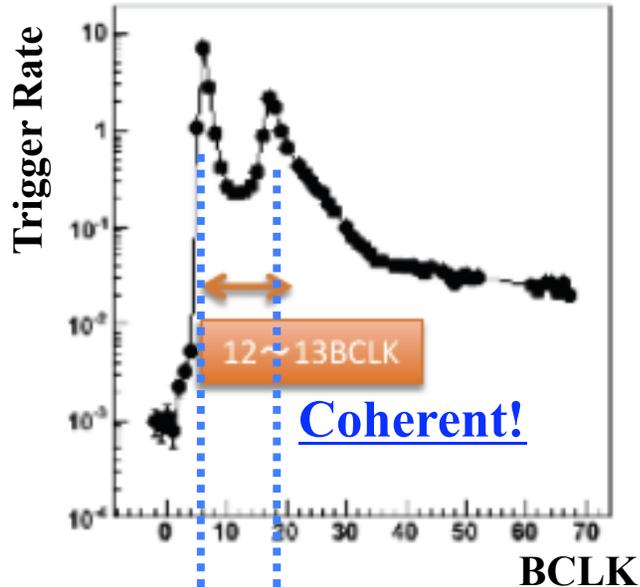
MuTRG Trigg. rate survey with 1 bunch beam supports its phenomenon

- the negative signals could fire MuTRG by its bipolar returns

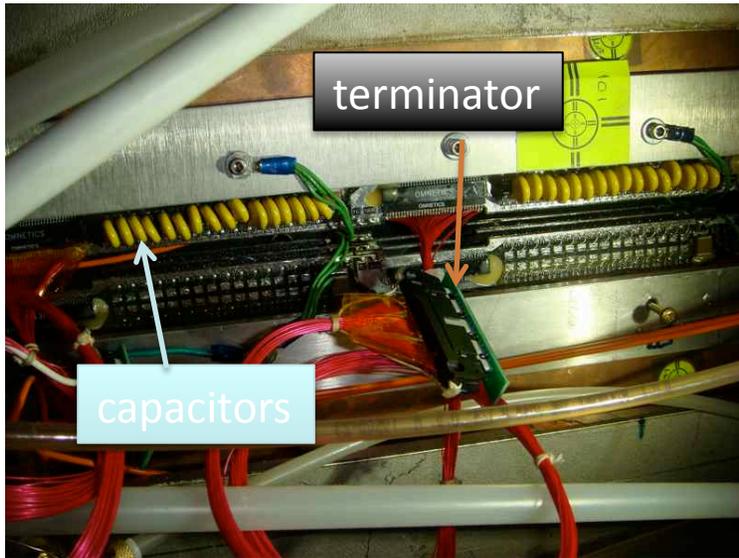
St. 1 Full Octant, Gap1 only

All capacitors are removed. New capacitors (soldered) and terminators installed.

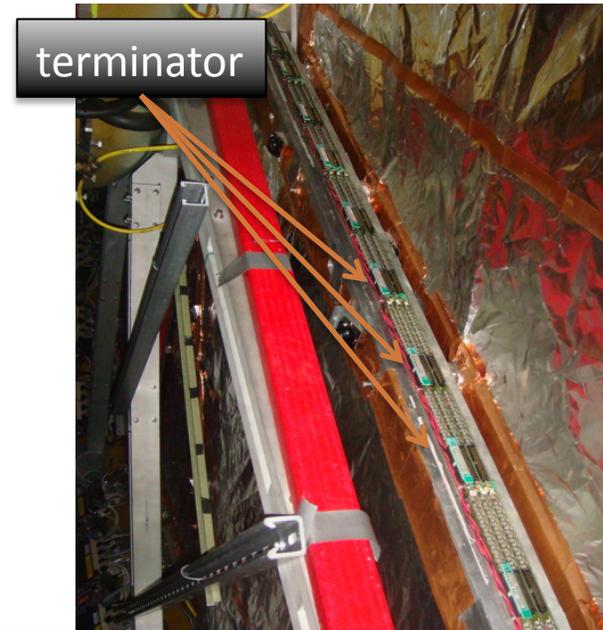
St. 2 Partial Octant, Full Gaps

Capacitors are remaining. new terminal cards mounted to the anode readout connector.

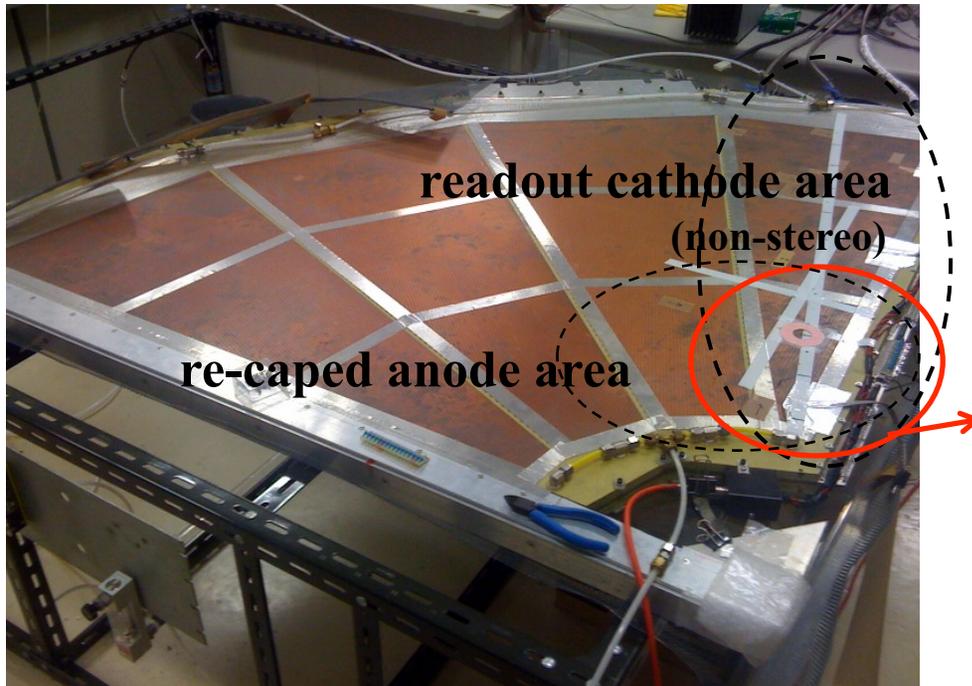
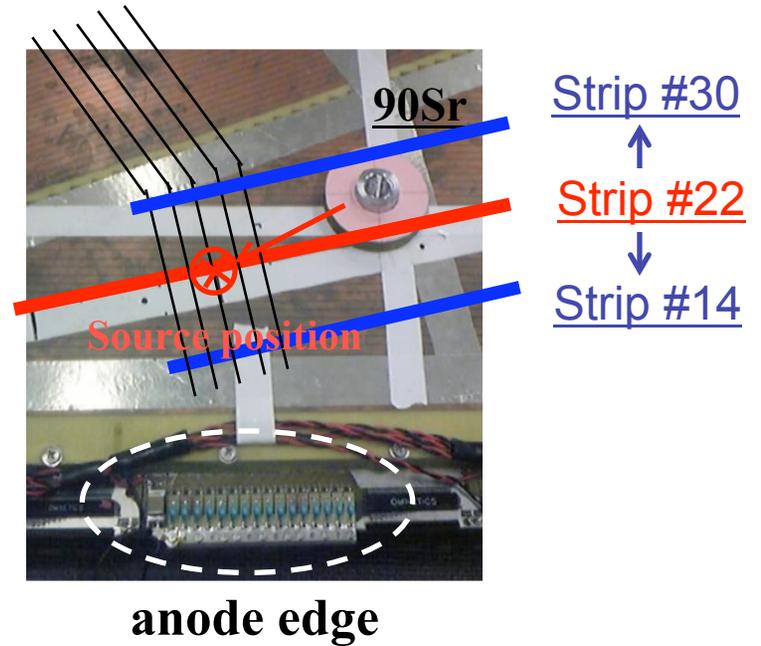
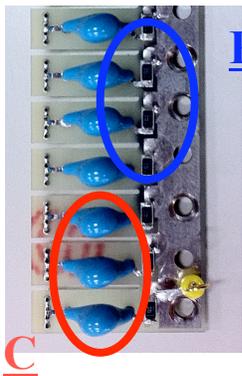
● Cross Talk Effect with a Test Bench @RIKEN

- Observation and evaluation of the cross talk effect w/ or w/o the circuit
- Optimization of the circuit parameter (C, R)

Sr-90

HV: +1.8kV
Cur: 10uA

Chamber

PMT

3×4 Scinti.
4cm Below

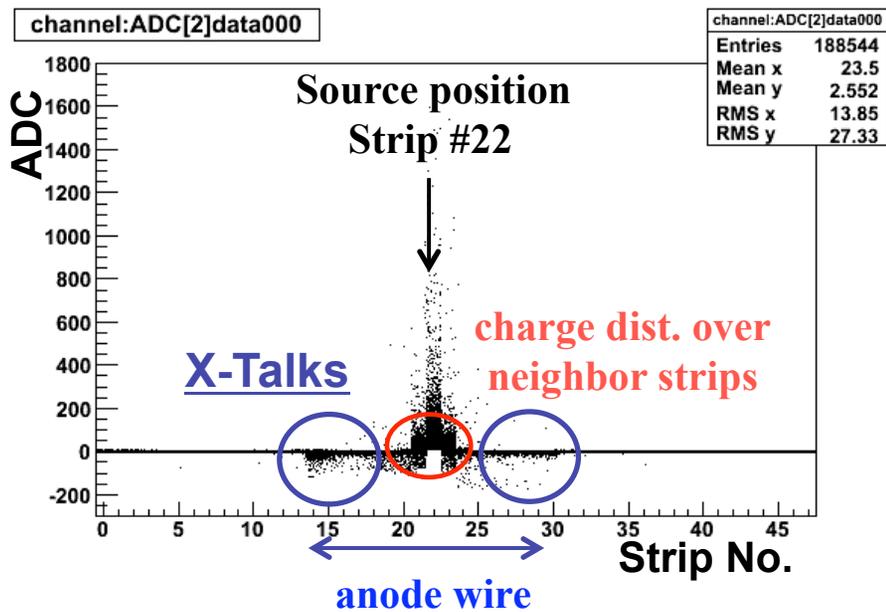
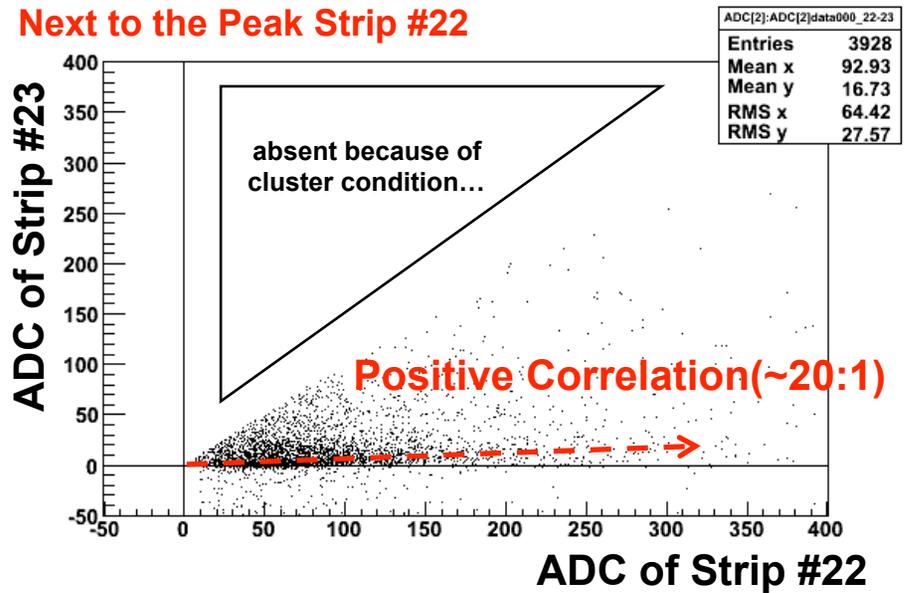
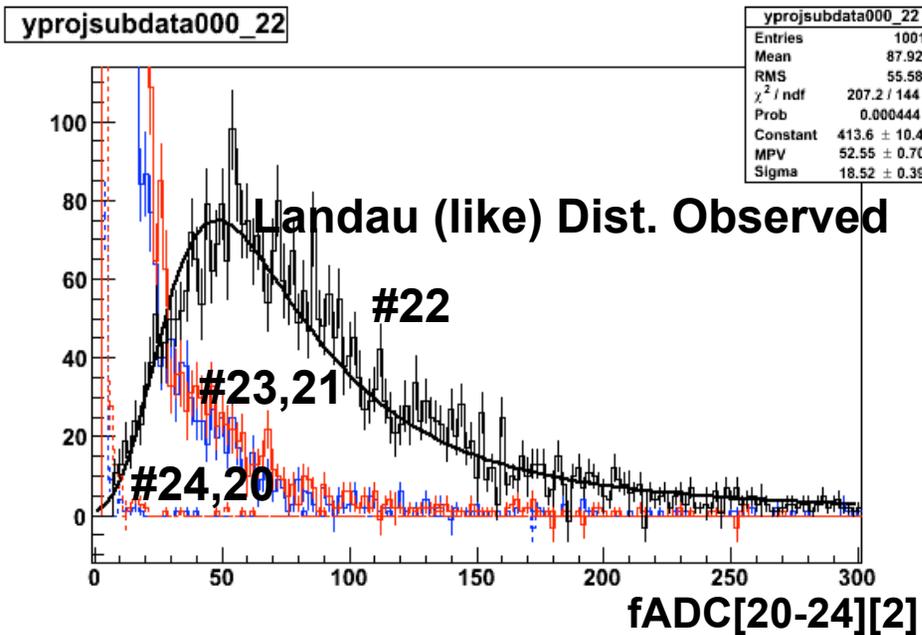
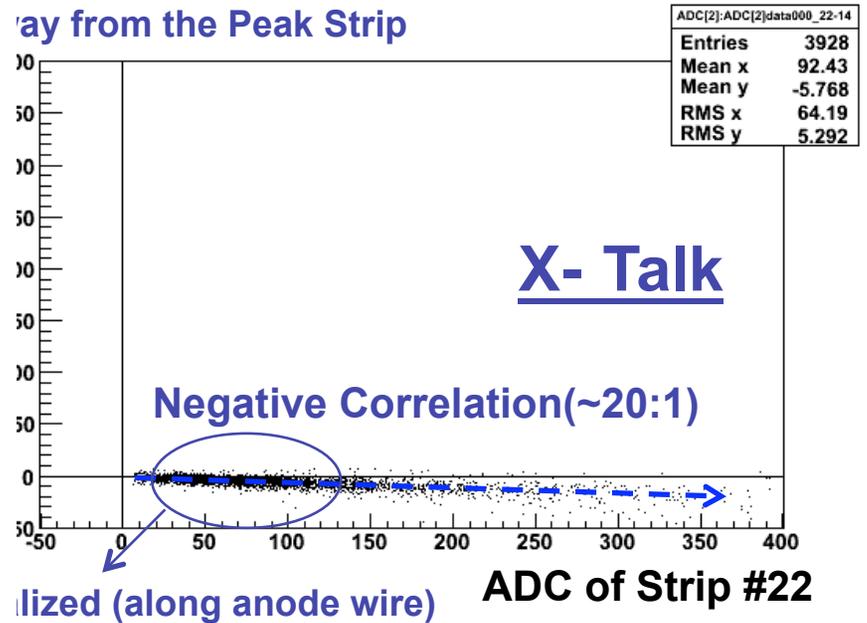
● Observed Cross Talk Effect w/o the circuit

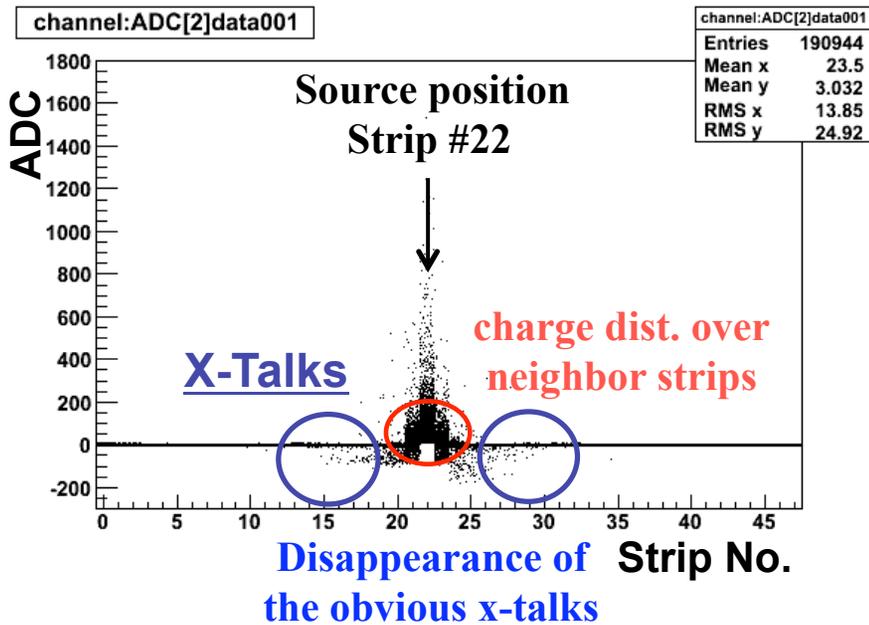
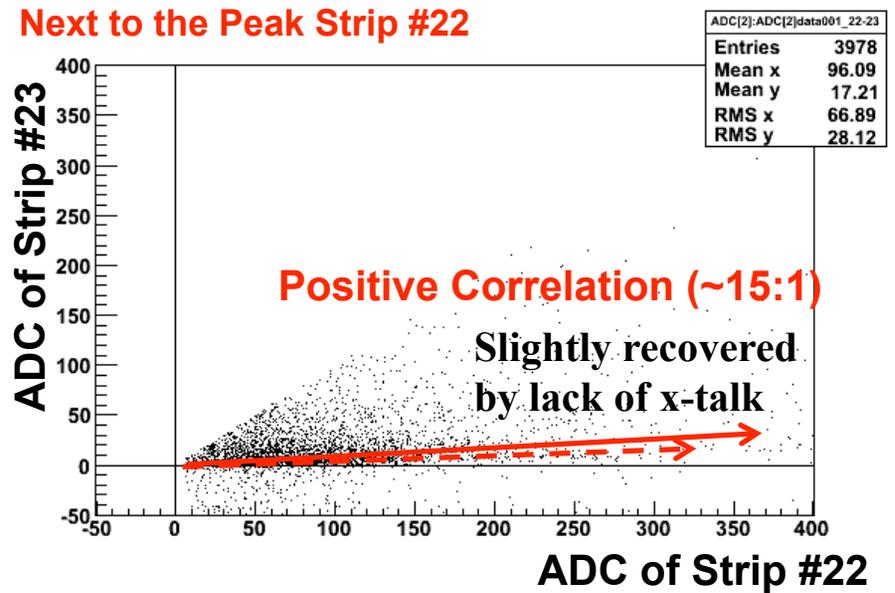
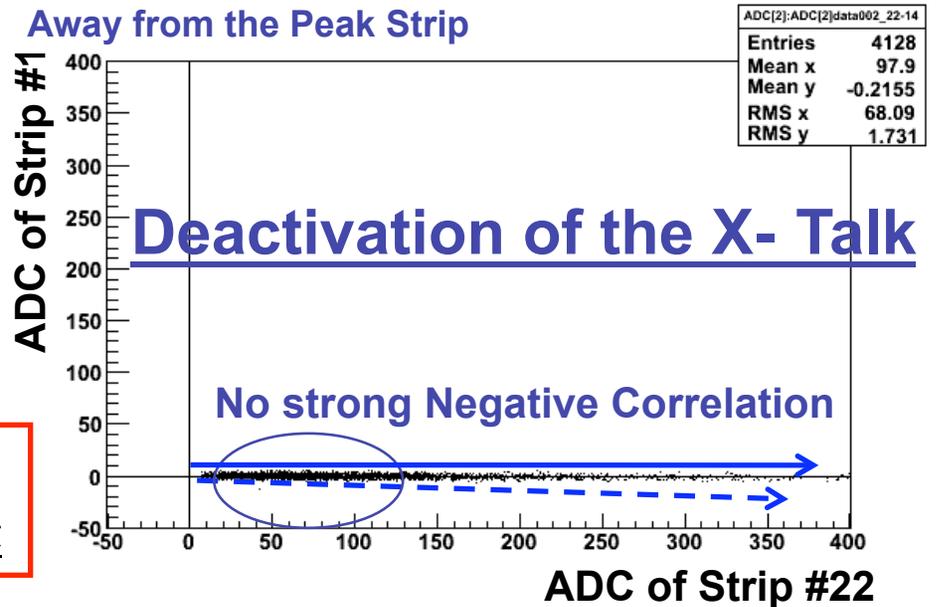
● **Observed Cross Talk Effect w/ the circuit (C = 100pF, R=360ohm)**

The installation of the compensating circuits surely suppress the x-talk effect

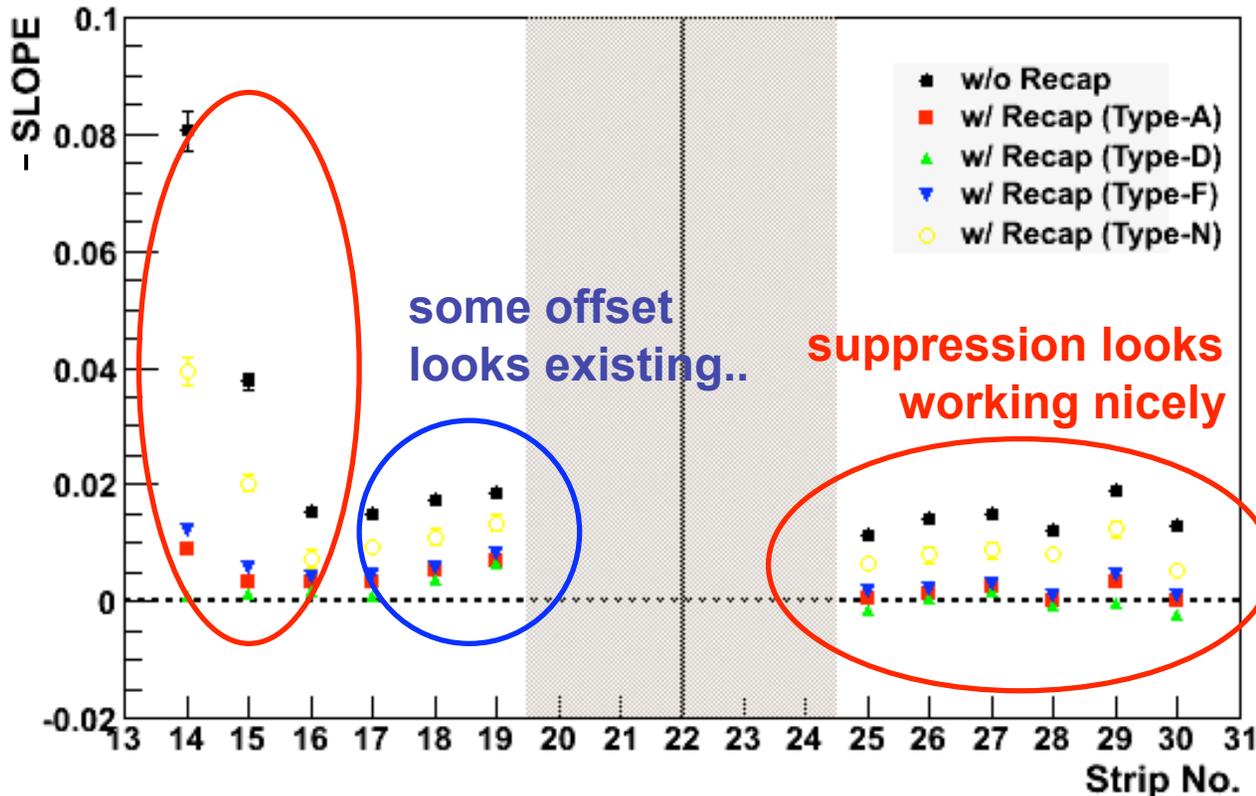
- Evaluation of the suppression effect by the circuit (ReCap) installation
 - Based on the correlation slope

Different types of C, R combinations

Type-A (100pF, 360Ω)

Strong Suppression

w/o Recap: Max 0.08 → w/ Recap (Type-A): Max 0.01 (PeakStrip:X-talk=100:1)
~1/10

- MuTRG becomes insensitive to its bipolar return of ~100(200)
MIP deposit for 40(100)mV MuTRG threshold.

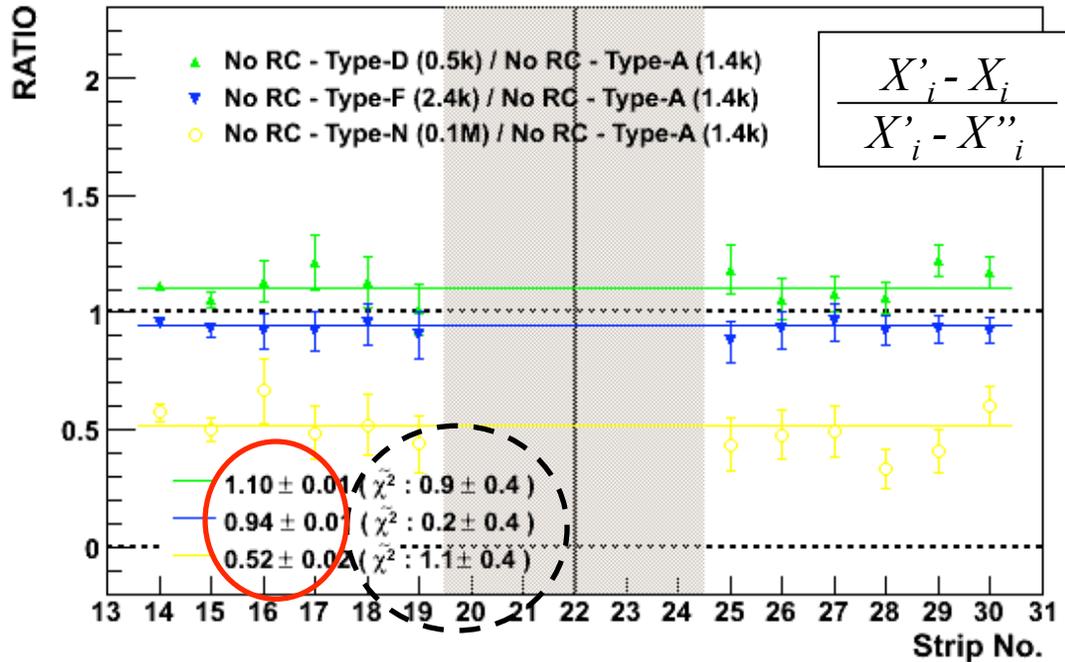
● Optimization of the ReCap parameter (C, R)

X-talk Effect X_i in each cathode strip

$$X_i \propto C_i | (Z_a - Z_c) / (Z_a + Z_c) |$$

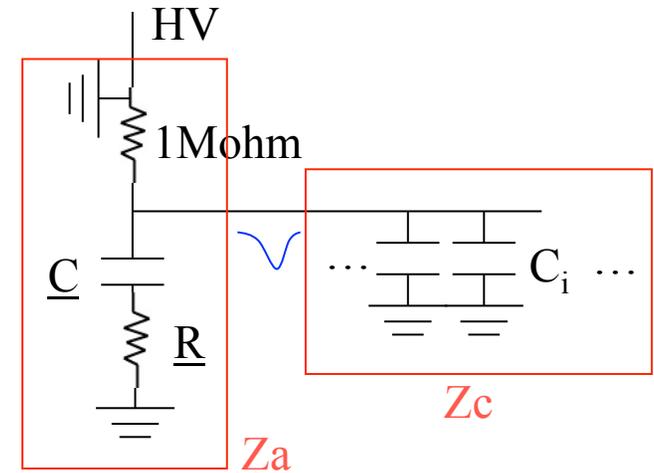
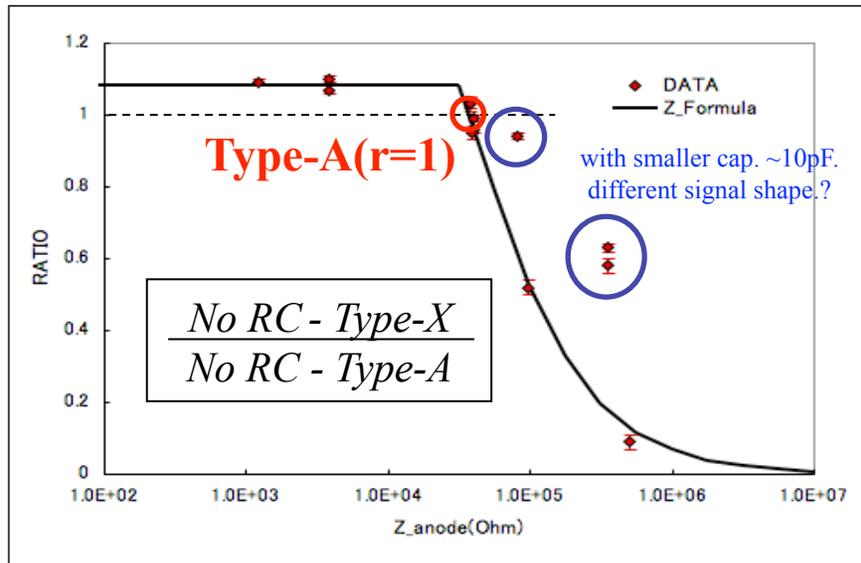
● Current Combination of C=100pF, R=360Ω (Type-A) shows enough (almost saturated) suppression

larger(smaller) C(R): will not improve so much the suppression effect of the current C-R combination

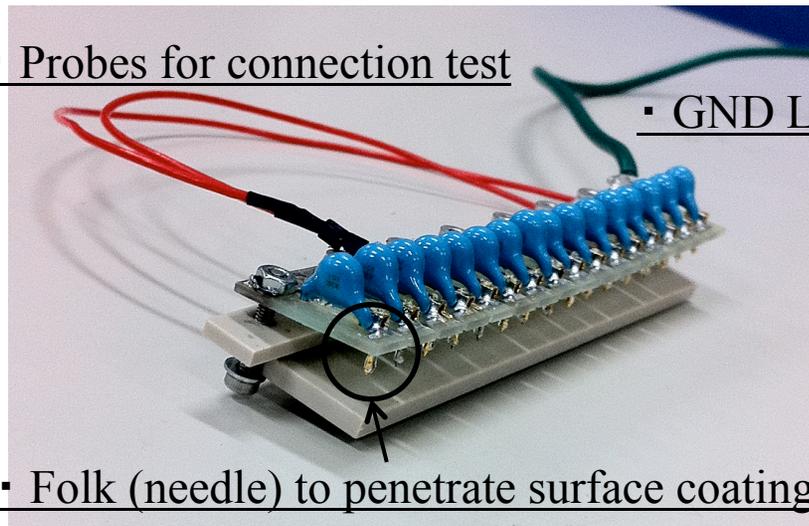
▪ Probes for connection test

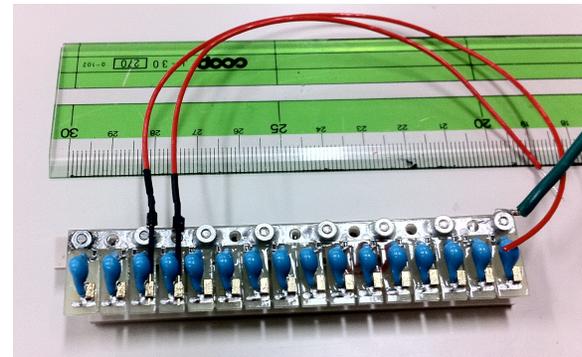
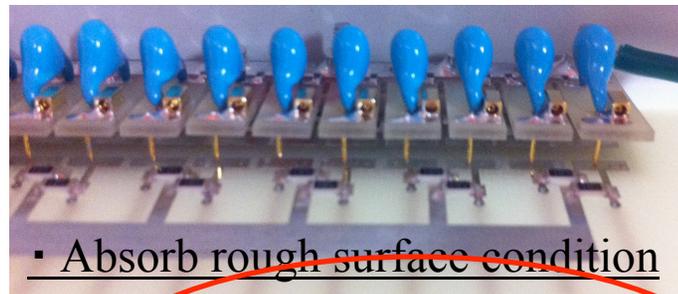
▪ GND Line

▪ Folk (needle) to penetrate surface coating

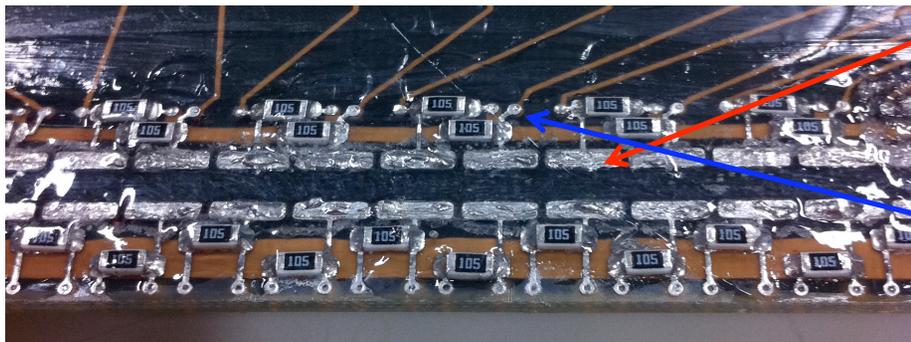
▪ Absorb rough surface condition

Leftover pad for the capacitance

Big Target

Rough surface

Through-hole to anode wire

Clean but Small Target (1Φ)

Need fine tuning

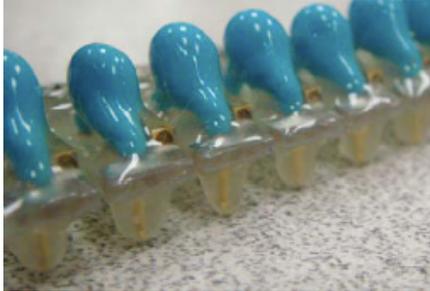
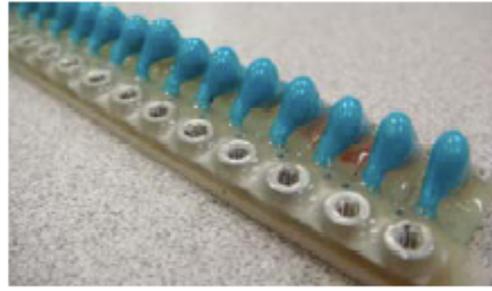
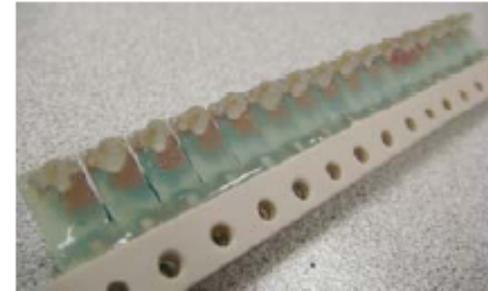
- To prevent moisture, polymer coating is carefully applied on the clamp

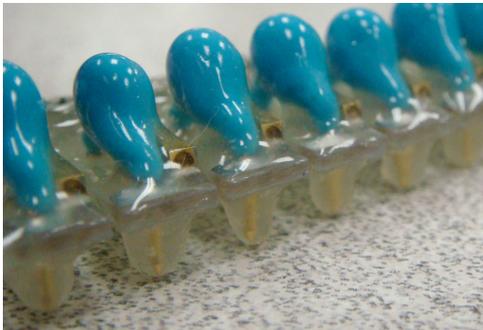
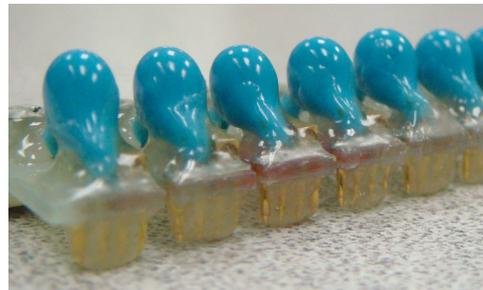
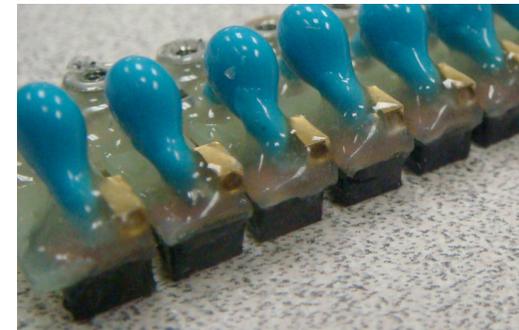
- 3 types of prototype clamps for testing (3 clamps for each type in our hand)
 - 1-pin Fork
 - 4-pin Fork
 - Conductive Rubber

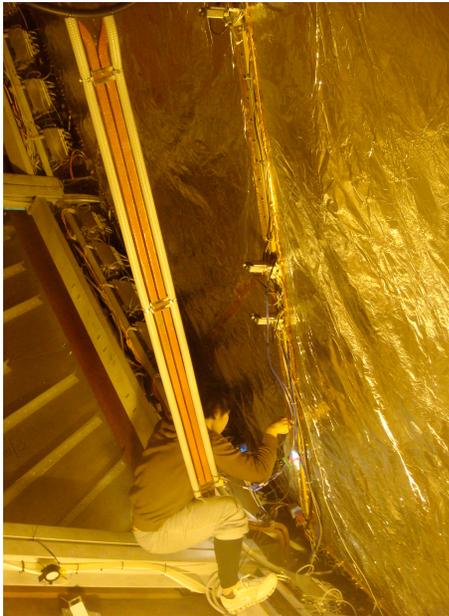
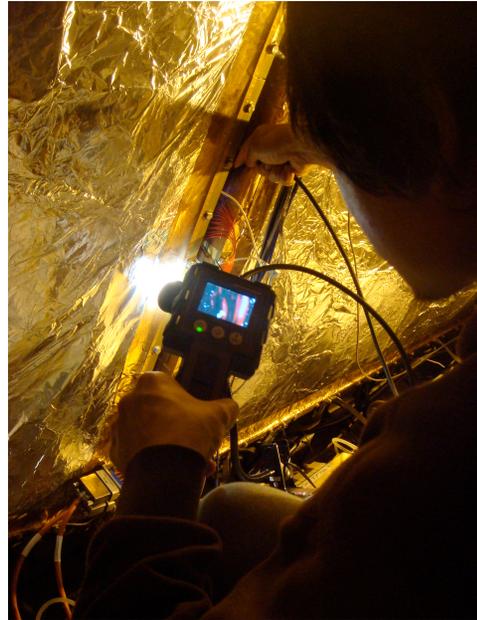
**Install target: Gap1 of Oct. 7-8 in North St. 3,
considering easy accessibility**

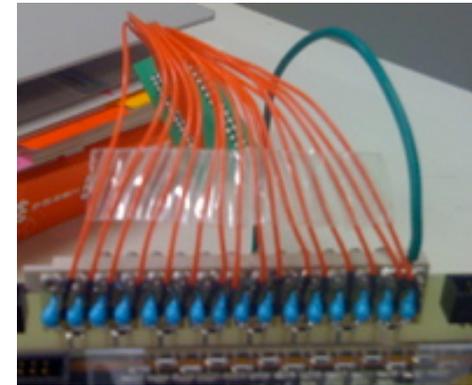
- Basically the designed clamp package mechanically works nice

achieving good alignment,
effective work of testing probes,...

We could achieve more than 95% contact

Connection failure observed in some channels were reasonably explained by measurements with the testing probes and scope observation.

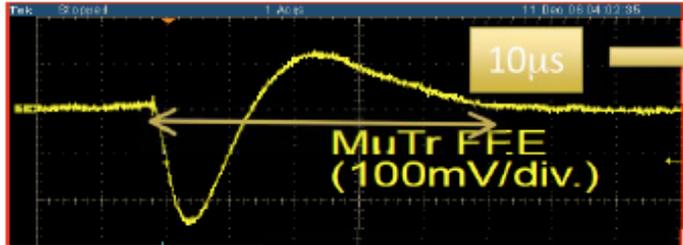
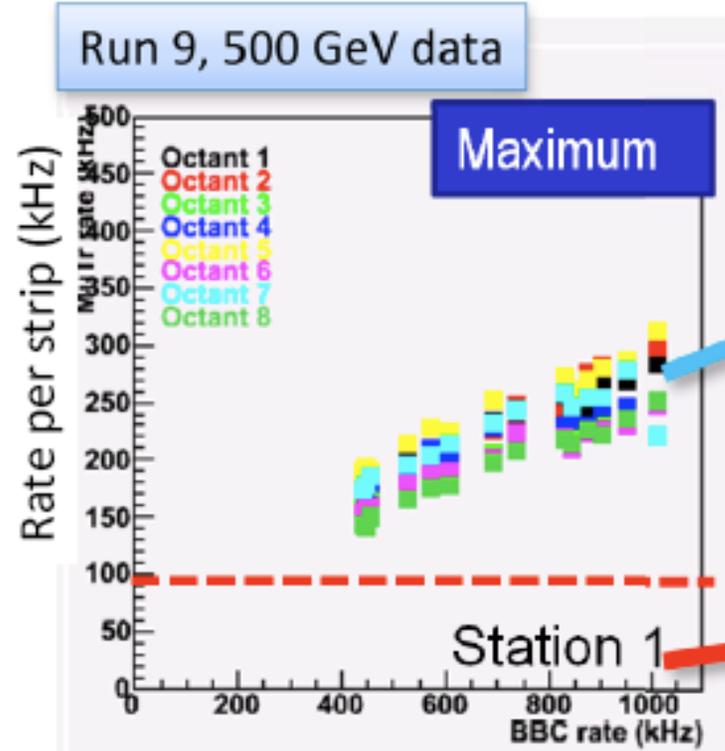
- **Pileups**

- **Effect to Off-line Analysis**

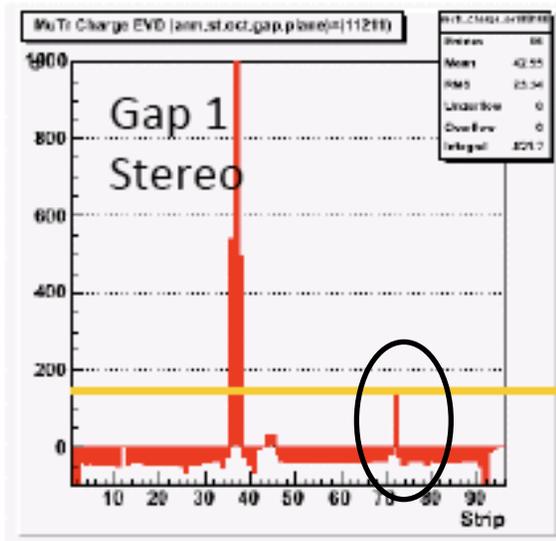
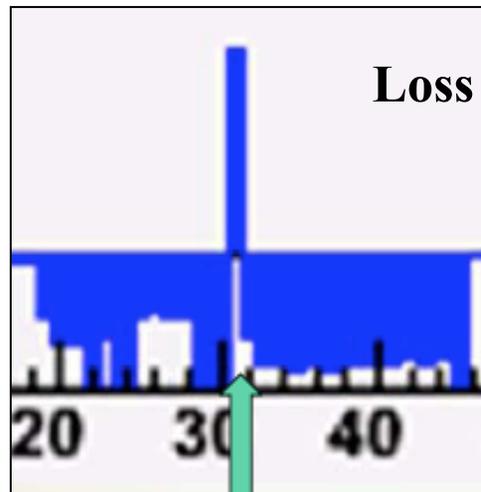
- **Charge Distribution**

Loss of real charge dist.

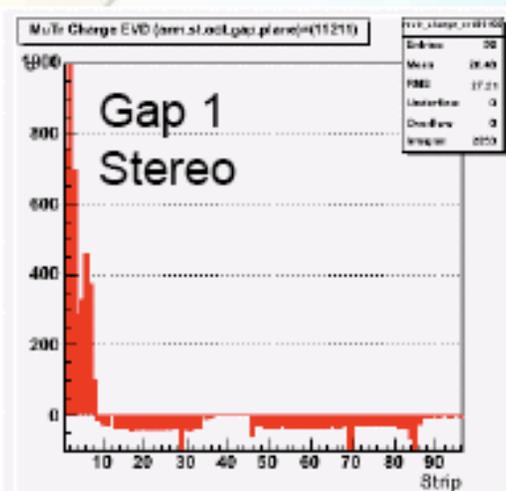
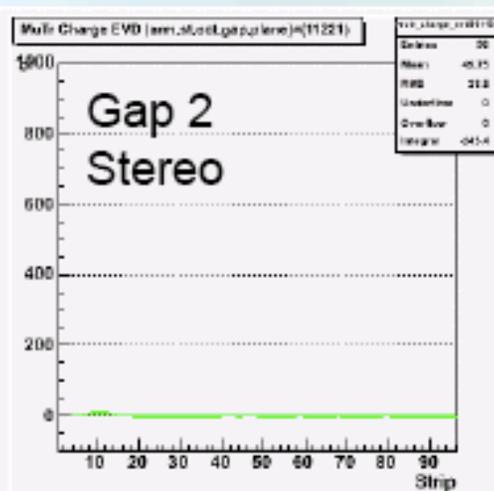
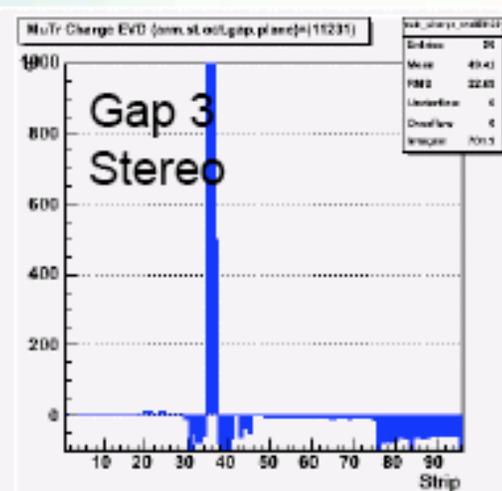
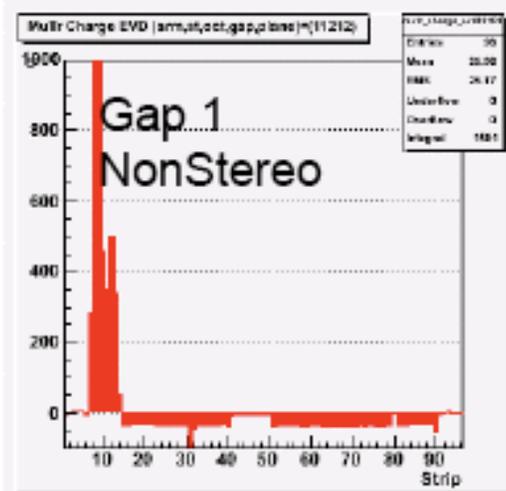
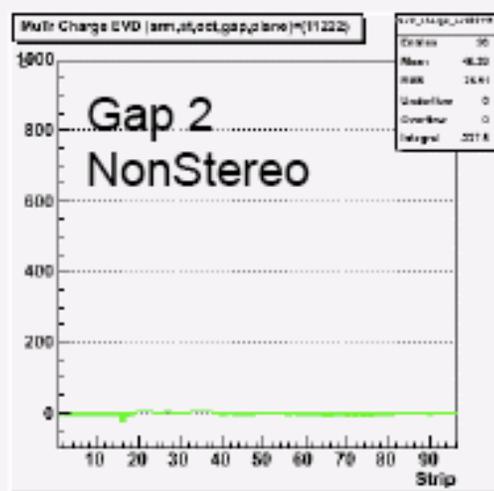
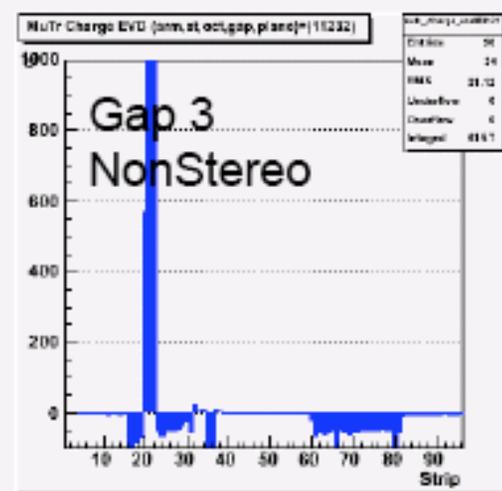
Hit distribution (200 GeV, zerosup OFF)

Pedestal - ADC(3)

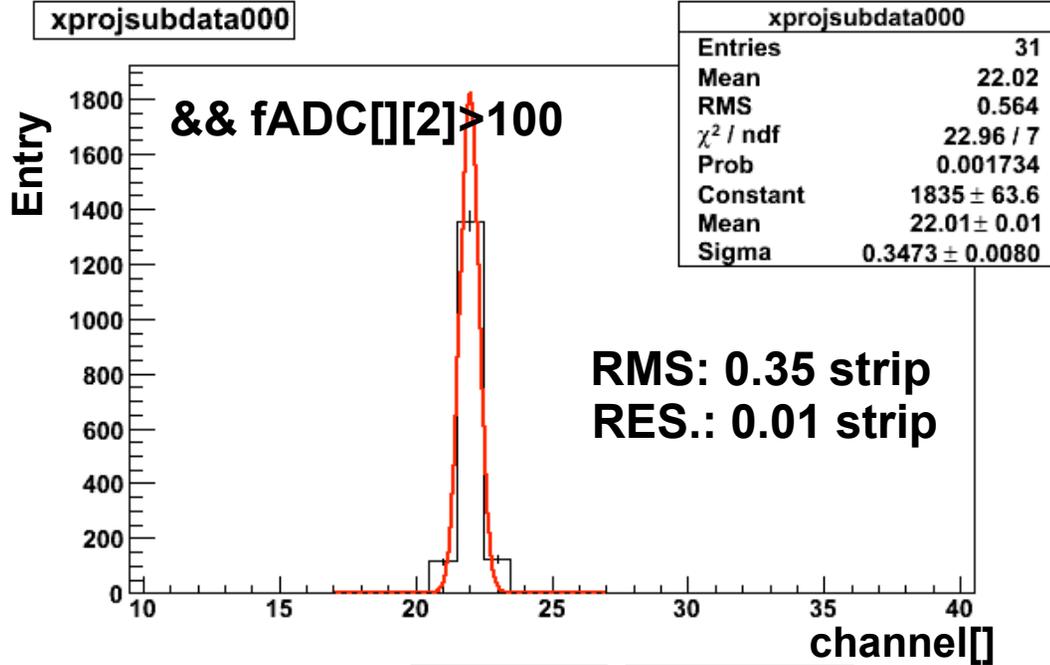
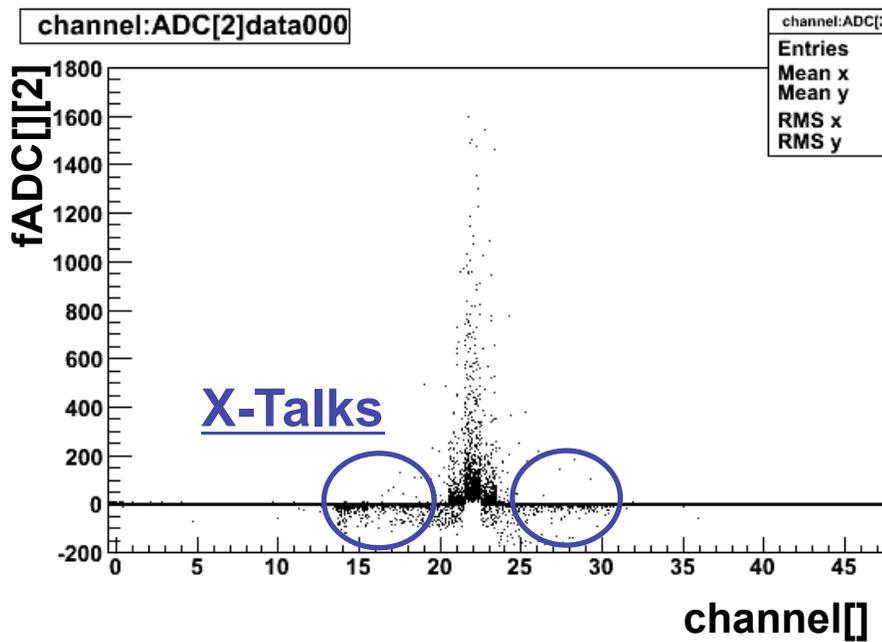
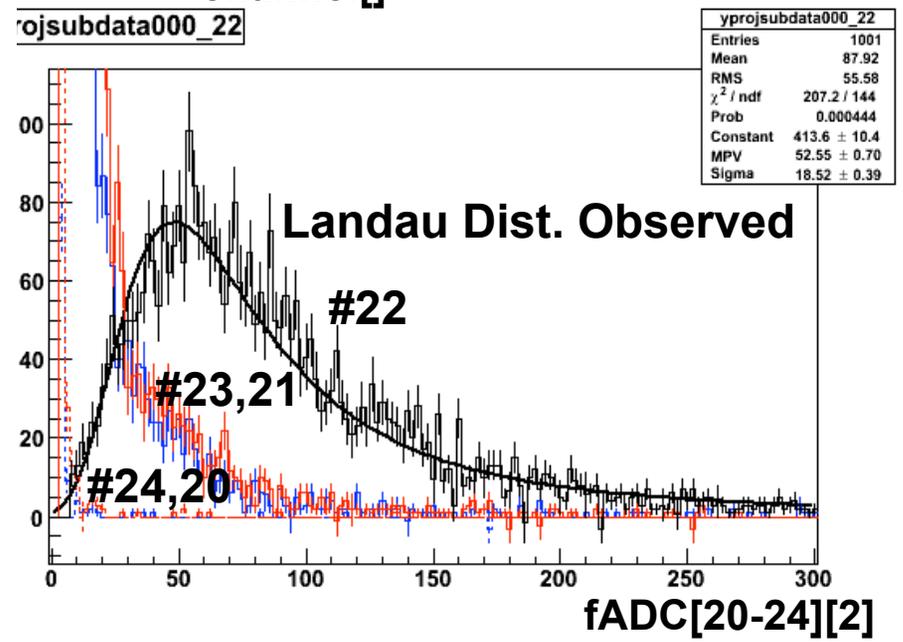
Ex. w/o Recap (15 min meas.)

mutr_strip_event000978_clk2424488676q

Strip

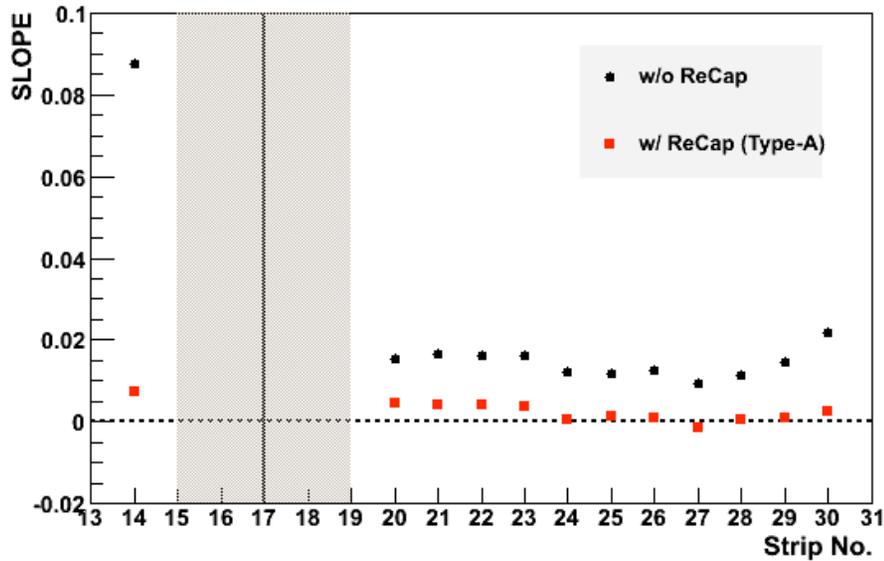
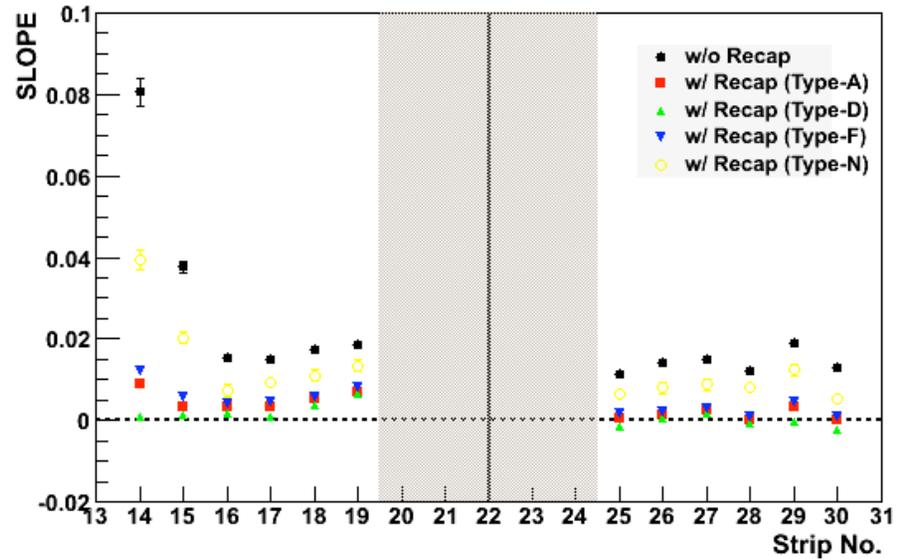
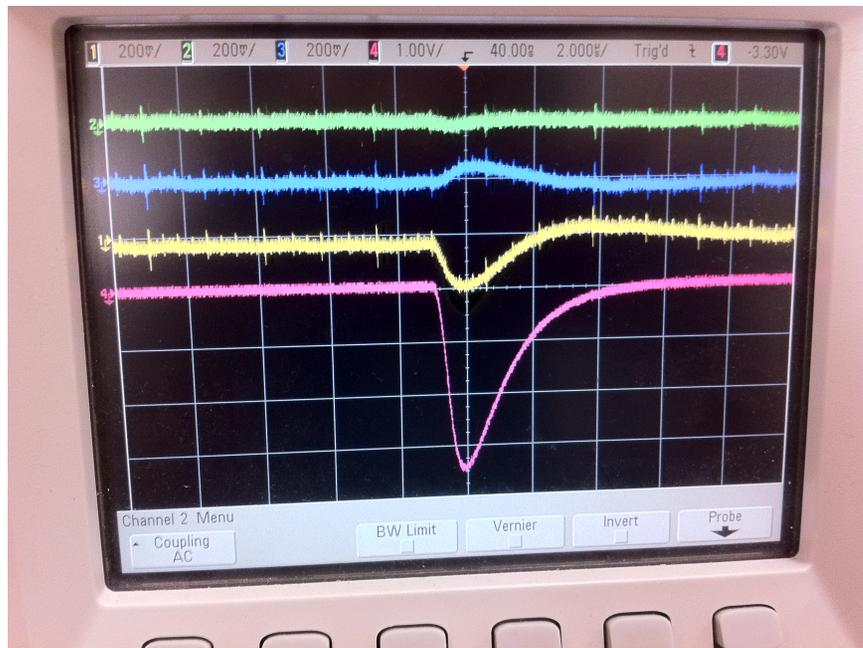
Different Behavior at Different Source Position

St. 28

St. 19

St. 24

St. 22

w/ Recap (Type-A)

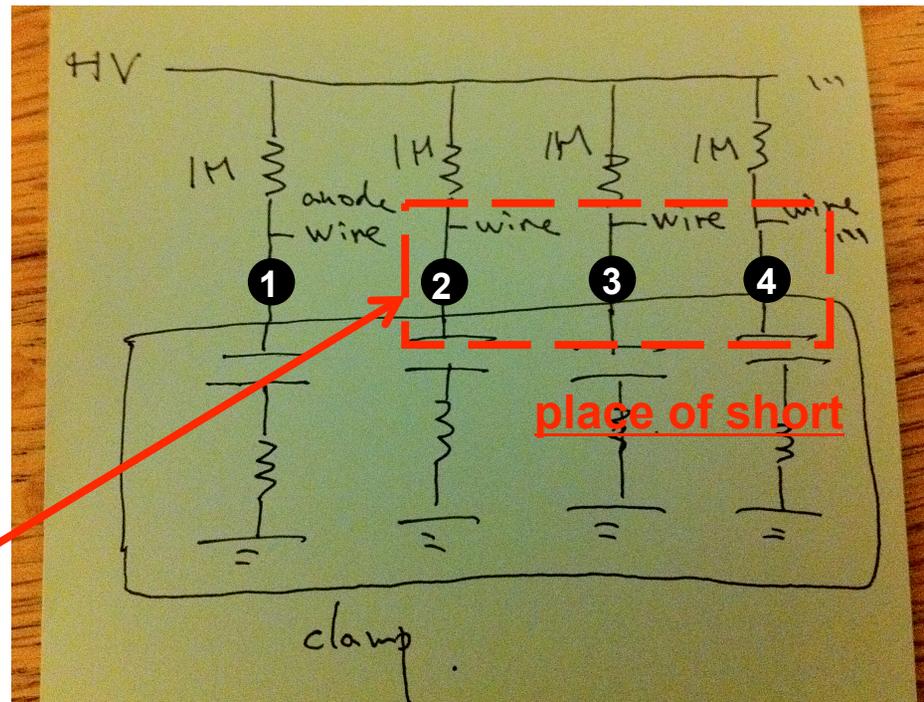
- Failure Case 2: lower resistance ($0(\Omega)$ vs $2M\Omega$ (normal cond.))
 between certain channels + sound voltages in all channels

by the measured resistance pattern between channels,
 the reason can be traceable to some extent

measured resistance

1-2,3,4: $1.3M\Omega$

1-others: $2.0M\Omega$

2-3,3-4,2-4: $\sim 0.0\Omega$

→ There is a short over the three channels somewhere in

● : measured points

scope survey did not find obviously strange pad and probe alignments...
 wires? circuit in anode card?
