PHENIX WEEKLY PLANNING

7/22/2010
Don Lynch

2010 Shutdown (Overview)

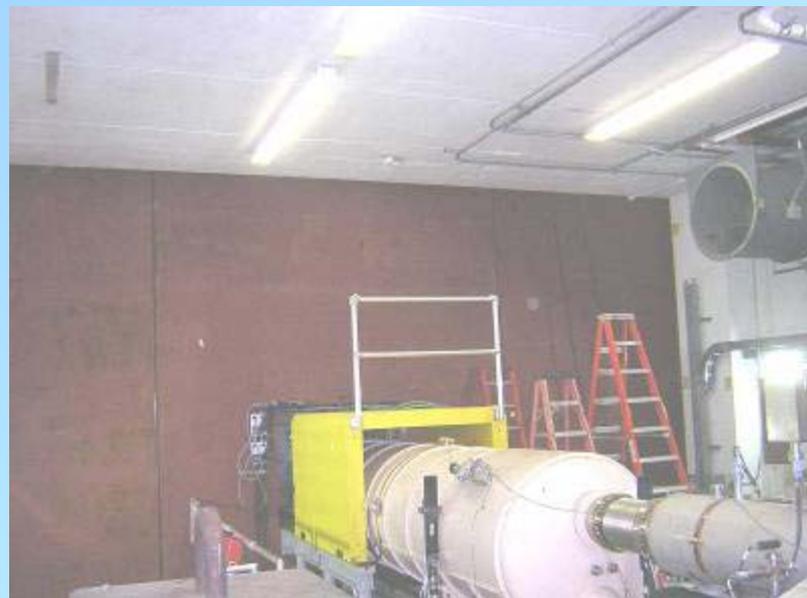
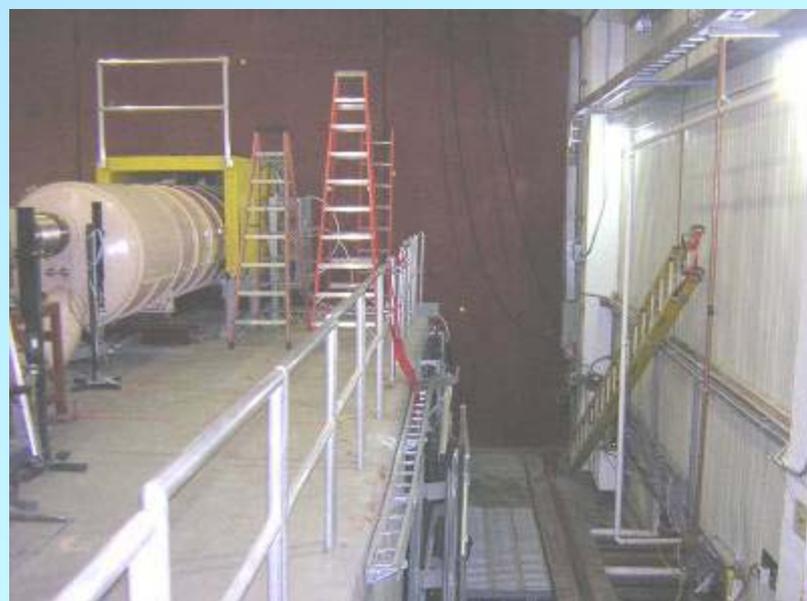
IR is currently in this configuration.

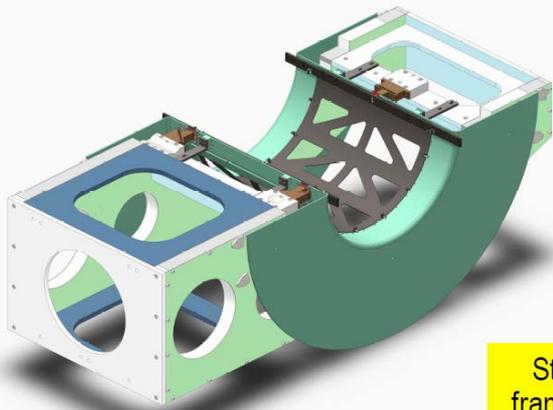
VTX Final Assembly

Start loading
frame Sept. 15th

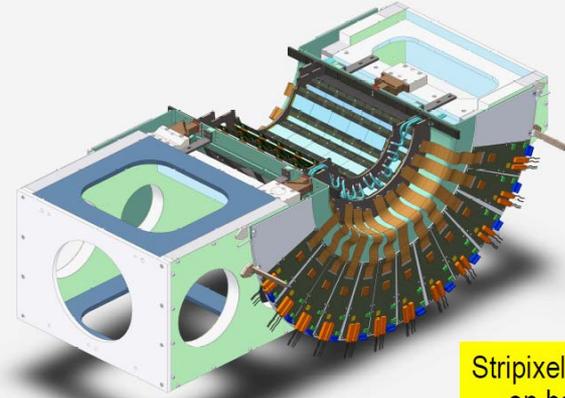
Stripixel layers L3/L4
on both halves
loaded by Sept 21st

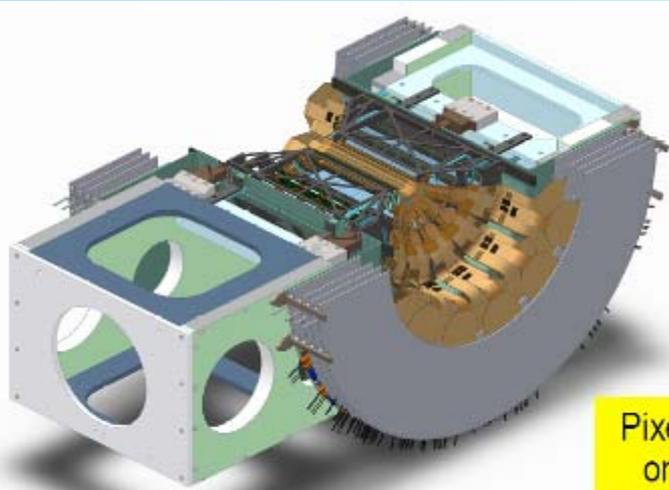
Pixel layers L1/L2
on both halves
loaded by Sept 30th

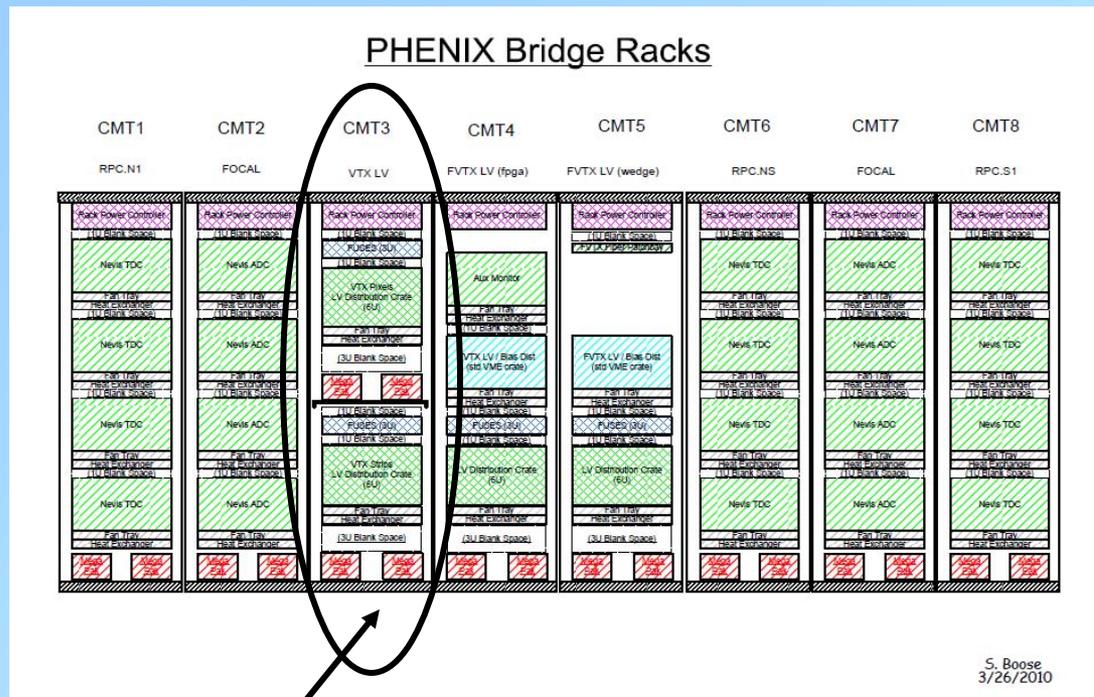
This rack to be installed this summer

1. HBD, RXNP Racks to be removed intact
2. Remove electric panels from 2 north sections of bridge
3. Temporary support for water pipes and cable tray
4. Remove 2 north sections of bridge to enable absorber installation
5. Reinstall 2 north sections, reconnect plumbing and cable trays to 2 north sections of bridge
6. Upgrade electric service to support 8 racks
7. Install 1-3 racks for VTX/FVTX electronics

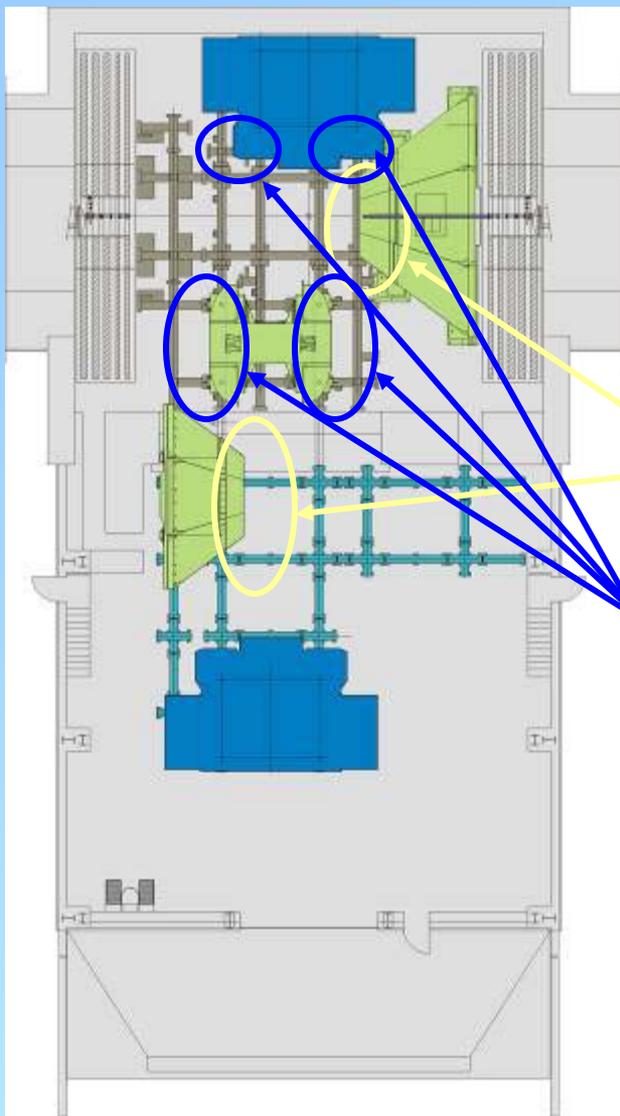
We expect the major PHENIX carriages and magnets to be in this configuration for most of August 2010. During this period the old PHENIX beampipe is removed, the north and south side of the CM is prepared for the absorber, the absorber is installed, work is done on MuTr and MuTrigger station 1, North and south and DC west.

Use CAD scissor-lift manlift to access work in these areas

Use (new?/PHENIX/CAD) manlift(s) to access work in these areas

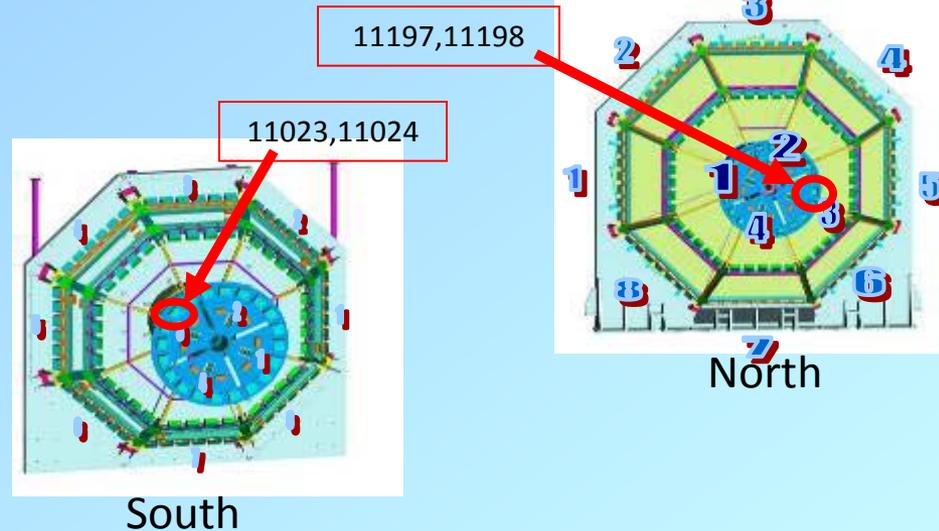
FEE - one FEM in each station-1

- 11023, 11024 - south S1 Q3 C2 (top); may be glink/clink RX module
- 11197, 11198 - north S1 Q3 C4 (bottom east); probably controller

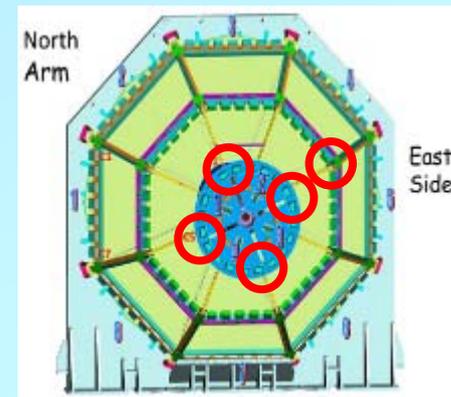
Calibration cable connections - fix terminations

- north S1 - O2 G1; O3,4 G3; O6 G3; O8 G2 - all infinite termination now
- north S1 - O3,4 G1,2 - 57 ohms (rest all 105 ohms)
- north S2 - O5 G1 - $\frac{1}{2}$ gain of all others (probably can't reach)

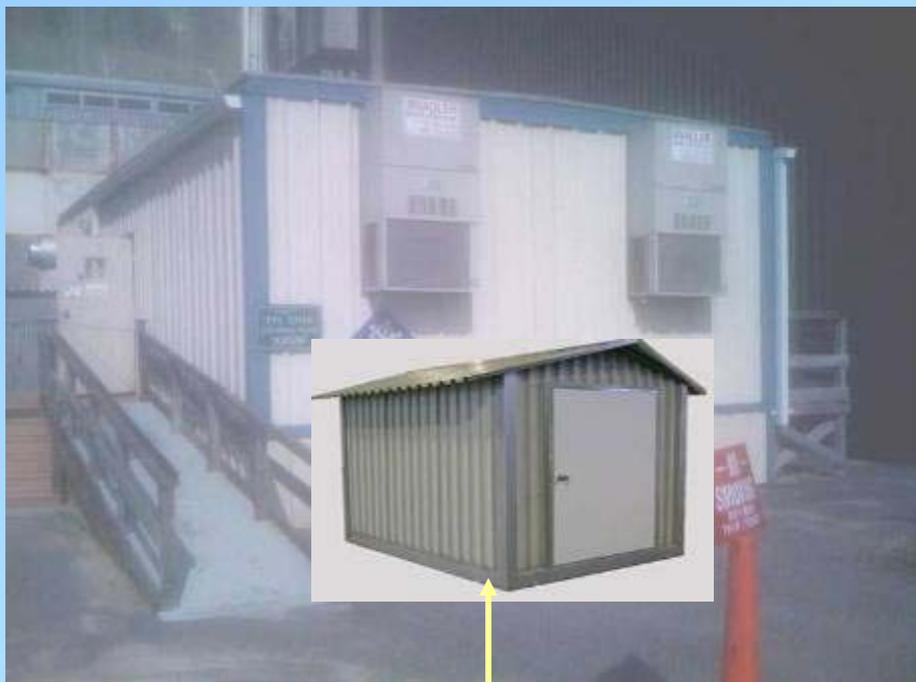
To be located in front of AC on east side of GMH

Proposed shed addition to Gas Mixing house

Purpose: to house/store larger bottles for R134A to keep up with TOF West & RPC requirements. No flammable gas, standard shed with heat. Barn style doors desirable. Palce on asphalt with no threshold to allow bottle management with pallet lifter.

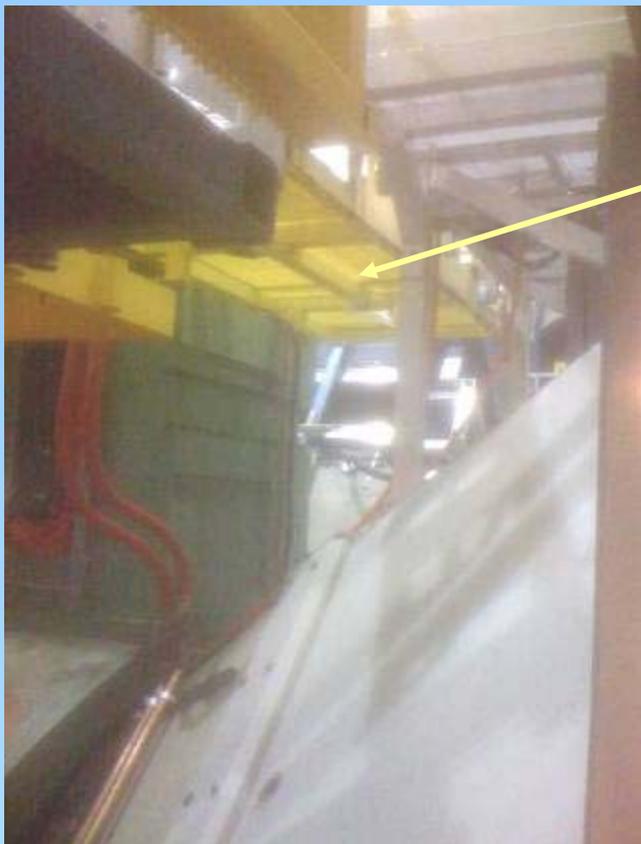
Need to take off 2 sections of Bridge to install north absorber.

- PHENIX Techs and electrician remove racks and breaker boxes and plumbing manifold

- CAD techs/Riggers take bridge sections down. Need this done by 8/6

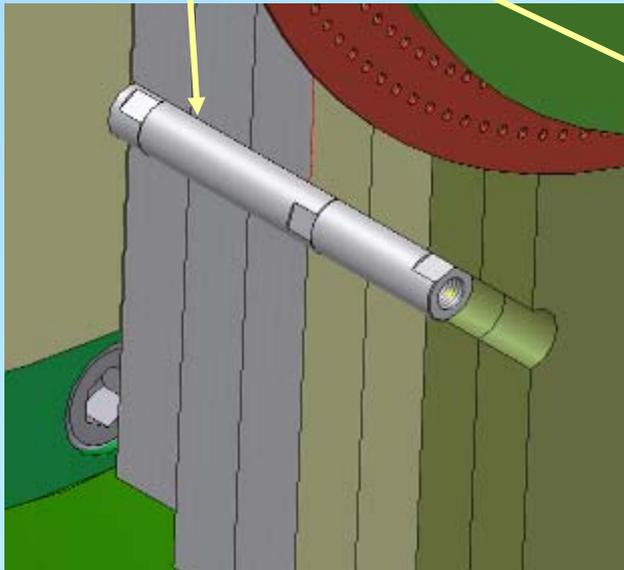
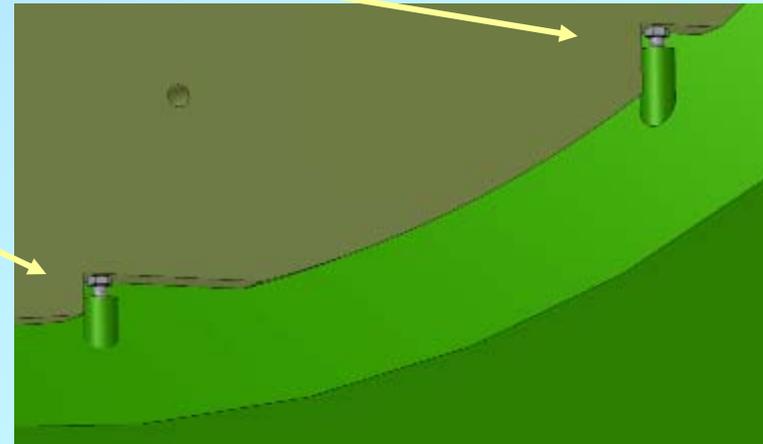
RPC Absorber Final Design

- Welded & tapped vertical support bossess
- 3 stage positioning rod

Absorber PO has been placed with ATLAS Tool and Die Works (Chicago)

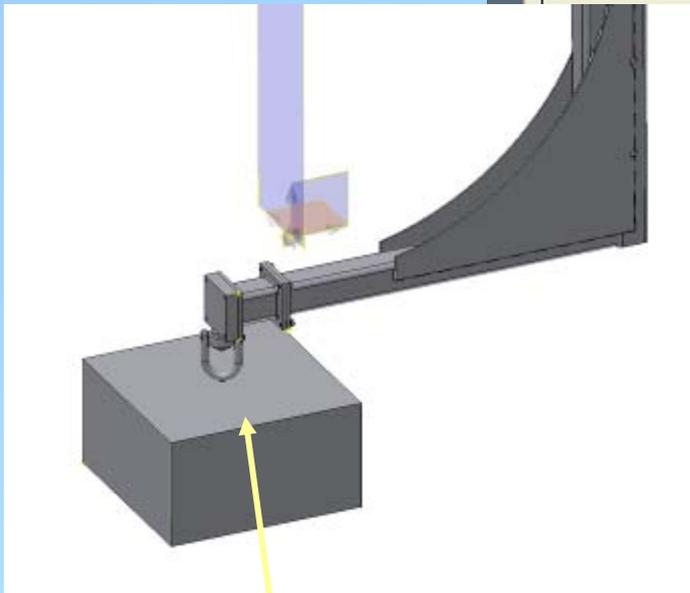
Design for absorber lifting fixture test arrangement

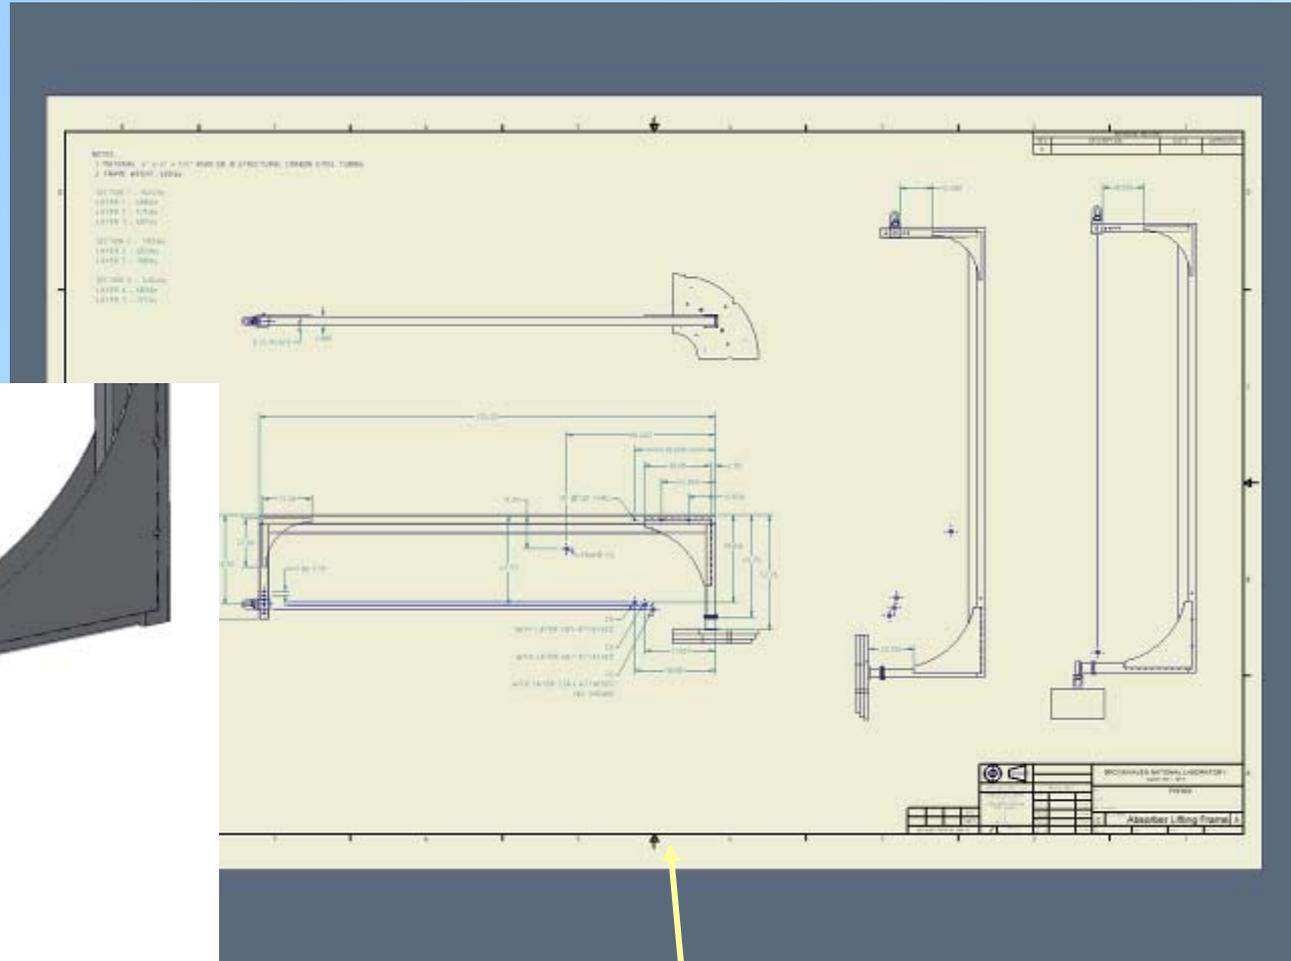
Absorber Lifting Fixture, initial design is complete, analysis in progress

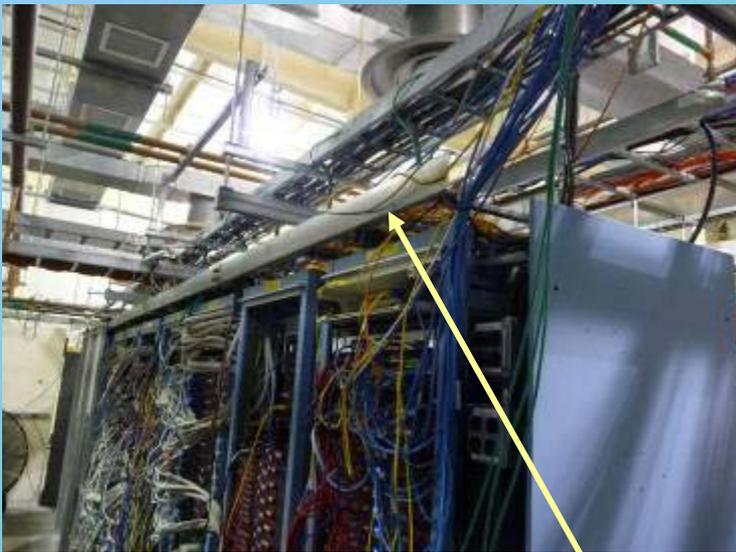
This is how it looks

- **The Event Builder Aisle**
- **This is the tray I'm talking about**

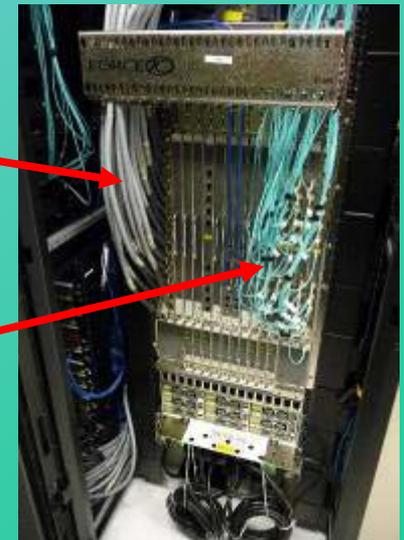
The future Switch

Standard Gigabit ports

“MRJ-20” cable bundles with 6 Gig ports each go to patch panels (or directly to the machines) May make our cable distribution easier, bring a few bundles to the racks

10GbE ports

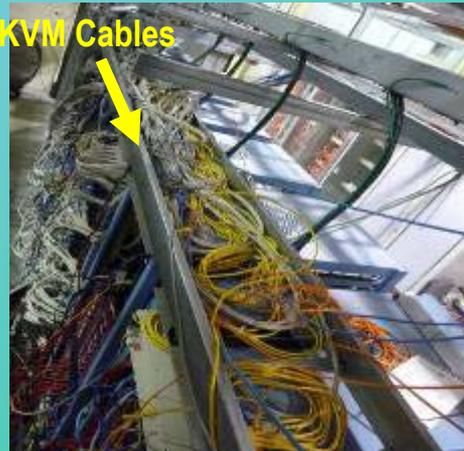
Tray from above and below

• KVM Cables

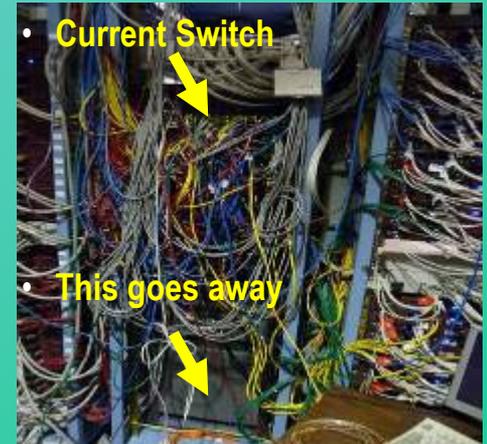
• Current Switch
